# Fire Risk Assessment

## Wesley Court

**Southbank Rd, Oldbury,  
Cradley Heath, B64 6LQ**

**Date Completed: 01/07/2024**

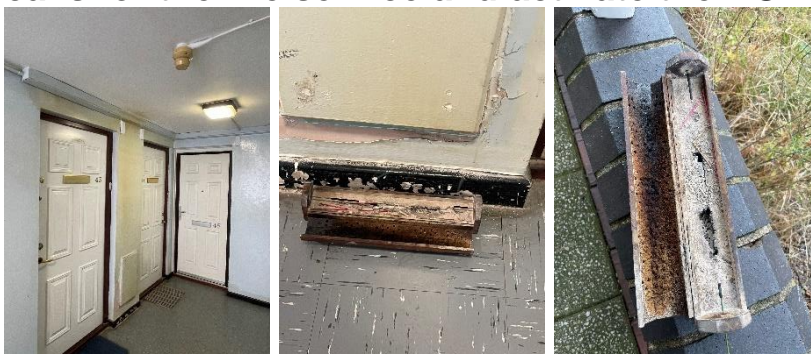
- 16) Incense sticks were found burning within a timber box in a 7<sup>th</sup> floor corridor adjacent flats 43, 44, 45. A significant amount of smoke was observed along with burning to the timber box they were housed within. Also, noted was a significant amount of staining to the nearby walls and flat entrance doors. The incense sticks and burning box were removed by the assessor and extinguished before handing the box to the caretaker.**

**Burning incense sticks in the communal corridor could have a negative impact on other residents, potentially ignite any combustible materials within the building, create false alarm calls for the fire service and activate the AOV system.**

<p>07/16</p>	<p>Tenants of flat 43 to be instructed to cease the burning of incense sticks within the communal corridor. <b>Note – This action was also raised on the previous FRA dated October 2022</b></p>

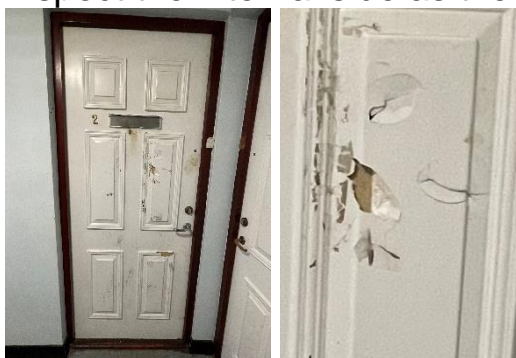
- A. Flat 2 – Entrance door had superficial damage to the decorative panels of the outer surface. The damage will not compromise the 30 minute fire resistance of the door. It was not possible to inspect the internal side as the resident was not home.

Flat 2 entrance door has superficial damage to surface. Replacement should be considered under any future door program.

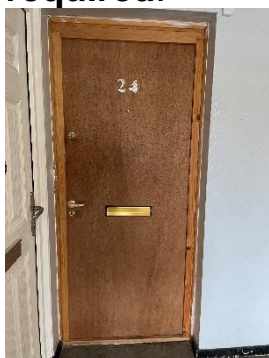
- B. Flat 24 – Door not reliably self-closing, adjustment required.**

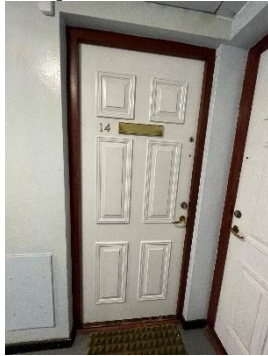
**G. Flat 14 – Door is not reliably self-closing, adjustment required.**

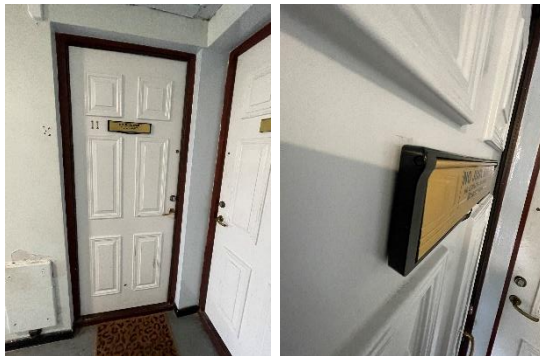
**H. Flat 11 – Letter box requires attention as is not securely fixed.**

P2	Within 3 months of action plan Fire Rapid Response	
07/27h	Flat 11 – Secure loose letterbox to entrance door.

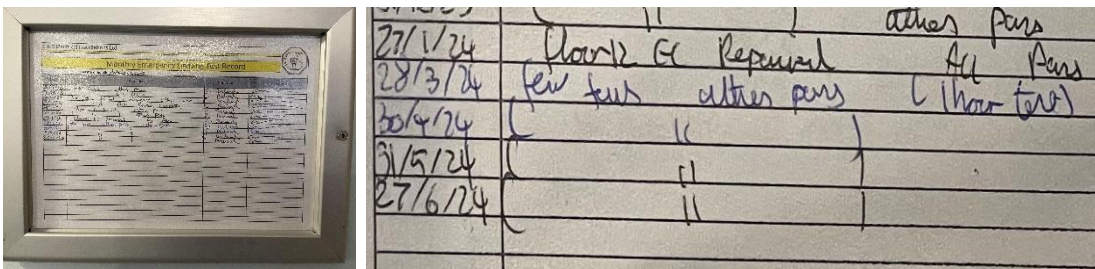
- 3) All installed equipment is checked and tested on a monthly basis by Sandwell MBC in house electrical team or approved contractor, in accordance with current standards. **All monthly tests from March 2024 have suggested that there are some faults within the system. Confirmation is required that all faults have been rectified.**

P2	Within 3 months of action plan Fire Rapid Response	
09/3	Confirm faults identified during each monthly emergency lighting test since March 24 have been rectified.

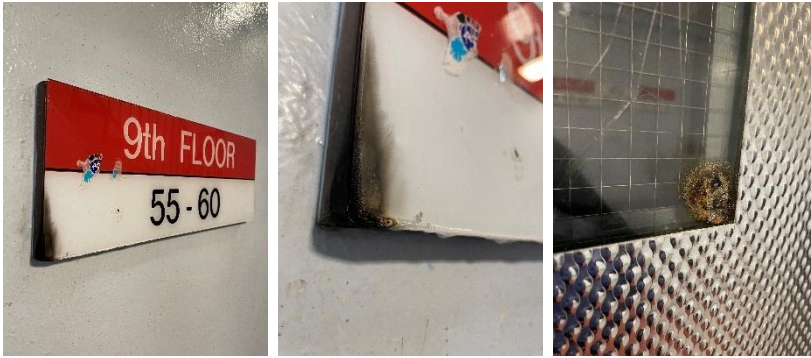
- 4) There is some evidence of arson to the 9<sup>th</sup> floor landing stairwell signage, resulting in some minor damage from applied heat to the lower left-hand corner. There is also a small area burnt to the vision panel of the lift car door on the 8<sup>th</sup> floor. Both items are still functional.
-
