# Fire Risk Assessment

## St Giles Court

**Reservoir Road,  
Rowley Regis  
B65 9PE**

**Date Completed: 09/02/2023**

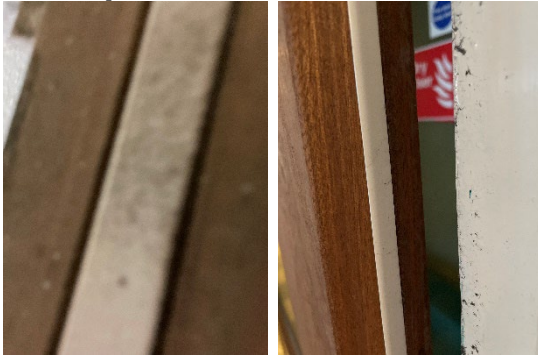
**28) 12<sup>th</sup> Floor. Fire door separating lobby from corridor, by staircase, requires cold smoke seal on leading edge.**

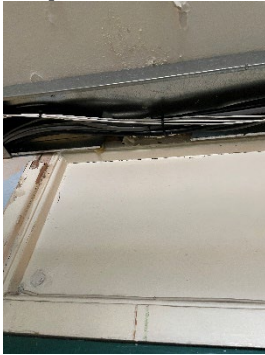
**32) 12<sup>th</sup> Floor. Fire door separating corridor and lift lobby has no cold smoke strips top and side.**

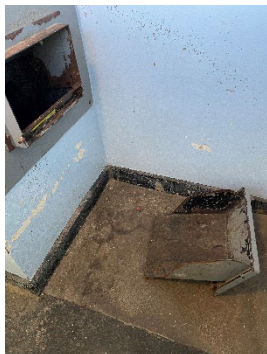
**48) Floor 8. Dry Riser Cupboard. No Lock.**

P2	Within 1 – 3 months of action plan. Rapid Fire. JM:10856968	22/05/2023
07/48	8 <sup>th</sup> Floor. Dry riser cupboard. Install budget lock to door.

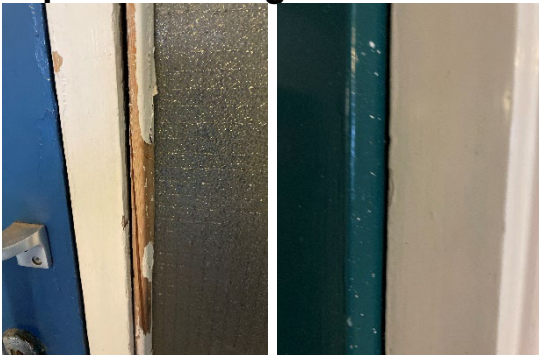
**51) Floor 8. Chute Room. Hole in boarded fan light.**

P2	Within 1 – 3 months of action plan. Rapid Fire JM:10857591	22/05/2023
07/51	8 <sup>th</sup> Floor. Chute room. Hole in fan light above store door. Fan light to be over-boarded with superlux.

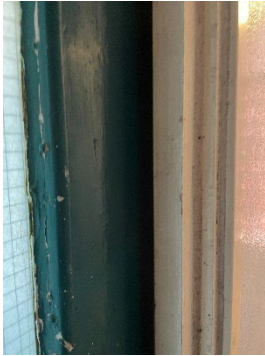
**60) Floor 5. Corridor door into lobby, by staircase, has a damaged cold smoke seal.**

P2	<p>Within 1 – 3 months of action plan. Rapid Fire.</p> <p>JM:10859019</p>	22/05/2023
07/60	5 <sup>th</sup> Floor. Corridor door into lobby by staircase. Replace cold smoke seal.

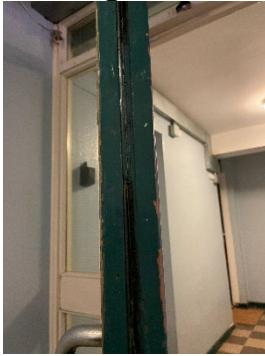
**61) Floor 5. Broken bolt lock to top of door to electrical cupboard.**

P2	<p>Within 1 – 3 months of action plan. Rapid Fire.</p> <p>JM:10859060</p>	22/05/2023
07/61	5 <sup>th</sup> Floor. Electrical cupboard.. Replace broken bolt

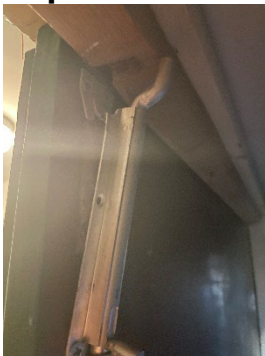
**62) Floor 5. Corridor Fire door by dry riser requires repair as crack evident.**

07/62	5 <sup>th</sup> Floor. Corridor fire door , by dry riser, requires suitable repair to maintain fire resistance.

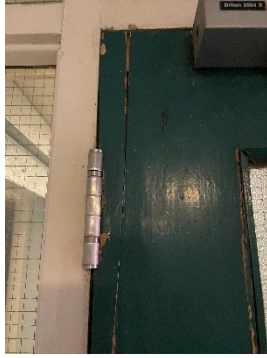
**63) Floor 5. Door 32 has had a suitable temporary repair . Flat not accessible at time of FRA to conduct further assessment (Jm 8225114)**

P2	Within 1 – 3 months of action plan. Rapid Fire. JM:10859219	22/05/2023
07/63	5 <sup>th</sup> Floor. Door 32 is damaged. Investigation is required to ascertain extent of damage and associated required action.

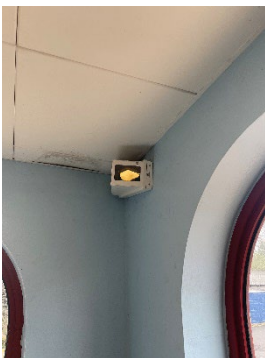
- 4) Evidence of arson was noted to the: ground floor internal window to corridor, flat entrance door 12 and side panel entrance to chute room on floor 2.
