Fire Risk Assessment

Addenbrooke Court

**Southbank Rd, Oldbury,
Cradley Heath, B64 6LJ**

Date Completed: 09/07/24

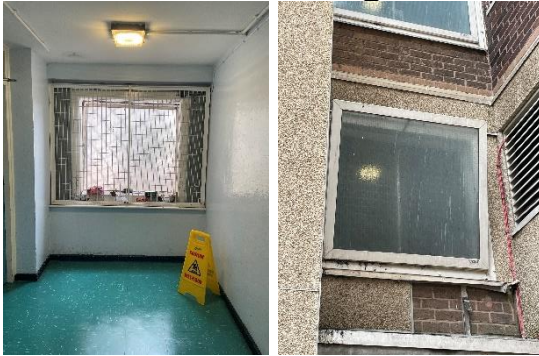
- 10) The AOV to the first floor lobby by flats 10, 11, 12 is defective and stuck in the open position due to the hinges failing. The assessor has been informed that replacement hinges are no longer available therefore, a solution to resolve the issue is likely to involve commissioning an engineering firm to re-manufacture the hinges.

7/10	Replace defective hinges to 1 st floor AOV that remains in the open position

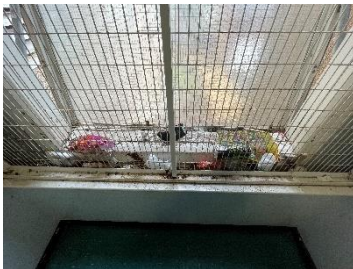
- 11) It was noted that due to the AOV being stuck in the open position there is a small amount of rubbish that has blown in and has become trapped between the AOV and the mesh grill. This will need to be monitored to prevent a build-up of combustible waste.

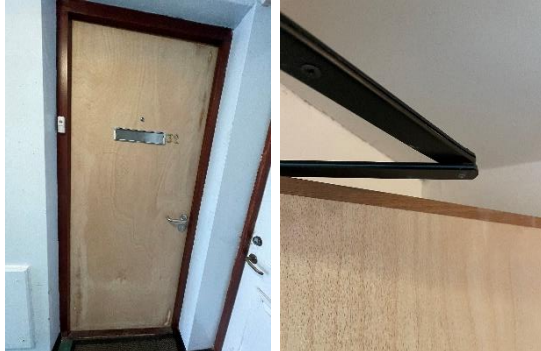
G. Flat 32 – Combined intumescent strip partially missing on lock side. Self-closing device arm catching on door leaf.

P2	Within 1-3 months of action plan. Fire Rapid Response JM14499015	
7/32g	Flat 32 – Replace missing section of combined intumescent / CSS strip. Self-closing arm catches on door leaf refit / adjust as necessary.		P2	Within 1-3 months of action plan. Fire Rapid Response JM:14499059	23/07/2024

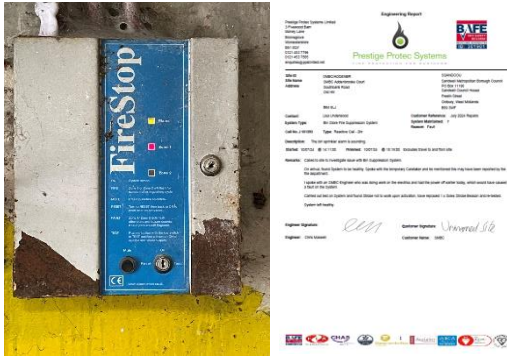
- 9) The control panel is within the bin store on the right hand side wall. At the time of the survey the control panel buzzer was sounding which indicates fault. The contractor was immediately informed to attend for inspection & repair. Update from contractor (10/07/24) confirmed that a strobe light had been replaced and the system is healthy.
-

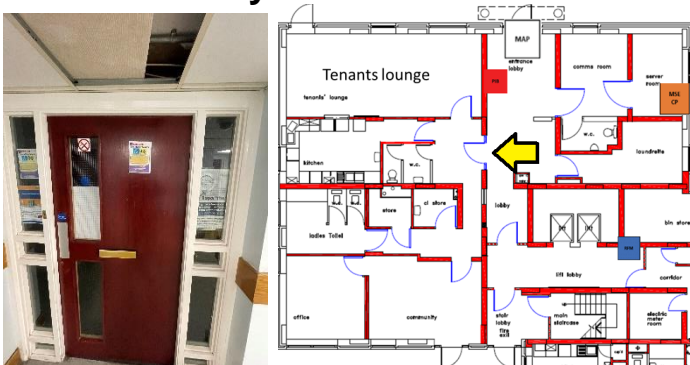
- 12) Enhance fire stopping above community room door from entrance lobby.

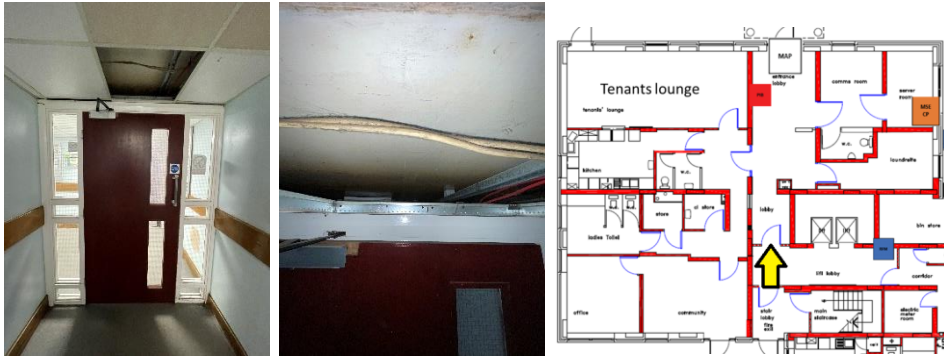
- 13) Fire stop above communal door from entrance lobby to lift lobby. Also, architrave is coming away requires fixing.
-

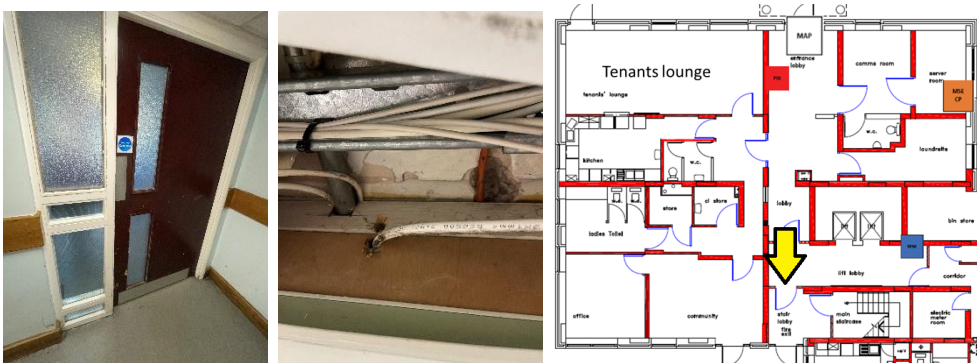
14) Fire stop penetrations above communal door from lift lobby to stairwell.

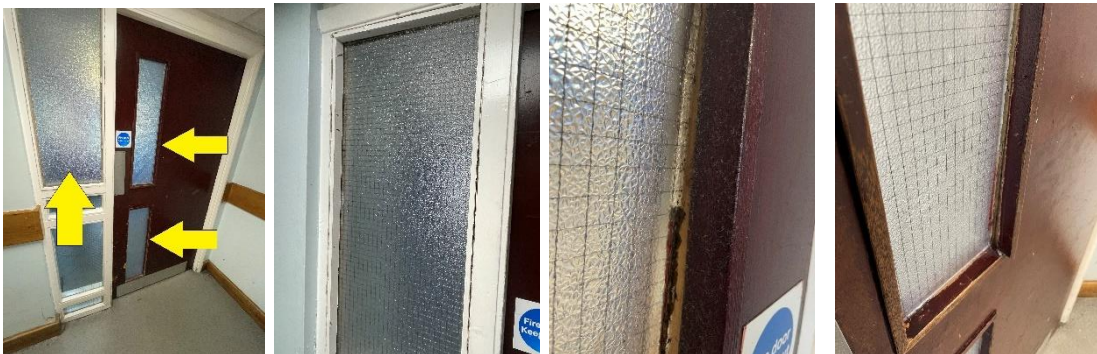
15) Communal door from lift lobby to stairwell, 3 x Fyberglaze GRP panels are loose and require refixing. Upper panel in combination frame is poorly fitted and loose. Upper panel in door - beading / panel not secure. Lower panel moves / not secure.

P2	Within 1-3 months of action plan. Fire Rapid Response JM:14496168	23/07/2024
10/15	3 x Fibreglaze GRP panels are loose and to be correctly re-fixed.

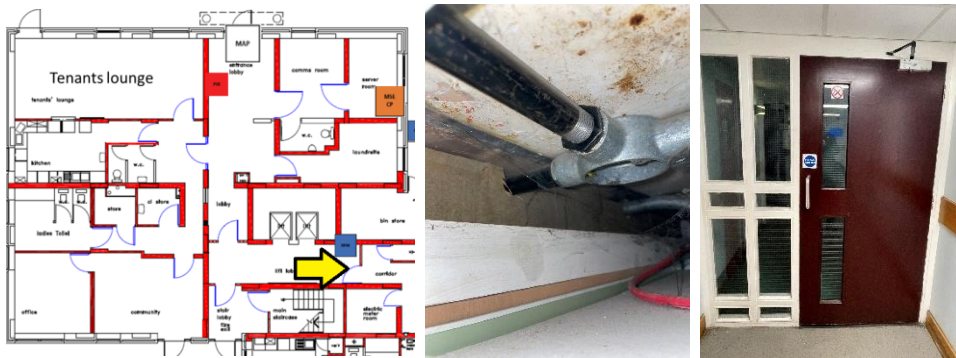
16) Firestop penetration holes above communal door from lift lobby to ground floor flats adjacent Dry Riser cupboard.
