# Fire Risk Assessment

## Addenbrooke Court

**Southbank Rd, Oldbury,  
Cradley Heath, B64 6LJ**

**Date Completed: 17/10/22**

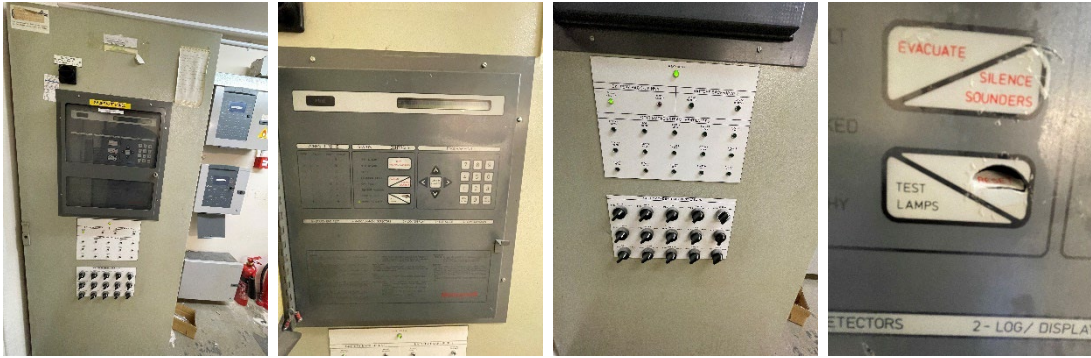
- 10) There is an indicator / control panel located on the wall of the ground floor Comms / Server room. This provides control over each individual vent and displays the status of the system. It was noted that the Test Lamps reset button has signs of wear however the system displays as healthy.

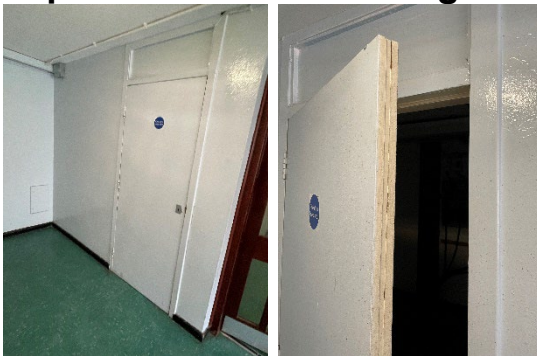
- 17) Service cupboards are FD30s rated and contain resident's electricity metres, automatic smoke ventilation reset panels and are secured with type 38 suited mortice locks. **1st floor service cupboard door is missing its cold smoke seal.**

Question/ Ref No	Required Action	Supporting photograph	Priority	Timescale and Person Responsible	Date Completed
07/17	1 <sup>st</sup> floor service cupboard reinstate missing cold smoke seal.

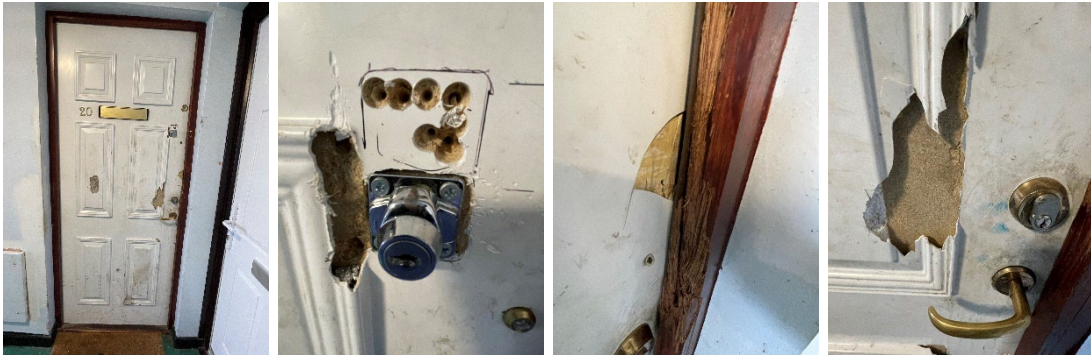
**22) Flat 20 entrance door & frame has been damaged by what appears to be signs of a forced entry. The external face of the door has also been damaged by attempts to fit an additional lock. It was not possible to gain entry to assess the internal side. It is recommended that this door is replaced with a new FD30s rated door set.**

07/22	Flat 20 – replace damaged door with FD30s door set

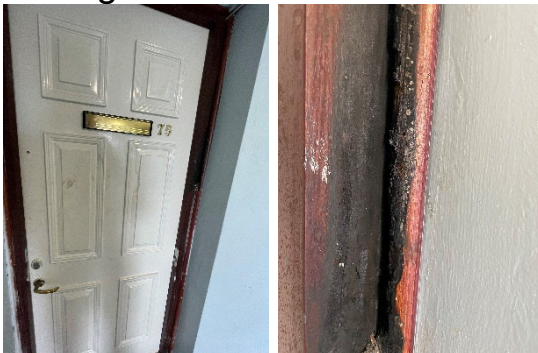
23) Flat 75 – there is an area of burn damage to the bead around the frame of the entrance door. This has not caused any significant damage to the door or frame. Occupier was not home.

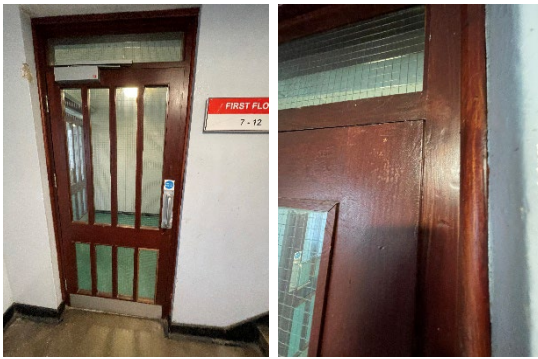
**25) 1<sup>st</sup> floor – stairwell door binds and doesn't reliably self-close into frame.**

P1	Within 10 days <b>Repairs</b> JM9964320	09/02/2023
07/25	1 <sup>st</sup> floor – Stairwell door binds doesn't reliable self-close, requires adjustment.

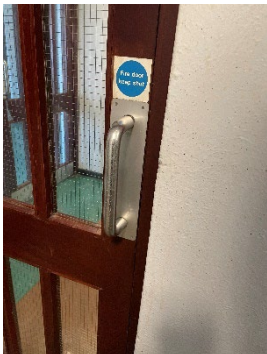
**26) 2<sup>nd</sup> floor stairwell door has loose handle.**

07/26	2 <sup>nd</sup> floor – Stairwell door tighten loose handle.

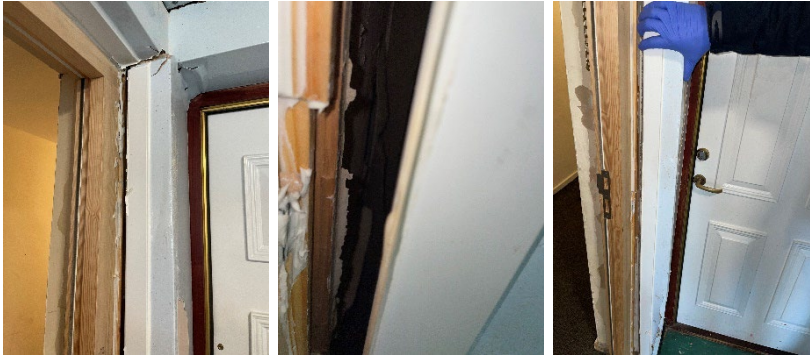
**27) 4<sup>th</sup> Floor - Between flats 26 & 27 entrance doors the stud wall has been dislodged following a forced entry to flat 26. Compartmentation to the flats is intact and the wall is still secured on one side however should the wall come fully away**

it could compromise the means of escape for some individuals.

P2	Within 1 – 3 months. Fire Rapid Response JM:9806798	02/11/2022
07/27	4 <sup>th</sup> floor – Make good damaged / loose stud wall between flats 26 & 27

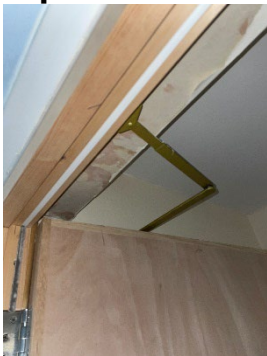
28) 4<sup>th</sup> Floor - Flat 26 entrance door requires cold smoke seal to top of frame.

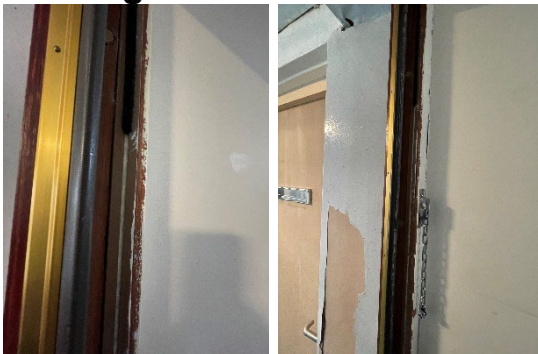
29) 4<sup>th</sup> Floor - Flat 27 entrance door section of cold smoke seal missing from side of frame.

<p>P2</p>	<p>Within 1 – 3 months. Fire Rapid Response JM:9806818 JM10176990</p>	<p>09/02/2022</p>
<p>07/29</p>	<p>4<sup>th</sup> floor – Flat 27 reinstate missing cold smoke seal to lock side of frame.</p>

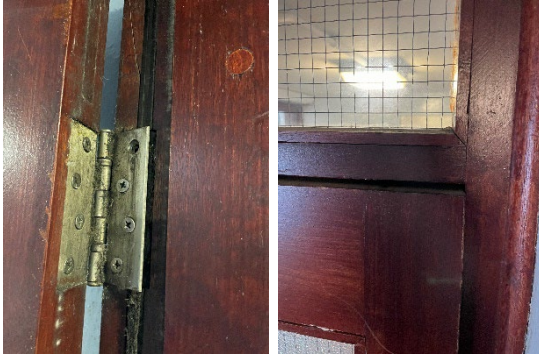
30) 4<sup>th</sup> Floor – Door to protected stairwell not reliable self closing into frame and there is a screw missing from one of the hinges.

<p>P2</p>	<p>Within 1 – 3 months. Fire Rapid Response JM:9806834</p>	<p>03/11/2022</p>
<p>07/30</p>	<p>4<sup>th</sup> floor – Stairwell door requires adjustment, not reliably self-closing into frame. Also replace missing screw to hinge.</p>

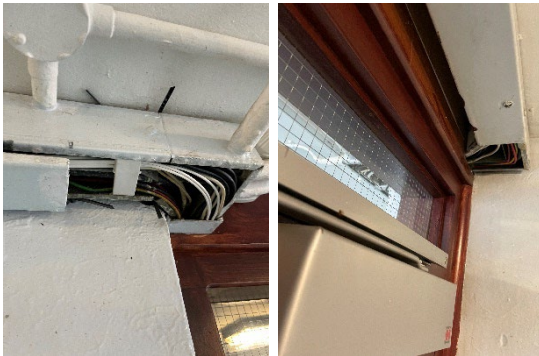
33) 5<sup>th</sup> floor – Covers are missing to a section of trunking either side of the communal door near to flat 31. Compartmentation is maintained. Cable management will be upgraded as part of a future refurbishment.

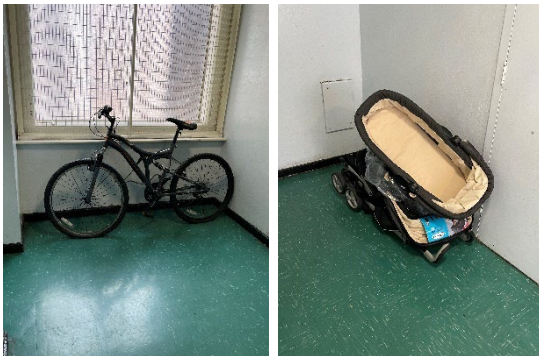
**34) 5<sup>th</sup> floor by flats 34, 35, 36 – Bike and pushchair in communal corridor.**

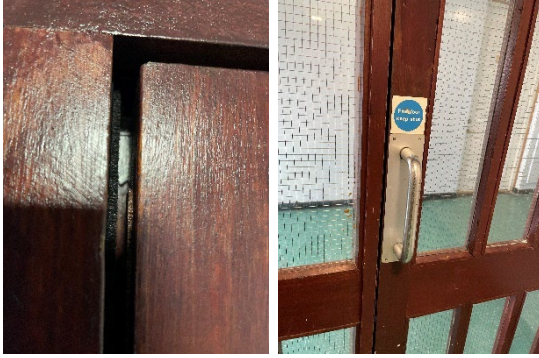
**35) 9<sup>th</sup> floor – communal door near to flat 55 has a loose handle and excessive gap on leading edge.**

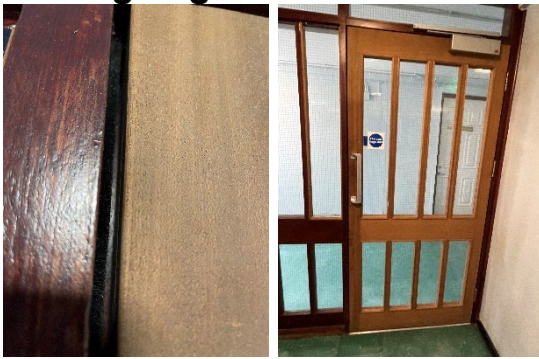
**36) 10<sup>th</sup> floor – Communal door by flat 64 excessive gap on leading edge.**

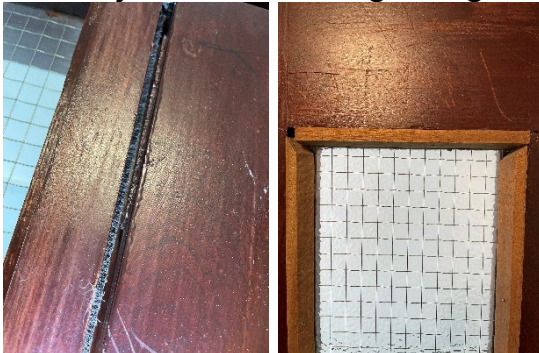
**37) 11<sup>th</sup> floor – Communal door by flat 70 excessive gap on leading edge.** It was also noted that the beading to one of the vision panels has been poorly installed with poor workmanship to mitred joints however glazing is sufficiently secured.

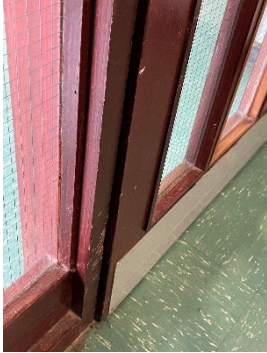
**38) 12<sup>th</sup> floor – Communal door near to flat 76 doesn't reliably close fully into frame leading lower edge.**

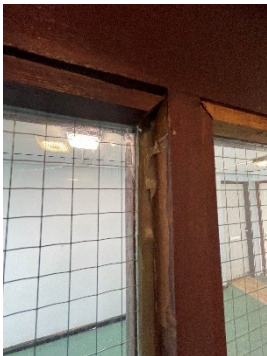
**39) 12<sup>th</sup> Floor – Section of beading is missing to glazing on communal door near to flat 73.**

07/39	12 <sup>th</sup> floor – replace missing section of beading to glazing on communal door by flat 73.

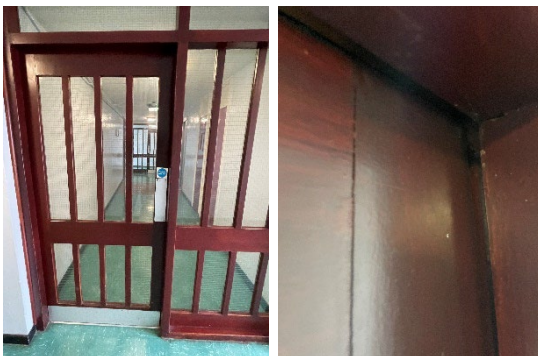
**40) 13<sup>th</sup> floor – Communal door by flat 82 doesn't reliable self-close into frame.**

P2	Within 1 – 3 months. Glazing Repairs JM9870504	14/11/2022
07/40	13 <sup>th</sup> floor - Communal door by flat 82 requires adjustment, not reliably self-closing into frame.

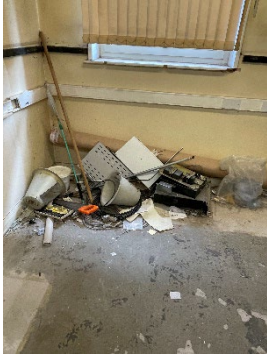
**41) Ground floor server / concierge room is untidy with items consisting of cabling, cardboard, redundant equipment having been discarded on floor.**

P2	Within 1 – 3 months. Fire Rapid Response JM:9814438	03/11/2022
07/41	Ground floor server / concierge room, remove discarded rubbish that's built up on floor.

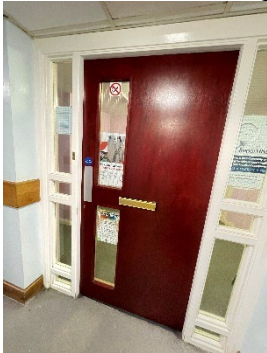
- 42) The batwing type cold smoke seal to the community room door is missing in parts and or worn away.

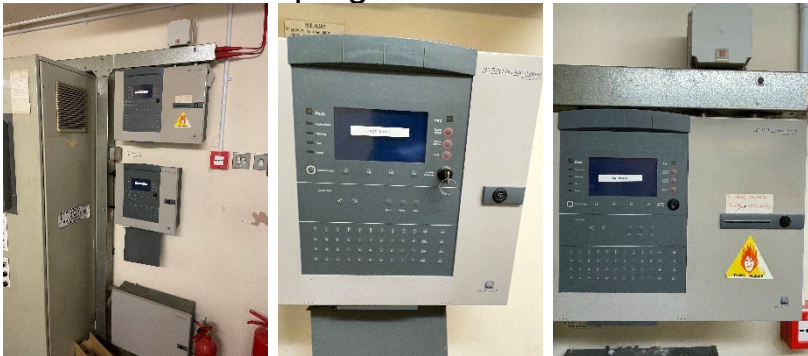
- 7) It was noted that there are 2 decommissioned fire alarm panels within the room between the server room and corridor off ground floor / main entrance lobby. Although both panels have been labelled as not in use it is recommended that they are removed as part of any future renovation program.

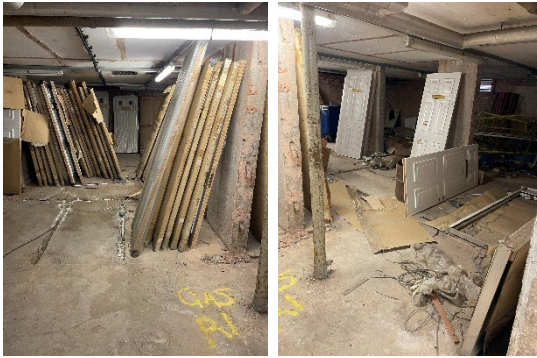
- 6) The basement appears to have become an area where by surplus SMBC materials and items are being stored. WMFS have been to site and are aware of the items and although it is not a major concern to them. The basement is secured by a none suited key that is stored in the firefighter’s white box.
-
