Fire Risk Assessment

Addenbrooke Court

**Southbank Rd, Oldbury,
Cradley Heath, B64 6LJ**

Date Completed: 09/07/24

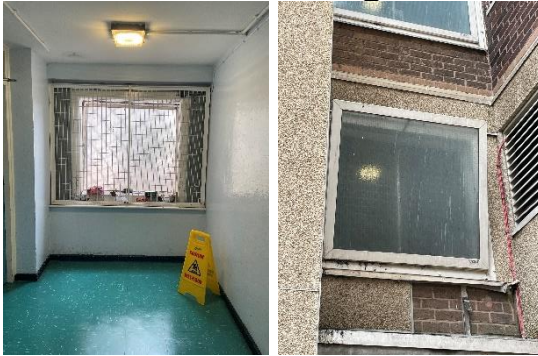
- 10) The AOV to the first floor lobby by flats 10, 11, 12 is defective and stuck in the open position due to the hinges failing. The assessor has been informed that replacement hinges are no longer available therefore, a solution to resolve the issue is likely to involve commissioning an engineering firm to re-manufacture the hinges.

7/10	Replace defective hinges to 1 st floor AOV that remains in the open position

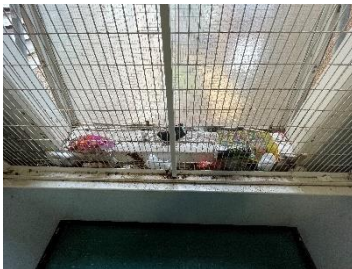
- 11) It was noted that due to the AOV being stuck in the open position there is a small amount of rubbish that has blown in and has become trapped between the AOV and the mesh grill. This will need to be monitored to prevent a build-up of combustible waste.

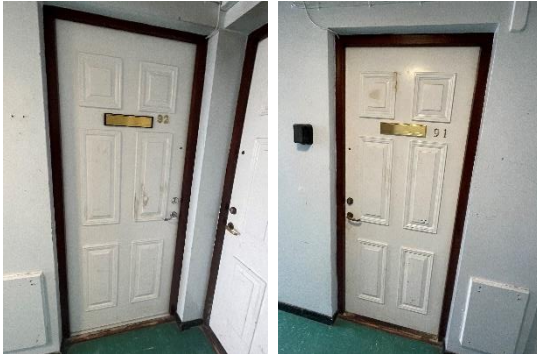
- 29) Repairs to superficial surface damage have been carried out to some flat entrance doors using intumescent filler. All repairs were noted as sufficient.

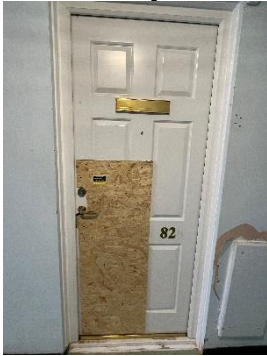
- 30) Emergency repair using sterling board to flat 82 entrance door. Confirmation required that a new FD30s door has been requested.**

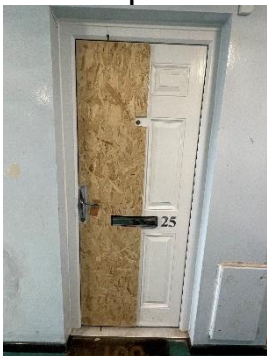
- 31) Emergency repair using sterling board to flat 25 entrance door. Door replacement job number is JM 13840042.

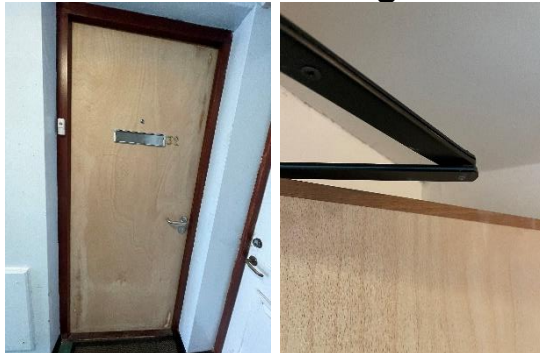
G. Flat 32 – Combined intumescent strip partially missing on lock side. Self-closing device arm catching on door leaf.

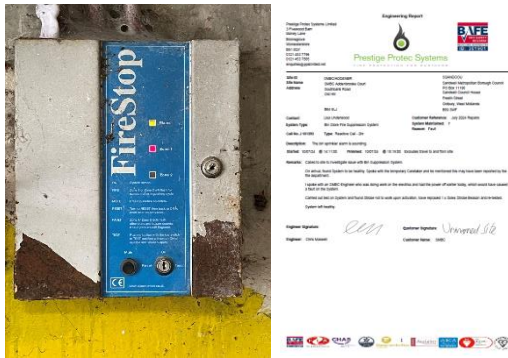
- 9) The control panel is within the bin store on the right hand side wall. At the time of the survey the control panel buzzer was sounding which indicates fault. The contractor was immediately informed to attend for inspection & repair. Update from contractor (10/07/24) confirmed that a strobe light had been replaced and the system is healthy.
-

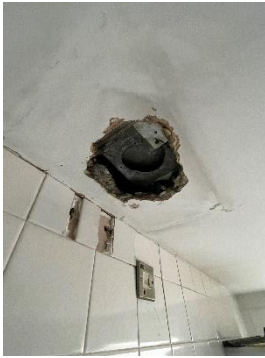
- 10) Fire stopping required to hole in kitchen ceiling where the extraction unit has been removed.

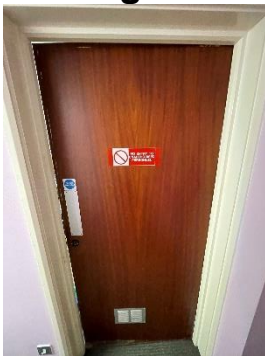
- 11) Cleaners' cupboard notional fire door within the community room area requires intumescent strip, cold smoke seal and replacement intumescent vent. Cupboard contains electrical switchgear.**

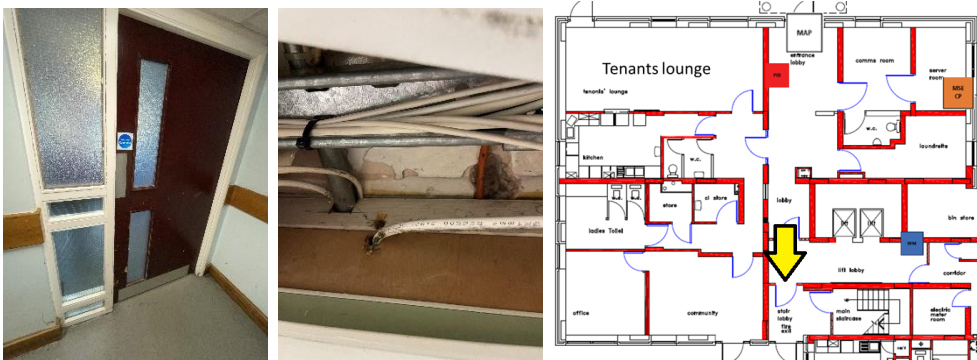
14) Fire stop penetrations above communal door from lift lobby to stairwell.
