# Fire Risk Assessment

## Moorlands Court

**Reservoir Road,  
Rowley Regis  
B65 9PB**

**Date Completed: 26/01/23**

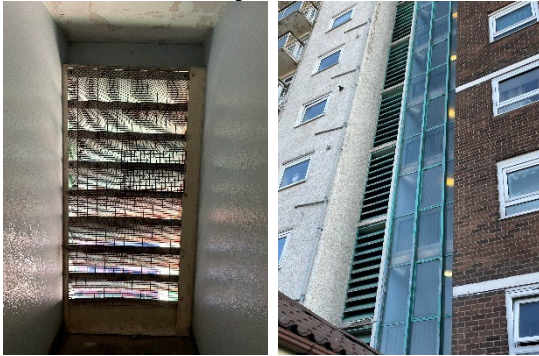
- 11) The louvred ventilation panel to 12<sup>th</sup> floor has been boarded over with Supalux board. It is recommended that this boarding should be removed to reinstate natural ventilation to the communal corridor.

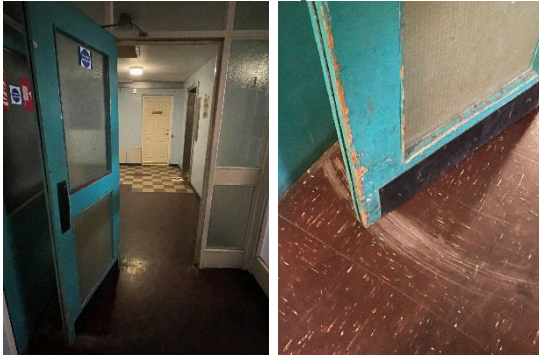
- 25) 13<sup>th</sup> floor by flat 80 - communal door binds on floor allowing door to remain open.

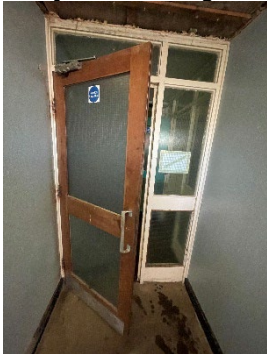
- 26) 13<sup>th</sup> floor communal door to chute room doesn't remain fully closed due to air pressure from natural ventilation. Self-closer requires adjustment or replacement.

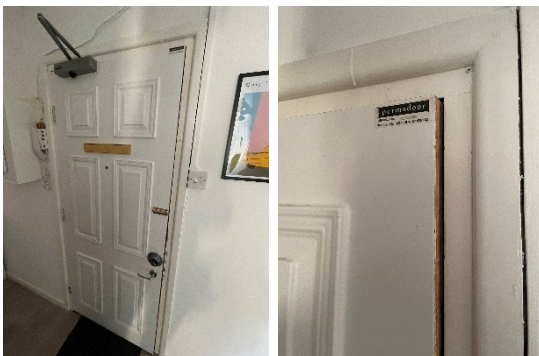
- 28) 12<sup>th</sup> floor, flat 77 entrance doesn't reliably fully self-close into frame.

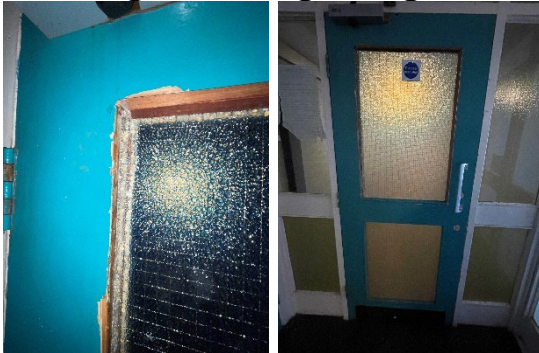
- 30) 10<sup>th</sup> floor communal door by flat 62 is requires a section of beading around glazing.

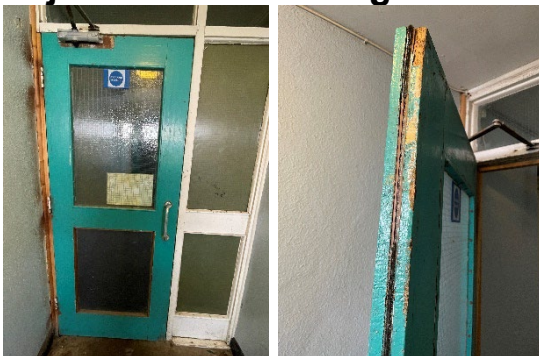
- 31) 10<sup>th</sup> floor communal door to chute room has damaged cold smoke seal to upper leading edge. There is also an excessive gap to the head which could be corrected with some adjustment & missing screw from the top hinge.

<p>P2</p>	<p>Within 1 – 3 months of action plan. Fire Rapid Response JM:10633936</p>	<p>02/05/2023</p>
<p>07/31</p>	<p>10<sup>th</sup> floor communal door to chute room – replace damaged smoke seal to upper leading edge / correct excessive gap to head / replace missing screw to top hinge.</p>

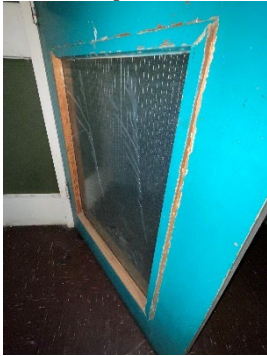
- 32) 10<sup>th</sup> floor by flat 65 the beading to the right hand side of the lower panel isn't secured and can be pulled out by hand.

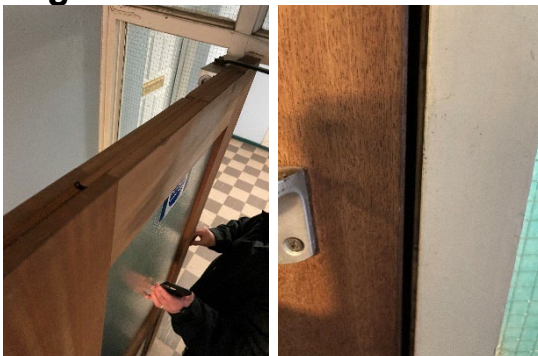
- 34) 9<sup>th</sup> floor – communal door by flat 59 is missing an intumescent strip to the head plus excessive gap to leading edge.

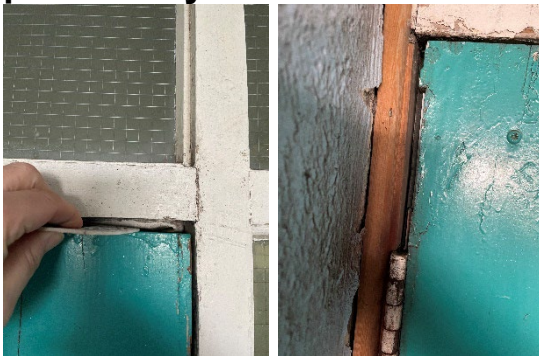
**36) 9<sup>th</sup> floor communal door to chute room has excessive gaps particularly to head.**

P2	Within 1 – 3 months of action plan. Fire Rapid Response JM:10704360	03/05/2023
07/36	9 <sup>th</sup> floor communal door to chute room, excessive gaps require adjustment / repair.

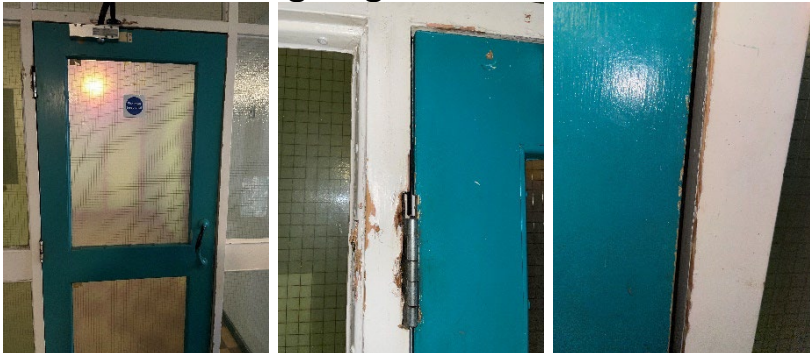
**37) 8<sup>th</sup> floor communal door by flat 50 damage to frame around top hinge creating excessive gap, also excessive gap around head and leading edge.**

07/37	8 <sup>th</sup> floor by flat 50 communal door excessive gaps to head & leading edge, damage to frame at top hinge – adjustment / repair required.

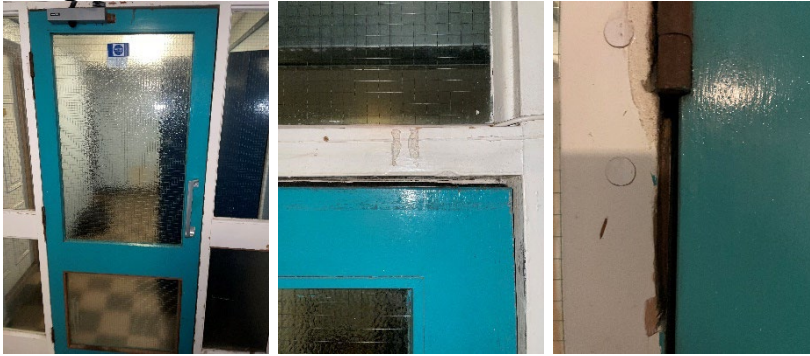
**39) 8<sup>th</sup> floor communal door by flat 53 excessive gaps around hinges and to head.**

07/39	8 <sup>th</sup> floor by flat 53 communal door has excessive gaps around head and hinges, adjustment / repair required.

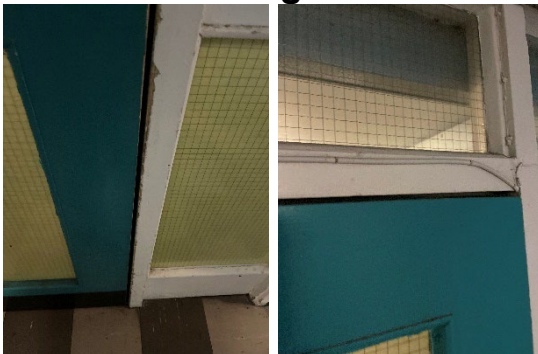
- 43) 7<sup>th</sup> floor communal door by flat 47 gap between stop and frame on leading side. Excessive gaps around door.

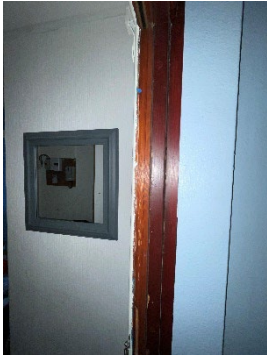
- 44) 7<sup>th</sup> floor flat 48 entrance door, section of combined intumescent strip / cold smoke seal is missing from frame.

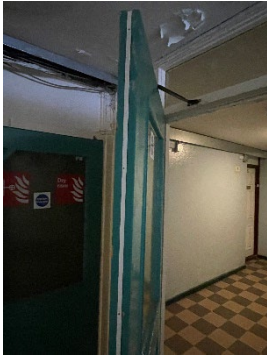
**47) 7<sup>th</sup> floor communal door by flat 44 doesn't have a cold smoke seal.**

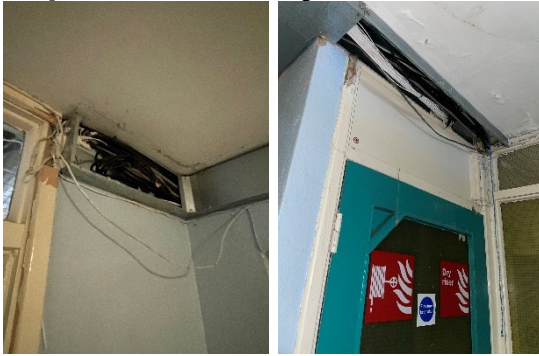
**48) 7<sup>th</sup> floor cable tray covers are missing above riser cupboard and adjacent flat 44.**

07/48	7 <sup>th</sup> floor cable tray covers missing above riser cupboard door and adjacent flat 44, both require replacing.

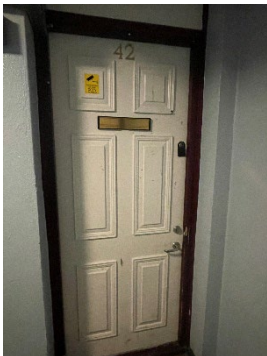
**49) 6<sup>th</sup> floor, flat 42 entrance door is not reliably fully self-closing into frame.**

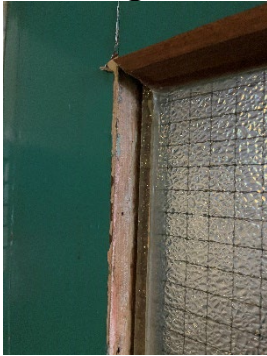
- 50) 6<sup>th</sup> floor communal door by flat 38 is missing a section of beading to the upper glazed panel.

07/50	6 <sup>th</sup> floor by flat 38, communal door, replace missing section of beading.

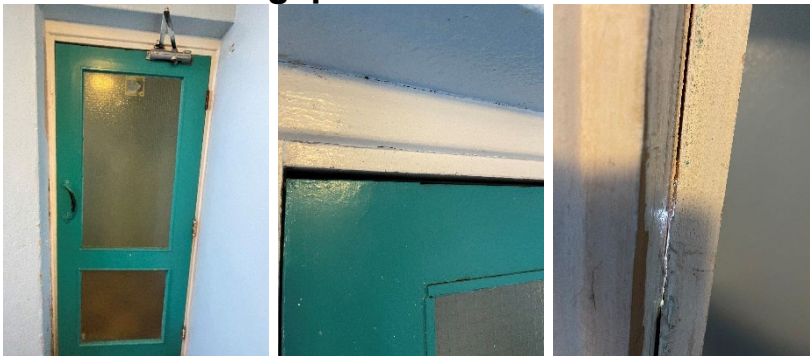
- 51) 6<sup>th</sup> floor communal door to stairs gap between stop and frame and excessive gap to head.

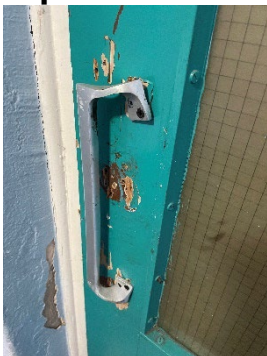
- 52) 5<sup>th</sup> floor communal door to stairs, door handle has been forcefully bent back into the door panel and requires replacement.

07/52	5 <sup>th</sup> floor communal door to stairs – replace damaged door handle.

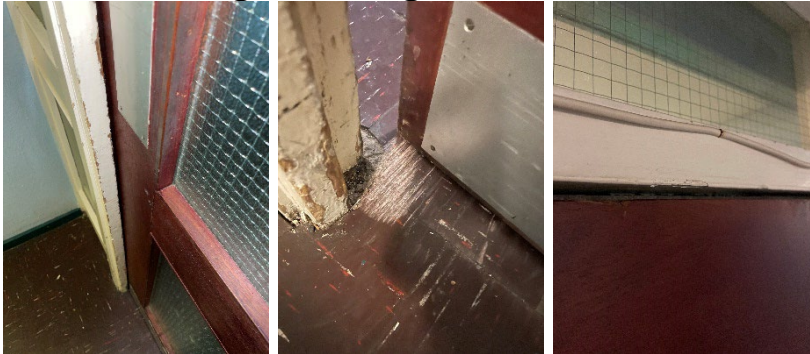
- 53) 5<sup>th</sup> floor communal door by flat 35 binds on floor, excessive gap to head and door doesn't fully close against stop. Frame is loose along floor edge.

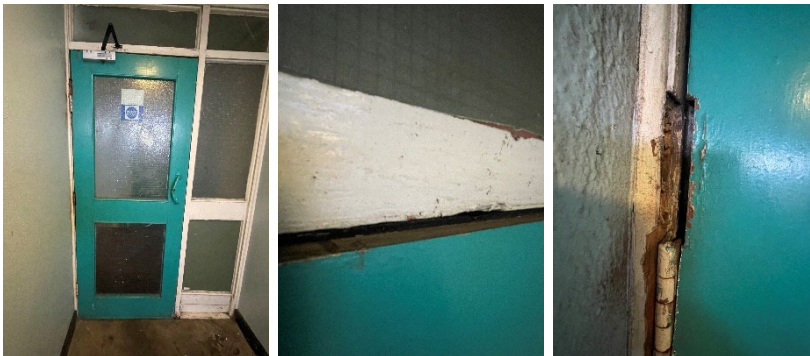
- 54) 5<sup>th</sup> floor communal door to chute room, door doesn't fully self-close adjustment required. Gaps remain in door and frame where hinges were previously fitted, also excessive gap to head.

07/54	5 <sup>th</sup> floor communal door to chute room adjustments / repairs require to correct excessive gaps around hinges & head, and to ensure door closes fully into frame.	 	P2	Within 1 – 3 months of action plan. Fire Rapid Response JM:10752700	16/05/2023
-------	---	--	----	---	------------

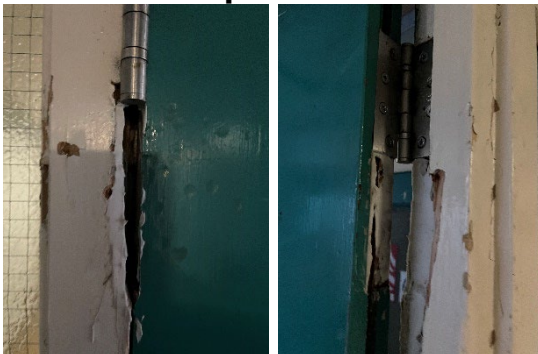
- 55) 5<sup>th</sup> floor communal door by flat 32 slight gap to door edge / frame / stop were hinge was previously located, some damage to 25mm stop.

07/55	5 <sup>th</sup> floor by flat 32, repairs adjustment required to communal door / frame to correct excessive gap around upper hinge

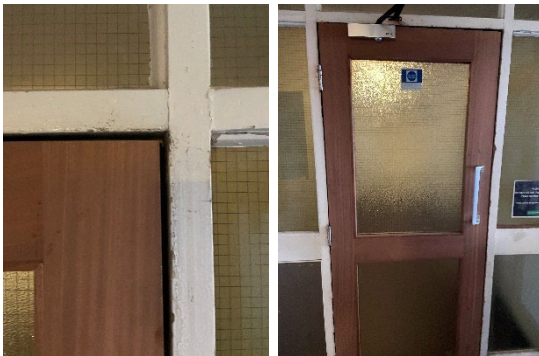
- 60) 4<sup>th</sup> floor communal door by flat 26 has excessive gaps around head.

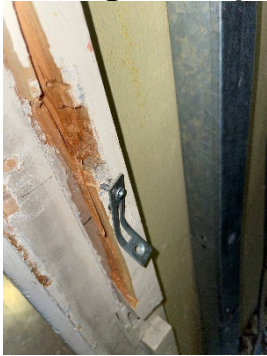
**66) 2<sup>nd</sup> floor dry riser cupboard door cannot be secured due to damaged stop.**

<p>07/66</p>	<p>2<sup>nd</sup> floor dry riser cupboard, repair frame to enable door to be locked.</p>

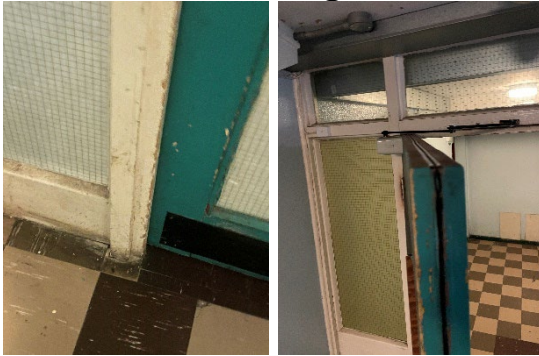
- 69) 1<sup>st</sup> floor communal door by flat 11 requires cold smoke seal to head and fixed glazed frame is loose to ground.

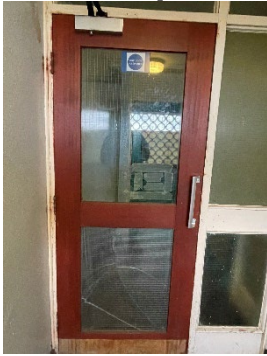
- 70) 1<sup>st</sup> floor communal door to chute room, glazing has cracked in lower panel.

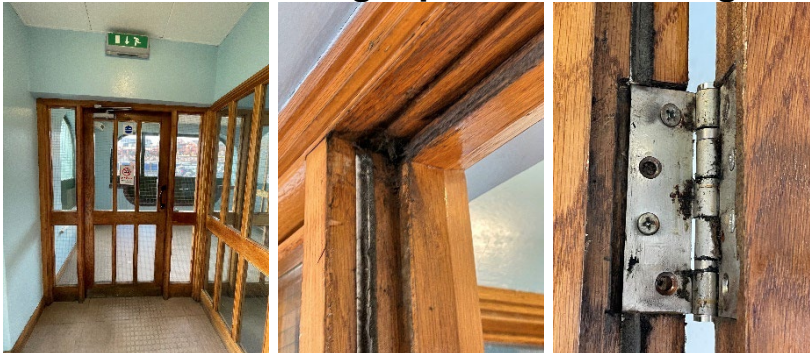
- 71) Ground floor communal door adjacent bottom of stairwell, combined intumescent strip / cold smoke seal missing to head. Screw missing top and middle hinges.

07/71	Ground floor communal door adjacent staircase, fit combined intumescent strip / cold smoke seal to head. Replace missing screws to hinges.

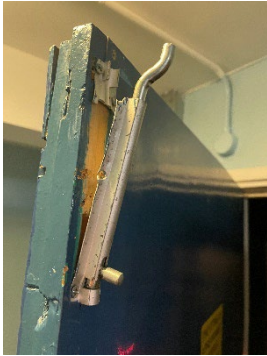
**72) Ground floor service cupboard securing bolt broken on slave door.**

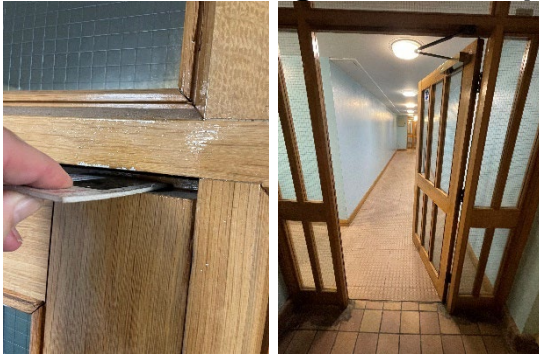
**73) Ground floor by flat 5 excessive gap to head, door binds on floor and missing screw to top hinge.**

07/73	Ground floor communal door by flat 74 adjustment / repair required to correct excessive gap to head / binding on floor. Replace missing screw to top hinge.

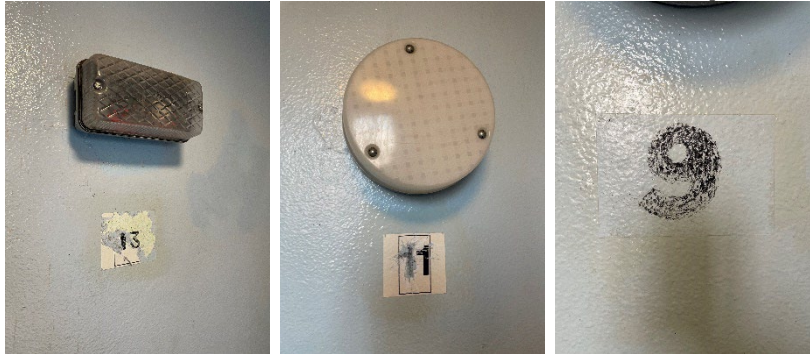
- 8) Floor indicator numbers are fitted to the wall of each floor on the communal staircase(s) **Signage to the 9<sup>th</sup> 11<sup>th</sup> & 13<sup>th</sup> floor stairwells have been vandalised and require replacement.**

12/08	Replace missing / damaged floor level signs to stairwell on floors 9, 11, 13
