Fire Risk Assessment

Bishops Close 8-12, 14-18

**Bishops Close, Smethwick,
B66 2RD**

Date Completed: 23/10/23

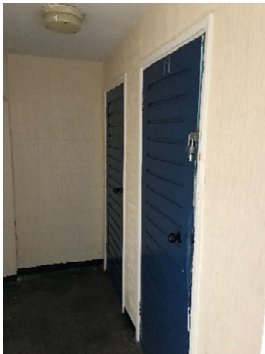
- 1) The site has a single staircase that provides a means of escape.
- 2) All corridors are of adequate width (at least 1050mm) and will be maintained clear to that width as a minimum.
- 3) communal cupboard doors within the staircase should be upgraded to certified FD30s fire rated doors as presently a dead end condition is evident.

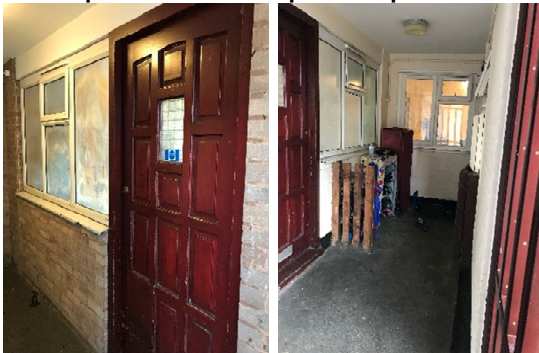
- 7) It was noted that the partition wall from the ground floor lobby area and the staircase contains a non-fire rated fire door and non-fire rated glazing. It is in the opinion of the fire risk assessor that this would not provide sufficient compartmentation between the ground floor flat and staircase and has been compromised. The flat windows are openable and non-fire resisting. These windows discharge directly into a corridor which has a non-fire resisting window and door that opens directly into the escape stair. Without removing the residents ventilation provisions and means of escape from an inner room it is considered a suitable solution to extend the compartment line of the flat to include the corridor. As a result, a remedy such as the corridor window being "bricked up" must be considered, to provide one hours fire resistance and a fully certified self-closing FD30S door installed should also be considered. this issue is reflected within both blocks. Under refurbishment works an outer door was installed which means this area where the opening and the flat window is present becomes a protected escape route that has now become compromised. Since initial FRA meetings have taken place to discuss possible solutions, emails have been sent and this has now been escalated so a plan can be put in place.

7) It was noted that the partition wall from the ground floor lobby area and the staircase contains a non-fire rated fire door and non-fire rated glazing. It is in the opinion of the fire risk assessor that this would not provide sufficient compartmentation between the ground floor flat and staircase and has been compromised. The flat windows are openable and non-fire resisting. These windows discharge directly into a corridor which has a non-fire resisting window and door that opens directly into the escape stair.
Without removing the residents ventilation provisions and means of escape from an inner room it is considered a suitable solution to extend the compartment line of the flat to include the corridor. As a result, a remedy such as the corridor window being "bricked up" must be considered, to provide one hours fire resistance and a fully certified self-closing FD30S door installed should also be considered. This issue is reflected within both blocks. Under refurbishment works an outer door was installed which means this area where the opening and the flat window is present becomes a protected escape route that has now become compromised. Since initial FRA meetings have taken place to discuss possible solutions.

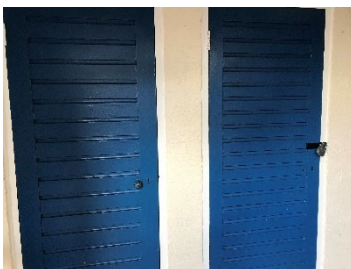
- 13) Storage cupboards, residents have access to storage cupboards within the blocks, these were picked up in the previous risk assessment to be upgraded to FD30s door sets. Consideration should be made for these to be upgraded

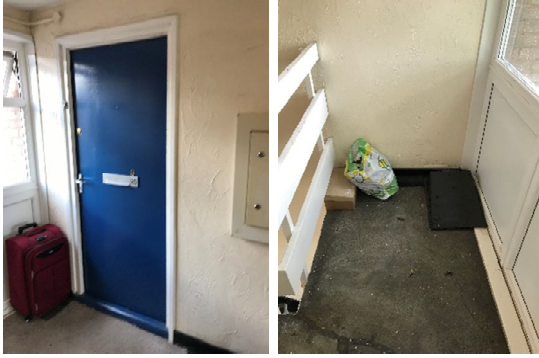
- 18) Access is gained to a sample of properties as part of the fire risk assessment to ensure the doors have not been tampered with by residents etc. access gained to flats 8 & 12 evident that doors had been tampered with (no self-closing devices)
- 19) **Combustible items including suitcase and non fire rated carpet left on the 2nd floor landing area of block 8-12 outside flat 9 as well as behind the barriers atop the staircase (communal area) the council has had a stance on allowing door mats however the carpet present outside flat 9 is peeling up from the floor creating a trip hazard.**
-

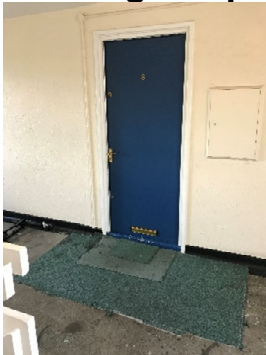
- 20) the council has had a stance on allowing door mats however the carpet present outside flat 8 is peeling up from the floor creating a trip hazard.

7/20	Remove the piece of carpet from outside flat 8 on the 2 nd floor

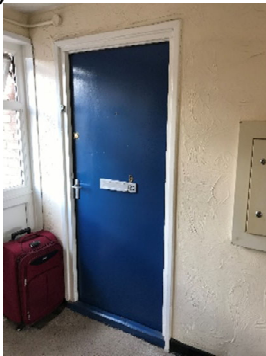
- 21) Flat 9 is numbered twice as 9 & 120. (8-12)

P2	Leasehold Manager 1-3 months	
7/21	Remove extra numbers (120) from flat 9

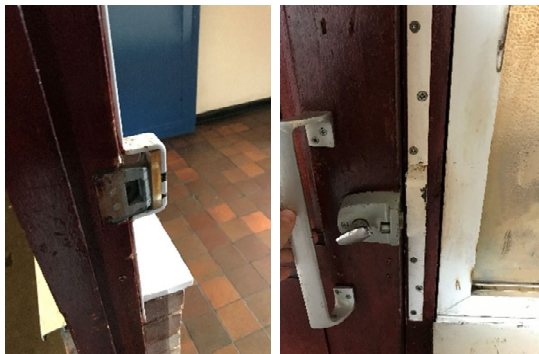
- 22) Block 8-12 communal door has a latch attached locking the door from one side.

<p>7/22</p>	<p>Remove latch from communal door on ground floor of both blocks and make good.</p>

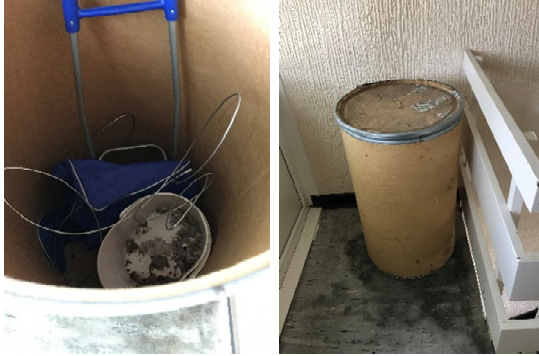
23) Block 14-18 Items left in 2nd floor communal area of block

7/23	Block 14-18 Items left in 2 nd floor communal area

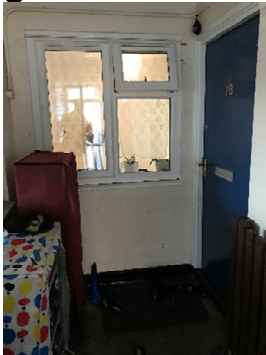
24) Ground floor communal landing area outside flat 18 timber gate has been erected and combustible items have been left.

P2	1-3 months Caretakers	
7/24	Removal of timber gate and combustible items stored outside flat 18

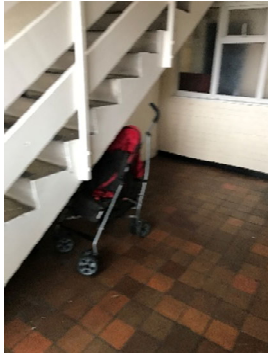
25) Pushchair has been stored in the ground floor communal area under the stairs of flock 14-18

7/25	Block 14-18 removal of pushchair from the ground floor communal area under the staircase

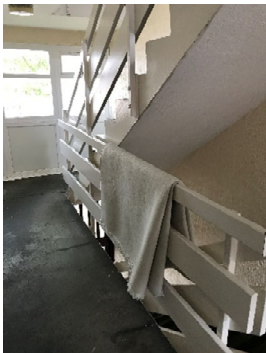
26) Combustible items left hanging over banister on the 1st floor of block 14-18

P2	Housing Manager 1-3 months	
7/26	Removal of combustible item on the banister of the 1 st floor within block 14- 18

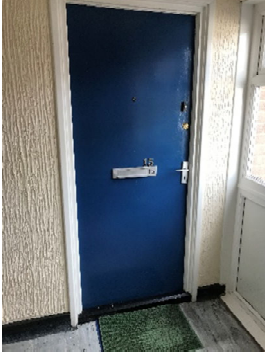
27) Flat 15 number twice as 15 & 115 (14-18)

P2	Housing Manager 1-3 months	
7/27	Removal of extra numbers (115) from flat 15

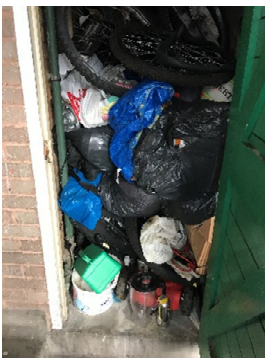
29) Residents' cupboards do not have certified fire rated doors, gas service risers are present and residents store potentially hazardous liquids within with combustibles. Email has been sent to SG

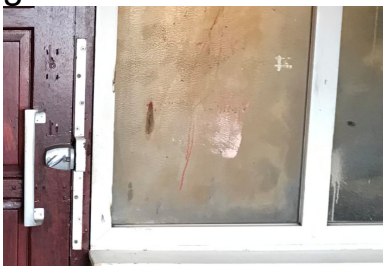
- 32) There are no CCTV provisions on the premises.
- 33) Noted that there are scorch marks on the window within the ground floor on the communal window

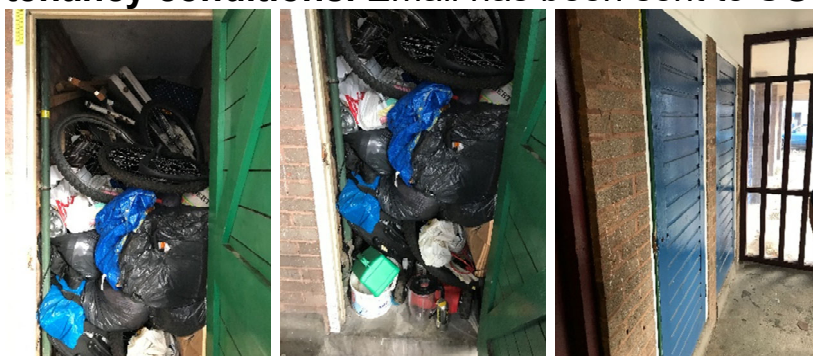
- 6) Residents have access to Storage cupboards that are located within the communal areas of the block and are not of a fire rated construction. **Access was gained to the storage cupboards on the ground floor of block 8-12 and a large amount of fire loading was evident, and a petrol can was also found. Refer to tenancy conditions.** Email has been sent to SG
