Fire Risk Assessment

New Hope Road.

Smethwick

Date Completed: 15 March 2024

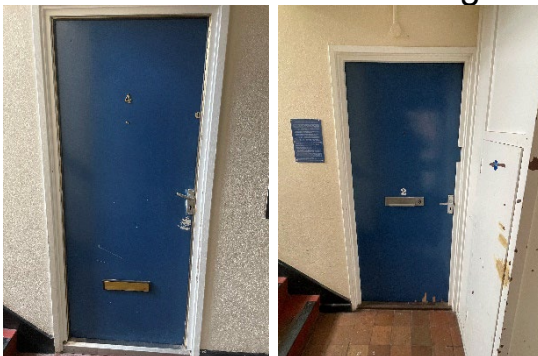
- 2) The means of escape are protected to prevent the spread of fire and smoke with predominately Notional FD30s timber doors. No internal access to flats was gained during the fire risk assessment.

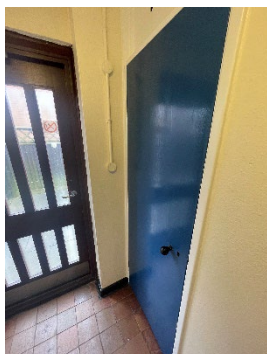
- 3) The only communal doors within the block are the final exit doors which are fitted with automatic closing devices that are checked on a regular basis by the Janitorial Teams as part of their daily checks. All blocks have a store door at ground floor level under the concrete stairs. These doors were not opened during the fire risk assessment as no key available.

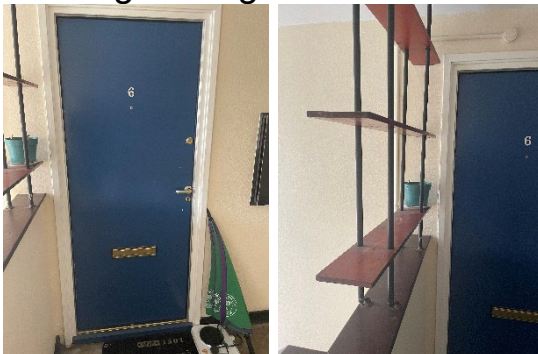
- 7) Communal areas are kept free of flammable items. Shelving and items outside of flat 6 to be removed. Email sent to housing manager on 15/03/2024.

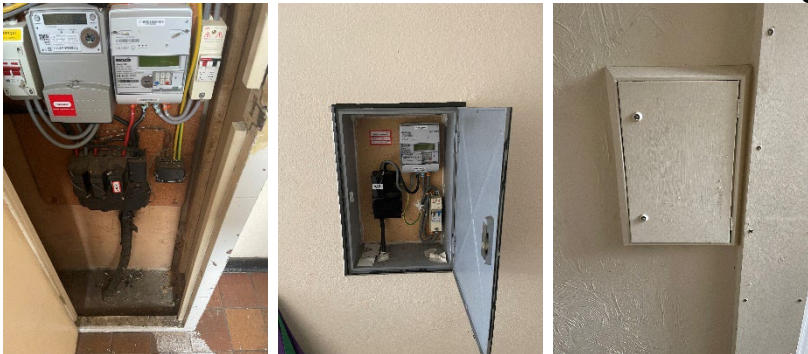
- 9) Ground floor communal area service cupboards have non fire rated fire doors and construction. Meter cupboards at first and second floor are a combination of steel and fibreglass.

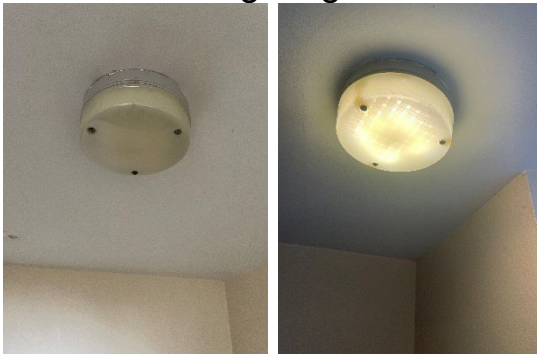
- 1) Blocks do not have an emergency / escape lighting system. This is deemed acceptable within a 3-storey block that has adequate conventional lighting installed.

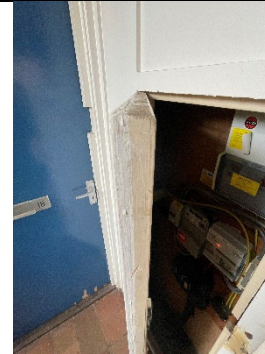
Future works programme should consider encasing the electrical intake within the ground floor staircase with fire resisting construction.

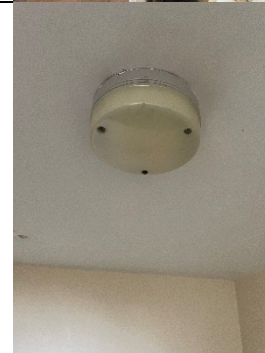
Future works programme should consider the installation of emergency lighting within the staircase.

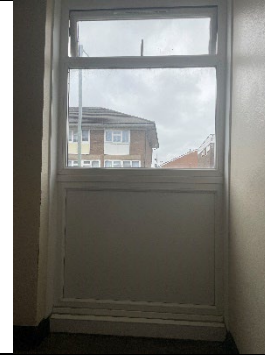
Future works programme should consider the replacement of the UPVC panels with a non-combustible construction.
