# Fire Risk Assessment

## Hewitson Gardens

**Flats 1 -26 Hewitson Gardens,  
Gladys Road,  
Bearwood,  
Smethwick,  
B67 5AR.**

**Date Completed: 15/04/2024.**

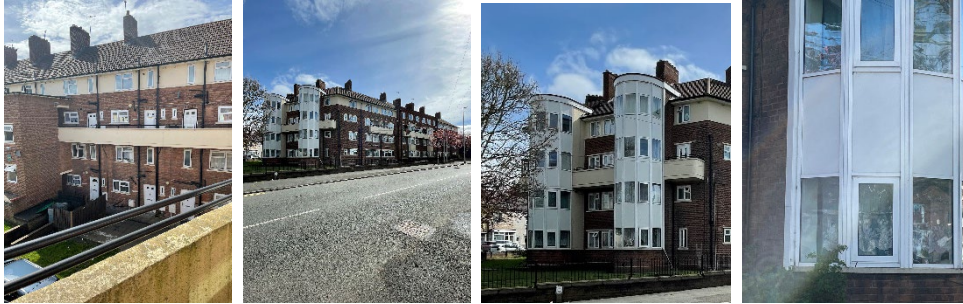
- 3) There is partial rendering applied at fourth floor level and over bay windows, it appears that the front elevation has a UVPC fabricated cover over Bow Windows.

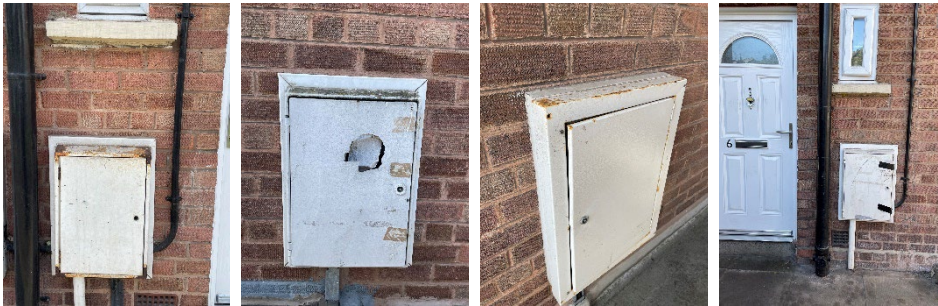
- 6) Observations were made of electrical boxes outside individual flats; some were noted as suffering from oxidation & will require replacements as part of any upgrades. Others needed to have work carried out to ensure they remained safe.
-

Faults noted with electrical boxes are: -

- Rusting in flats 3, 7 & 26.
- Replace door on Flat 6, 17 & 18.
- Flat 20 has a cracked door (Leaseholder).

Question/ Ref No	Required Action	Supporting photograph	Priority	Timescale and Person Responsible	Date Completed
06/06	Repair or replace defective electrical boxes to individual flats.

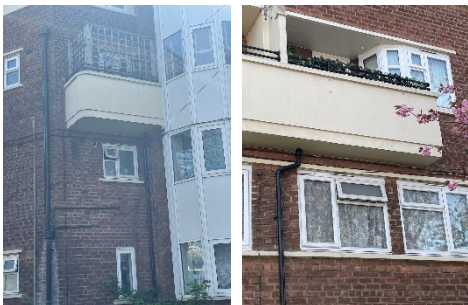
- 7) Combustible items were noted on the balconies of several Maisonettes, any combustible items should be removed at the earliest opportunity. It is believed these were Flats 25 and Flat 15.

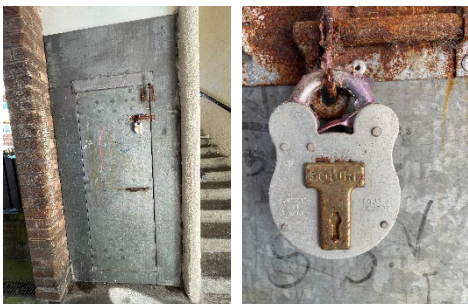
- 8) A cupboard was located under the central staircase at the rear of the premise, access was not gained to this room at the time of the assessment.

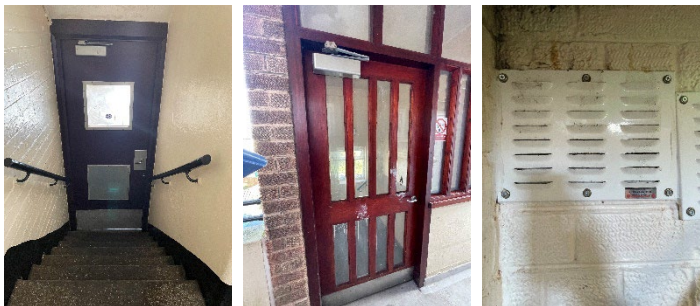
- 2) The central rear staircase only is protected by use of FD30 fire doors with vision panels. Intumescent vents were in this staircase. It was noted that a glazing panel had some damage which has resulted in a hole.

P2	Housing Management Team. 1-3 Months.	
07/02	Replace defective glazing in Means of Escape door to central staircase.

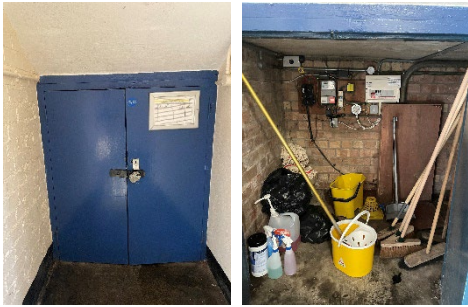
- 3) The electrical service cupboard/cleaner's cupboard is located on the ground floor under the staircase, this is adjacent to flat 1. Although bolted with a padlock, these doors require maintenance to ensure they bolt fully into the frame of the door set.
-

P2	Glazing. 1-3 Months.	
07/03	Repair service cupboard doors in staircase, adjacent to Flat 1. Ensure that doors fully lock into position.

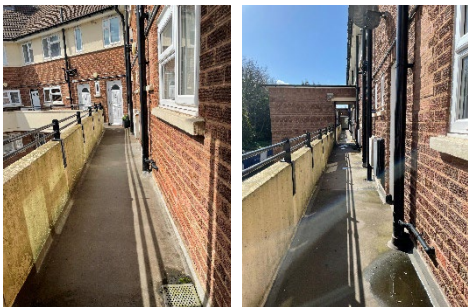
- 4) All corridors/balconies are of adequate width (at least 1050mm) and will be maintained clear to that width as a minimum. Brickwork on the escape route (deck corridor) is 1150mm, it is deemed acceptable for a person to crouch and pass the window. Please note a stay put unless strategy applies to this building.

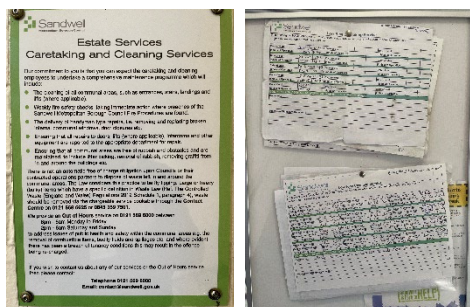
- 8) Communal areas, staircases and pedestrian balconies are kept free of flammable items. These areas are checked on a regular basis by the Caretaker and Cleaning teams, all items of rubbish are immediately removed. There is also an out of hour's service that allows combustible items of furniture / rubbish to be removed.
-

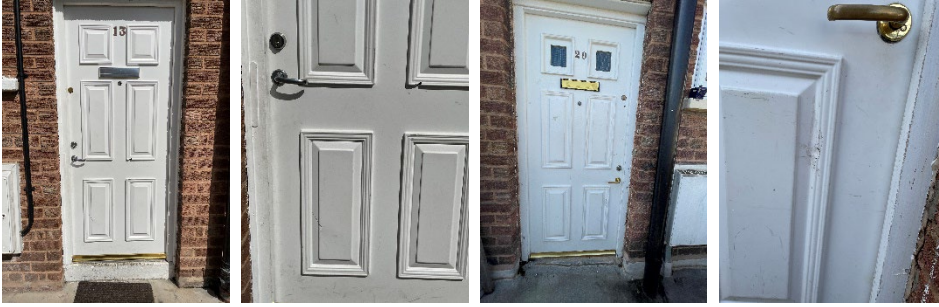
- 15) Flat Door 25 has a missing Letterplate which will need to be replaced.  
(Leaseholder)

07/15	Replace missing letterbox of Flat 25. (Leaseholder).

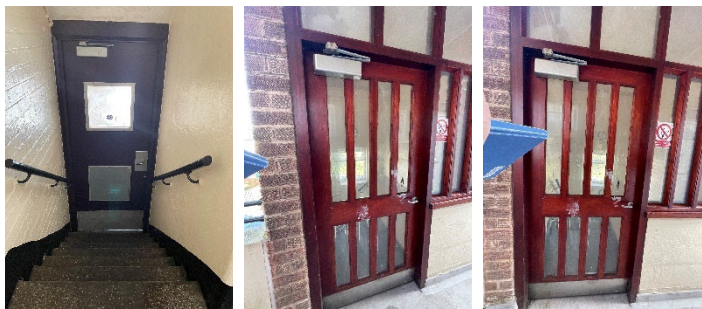
- 5) The fire stopping / compartmentation of the premises is subject to an annual inspection by the Fire Safety Rapid Response Team.
- 6) All communal fire doors are subject to an annual check by the Fire Safety Rapid Response Team.
- 7) The rear deck access staircase is protected by use of FD30 fire doors with vision panels. It was noted that one glazing panel is defective due to a hole, obviously this forms a breach of the staircase.

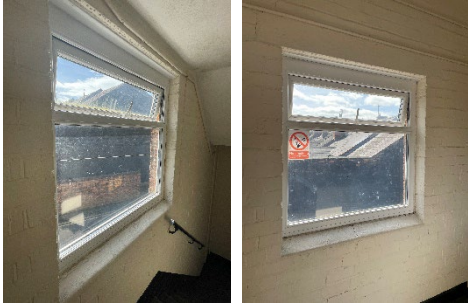
- 9) It was noted that the stairwell windows are UPVC double glazed units. The windows were open and non-lockable.
-

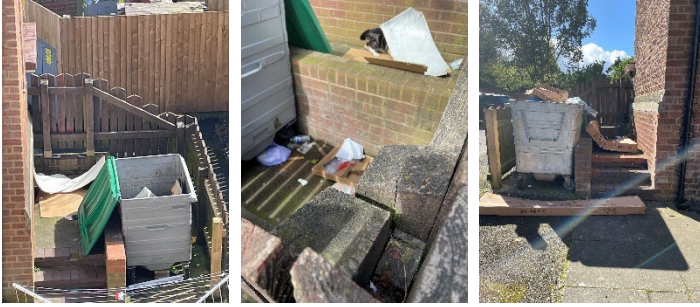
- 1) There is a regular Cleaning Service to communal areas of the premises to minimise risk of waste accumulation.
  - 2) Refuse containers emptied at regular intervals.
  - 3) There are refuse areas provided at the rear of the premise in three distinct areas; these are located at each staircase and centrally at the rear of the staircase.
  - 4) Bins are not secured (locked) to any immovable object and can be moved with ease. It was noted that a small amount of rubbish was building up around the bin area.
-

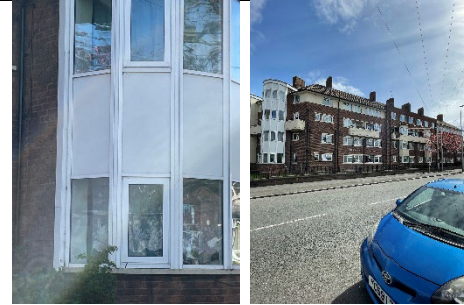
As part of the next improvement works for this premise upgrade the UPVC board at the front elevation.

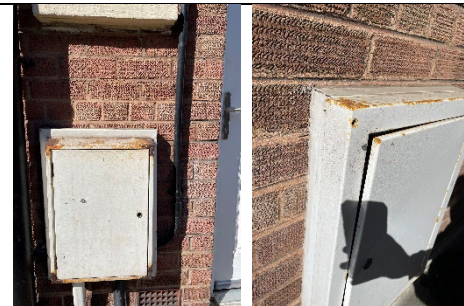
Consideration should be given to upgrading residents' electrical cupboards that are showing signs of oxidation.
