Fire Risk Assessment

Priory Close 5-9, 10-15

**Priory Close, Smethwick,
B66 3SL**

Date Completed: 22/03/2024.

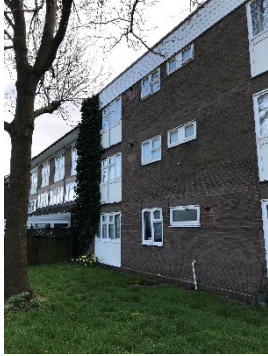
- 7) Shrubbbery scales along the one side of block 10-15

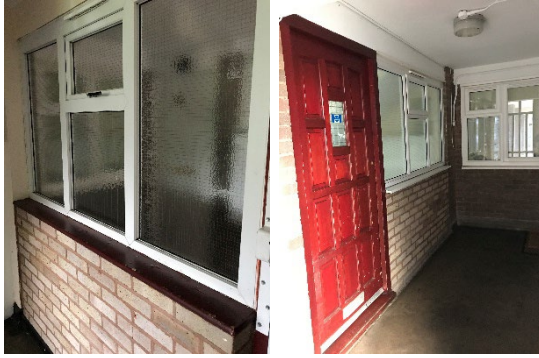
- 7) It was noted that the partition wall from the ground floor lobby area and the staircase contains a non-fire rated fire door and non-fire rated glazing. It is in the opinion of the fire risk assessor that this would not provide sufficient compartmentation between the ground floor flat and staircase and has been compromised. The flat windows are openable and non-fire resisting. These windows discharge directly into a corridor which has a non-fire resisting window and door that opens directly into the escape stair.
Without removing the residents ventilation provisions and means of escape from an inner room it is considered a suitable solution to extend the compartment line of the flat to include the corridor. As a result, a remedy such as the corridor window being "bricked up" must be considered, to provide one hours fire resistance and a fully certified self-closing FD30S door installed should also be considered. this issue is reflected within both blocks. Under refurbishment works an outer door was installed which means this area where the opening and the flat window is present becomes a protected escape route that has now become compromised. This was previously highlighted within another risk assessment with two blocks with the same archetypes.

7) It was noted that the partition wall from the ground floor lobby area and the staircase contains a non-fire rated fire door and non-fire rated glazing. It is in the opinion of the fire risk assessor that this would not provide sufficient compartmentation between the ground floor flat and staircase and has been compromised. The flat windows are openable and non-fire resisting. These windows discharge directly into a corridor which has a non-fire resisting window and door that opens directly into the escape stair. Without removing the residents ventilation provisions and means of escape from an inner room it is considered a suitable solution to extend the compartment line of the flat to include the corridor. As a result, a remedy such as the corridor window being "bricked up" must be considered, to provide one hours fire resistance and a fully certified self-closing FD30S door installed should also be considered. This issue is reflected within both blocks. Under refurbishment works an outer door was installed which means this area where the opening and the flat window is present becomes a protected escape route that has now become compromised. Since initial FRA meetings have taken place to discuss possible solutions.

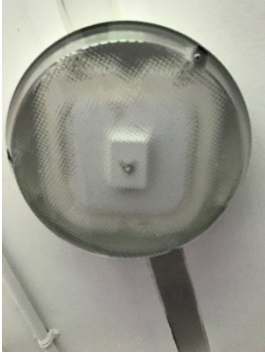
- 11) Emergency lighting is not provided, communal landings have standard lighting present within the blocks.

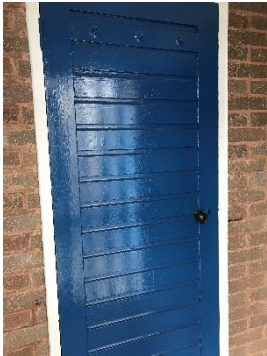
- 13) Storage cupboards, residents have access to storage cupboards within the blocks, these were picked up in the previous risk assessment to be upgraded to FD30s door sets. Consideration should be made for these to be upgraded.

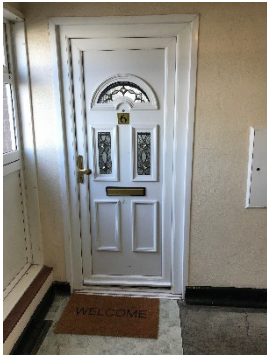
18) Access is gained to a sample of properties as part of the fire risk assessment to ensure the doors have not been tampered with by residents etc. During the FRA no access was gained to sample flat entrance doors despite best endeavours however it is believed that some doors within the blocks are non-fire rated door sets (Flat 6).

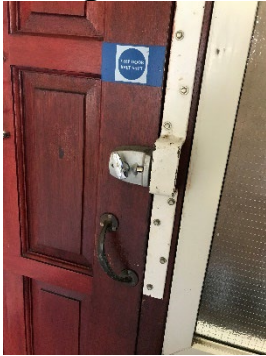
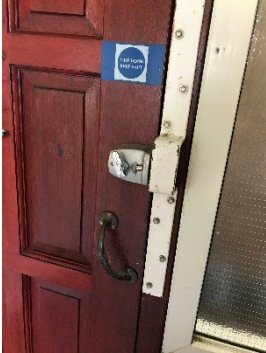
- 22) Door to communal area has a latch and the door is lockable along the means of escape in block 5-9

Question/ Ref No	Required Action	Supporting photograph	Priority	Timescale and Person Responsible	Date Completed
07/22	Remove latch from communal door in block 5-9 and make good.

P3	3-6 months Fire Rapid Response

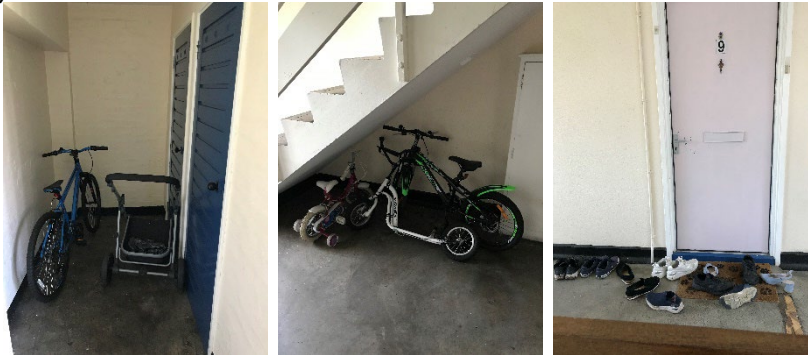
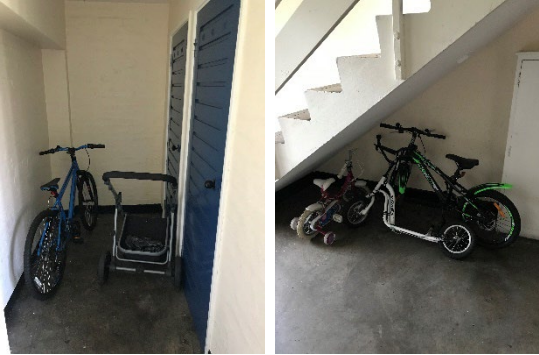
- 23) Items stored within the communal areas of both blocks.

07/23	Removal of items stored within the communal areas of both blocks

P2	1-3 months Housing Manager	
10/08	Replace missing number & letter plate from flat 15

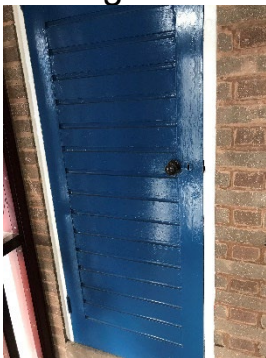
- 4) Residents have access to storage cupboards within the communal landing areas of the block (see section 7/13)

- 6) Residents have access to Storage cupboards that are located within the communal areas of the block and are not of a fire rated construction recommendation for the storage cupboards to be upgraded to fire rated doors with future improvement works to the blocks.

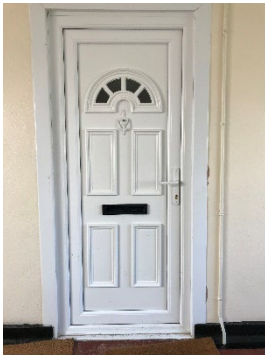
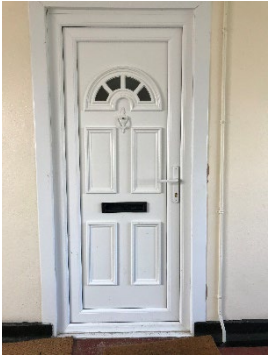
8) Missing number and letterplate to flat 15 entrance door

P2	1-3 months Fire Rapid Response	
10/11	Flat 6 appears to be a non fire rated door (UPVC) identification required / replace if needed

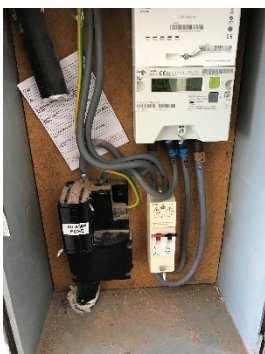
9) Evidence of fire stopping within meter cupboards

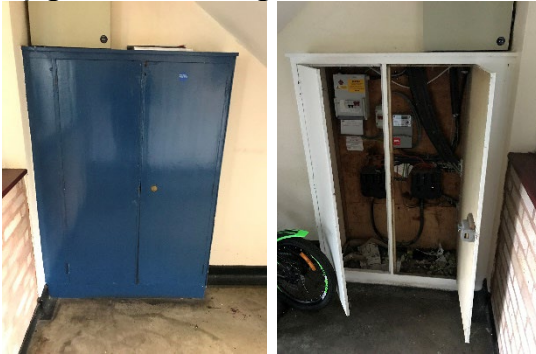
- 10) Electrical cupboards on the ground floor of both blocks are not of fire rated construction and it should be considered that this is upgraded during future works.

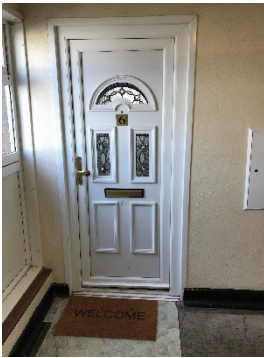
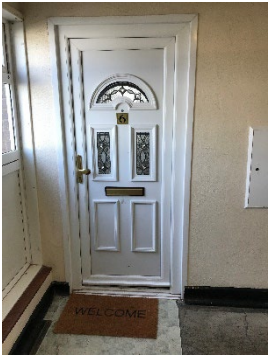
- 11) Flat 6 appears to be a non fire rated door no access was granted at the time of the fire risk assessment.

P2	1-3 months Leasehold Management
