Fire Risk Assessment

Pitcairn House

**Maisonettes 1 - 8 Pitcairn House,
Norman Road,
Smethwick,
B67 5ND.**

Date Completed: 18/04/2024.

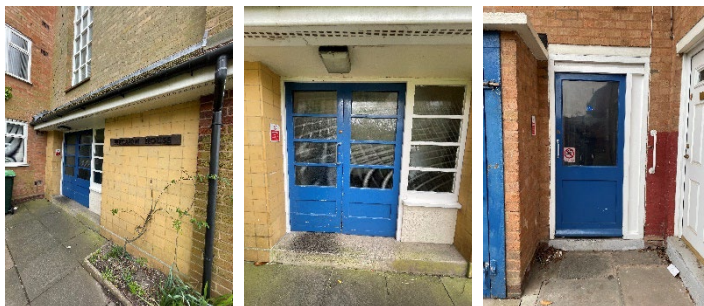
The main entrance/exits to the building are located at the front elevation of the building with an exit located at the rear elevation. Both the front and rear entrance do not have door entry system, or a fob reader installed, there is no firefighter override drop latch key.

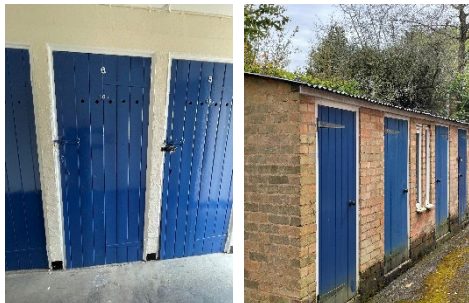
As well as storage cupboards inside common areas, several external storage cupboards are provided.

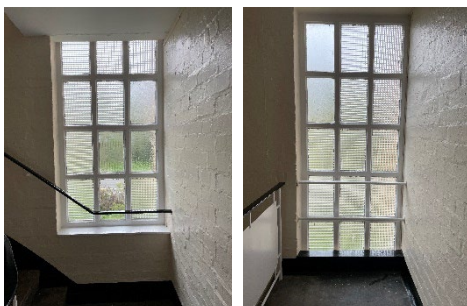
- 2) The staircase consists of borrowed lighting which constitutes timber frames with fixed glass panes.

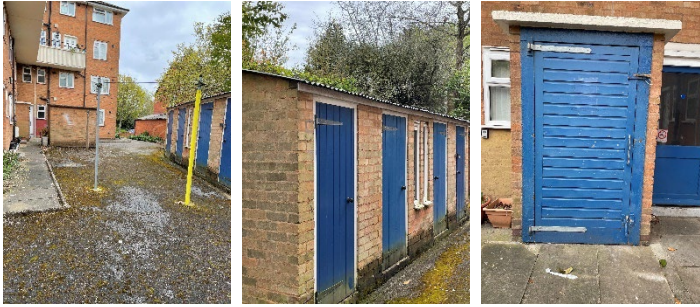
- 3) There is a small area at the rear of the premise, this reveals several outside storage cupboards and a bin room for use by residents.

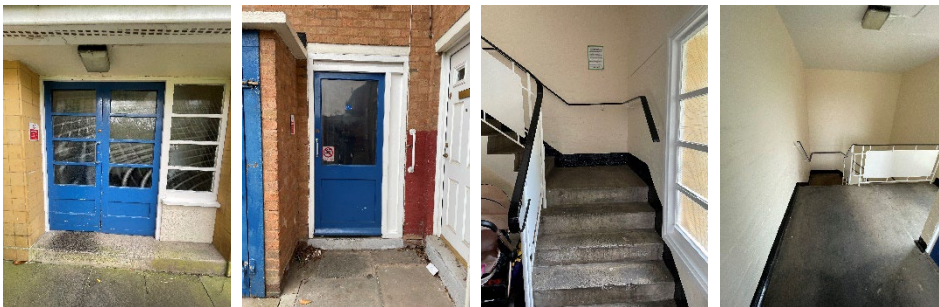
- 1) The premise has a single staircase that provides a means of escape, the staircase can be accessed from the front & rear entrance. It should be noted that this staircase provides access & egress for the tenants on the second floor.

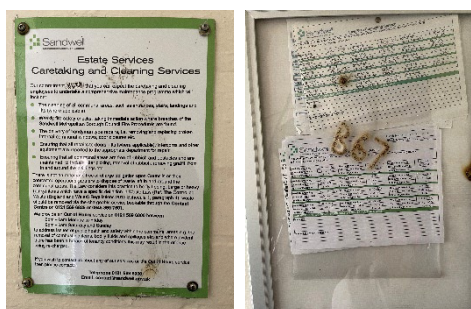
- 6) Communal areas, staircases and walkways are kept free of flammable items. These areas are checked on a regular basis by the Caretaker and Cleaning teams, all items of rubbish are immediately removed. There is also an out of hour's service that allows combustible items of furniture / rubbish to be removed.
