Fire Risk Assessment

Stanhope Road

Smethwick

Date Completed: 15th May 2024

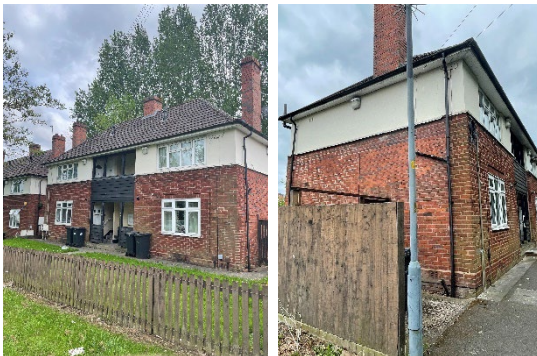
- 1) The exterior of the building is predominantly traditional brick construction.

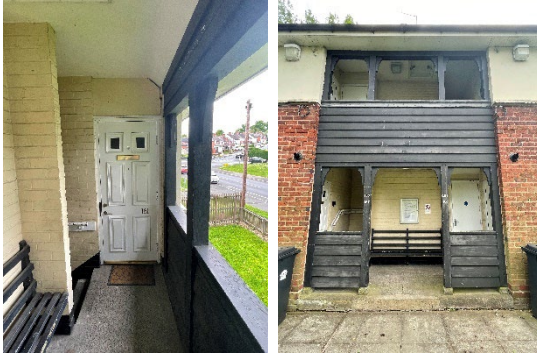
- 2) The staircase is open at ground and first floor (naturally ventilated). The staircase has no windows. The staircase has timber cladding at ground and first floor. This should be considered for replacement with a non-combustible board during the next planned programmed works.

Future works programme should consider replacing the timber cladding with a non-combustible boarding.

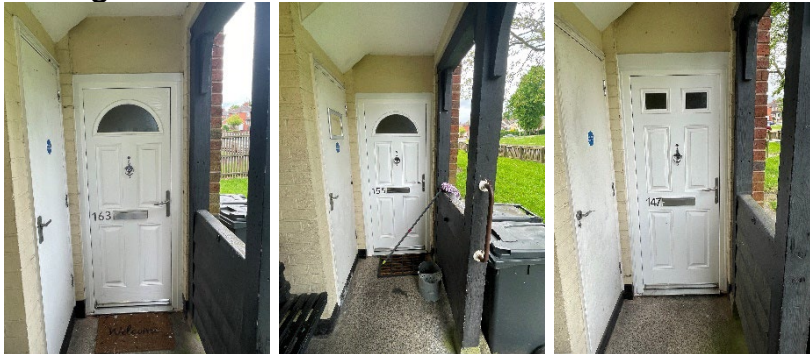
- 3) Front entrance doors are predominately nominal FD 30s self-closing Permadoor.

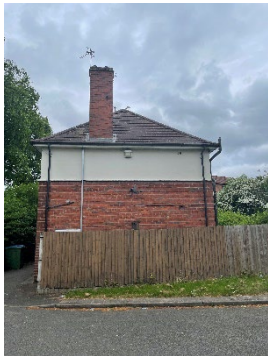
- 4) The block has a pitched tiled roof.

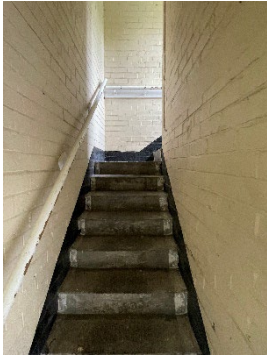
- 1) The block has one staircase that provides a means of escape.

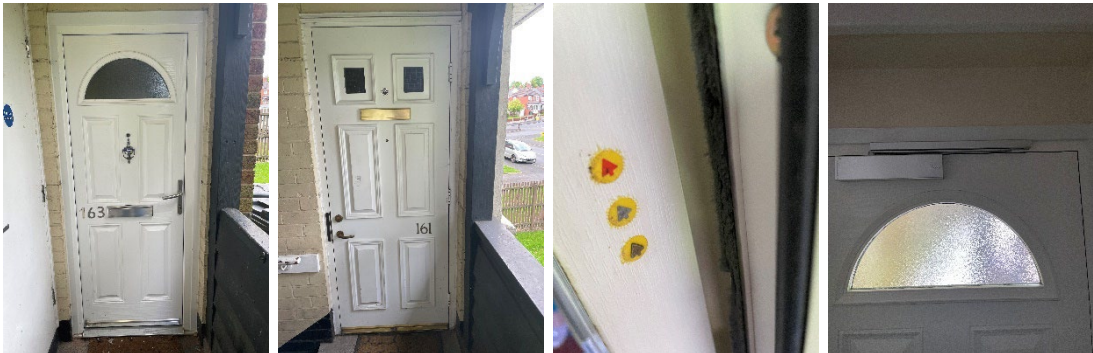
- 2) The means of escape are protected to prevent the spread of fire and smoke with predominately nominal Permadoor FD30s doors. Internal access to flat 117 was gained during the fire risk assessment.

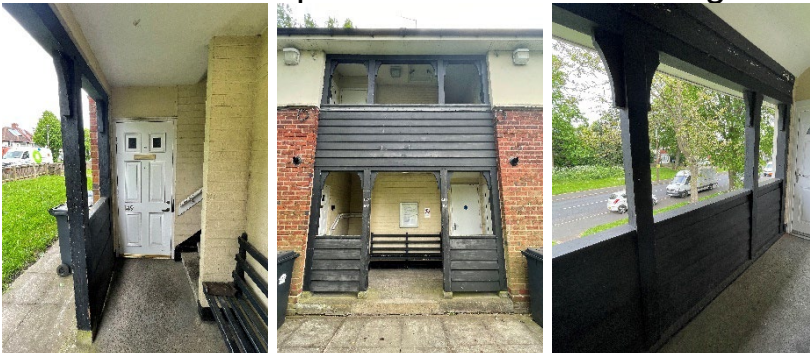
- 3) Automatic smoke ventilation is not employed. This is acceptable as the staircase has permanent ventilation at ground and first floor.

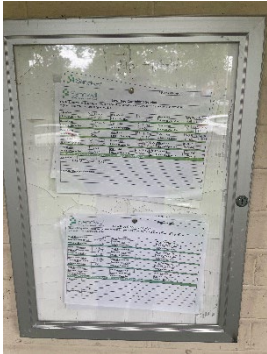
- 4) Communal areas are kept free of flammable items. The communal areas are checked on a regular basis by Janitorial/ Cleaning teams. There is also an out of hours service that allows combustible items of furniture / rubbish to be removed.

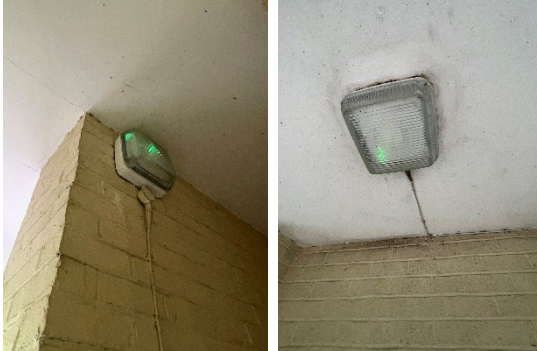
- 5) Emergency lighting is provided to the stairs and landings.

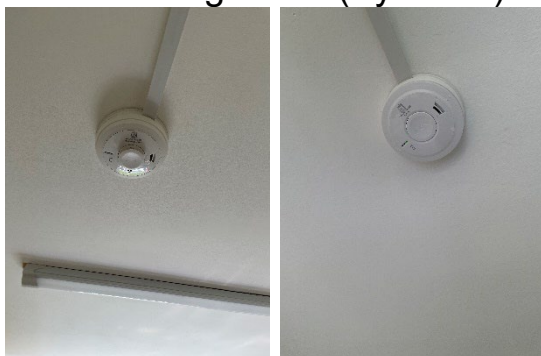
- 1) Early warning is limited to hard wire or battery smoke alarms within each of the resident's flats. The equipment is subjected to a cyclical test.
- 2) Internal access to Flat 117 (Ground Floor) was gained during this fire risk assessment. Heat detector noted in kitchen. Smoke detection noted in living room and bedroom. A carbon monoxide detector was noted in the hallway. Considered reasonable to classify as an L2 system. Resident complained that smoke detector in bedroom was very sensitive, this has been relayed to electrical engineers (By email).

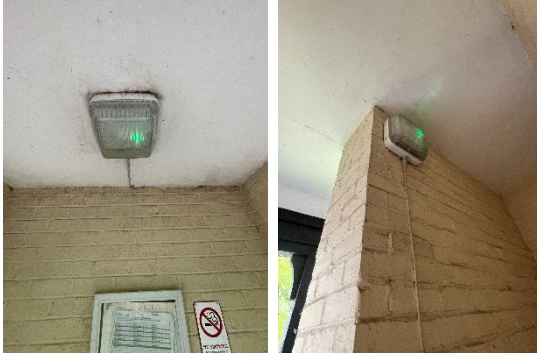
- 1) The premises has sufficient emergency / escape lighting system in accordance with BS 5266 and has test points strategically located.

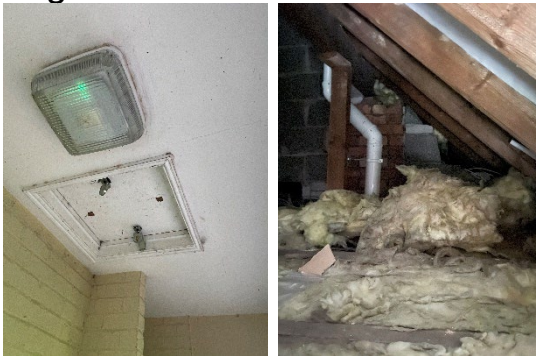
- 8) The main roof is accessed via a roof hatch on the communal landing. Roof access was gained (head and shoulders inspection) by flat 121. Padlock keys were not available however this hatch had accessible screws which were removed to allow the roof inspection. **It was noted that the brickwork between flat and roof space is incomplete and therefore should be fire stopped.** It was also noted that the walls within the roof space do not line up with the flat entrance walls below (the roof walls are approx. one metre further back and it is thought they “line up” with the internal hallway wall.) This should be addressed during the next phase of programmed works.

| Question/ Ref No | Required Action | Supporting photograph | Priority | Timescale and Person Responsible | Date Completed |
|---|---|--|---|--|---|
| 10/08 | Roof void fire stopping required, by flat 121. Brickwork missing. Acceptable to insert compact rockwool and then apply mortar covering. | | P3 | Fire Rapid Response. 3-6 Months. | |

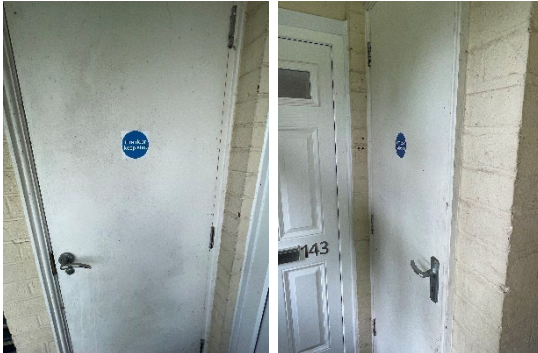
- 9) Resident store doors. Two number (one per floor) are located within the staircase. No access was available to the stores to confirm fire resistance of doors or construction.

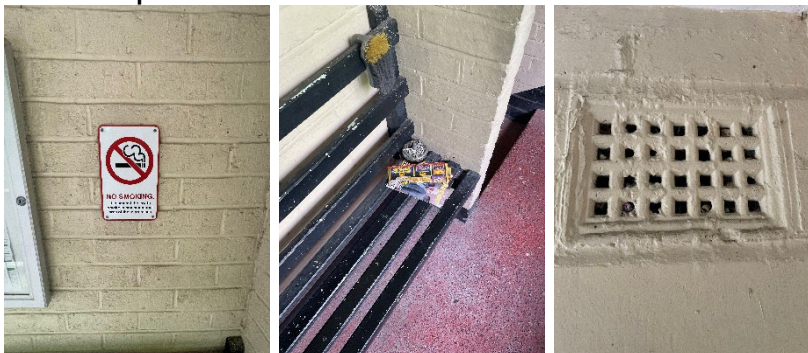
- 1) Fire Action Notices are not displayed throughout the building. The signs are not necessary due to the building not having a complex layout.
- 2) Smoking is prohibited within any communal parts of the building in line with Smoke Free England Legislation. An ash tray was noted outside of flat 105 (located on the landing bench). Also, cigarette ends noted in various air bricks. Email sent to housing manager requesting that residents are reminded that smoking in communal areas is prohibited.

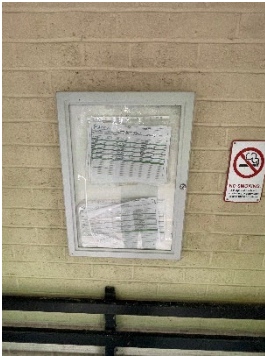
- 1) There is a regular cleaning service to the premises.
- 2) Regular checks by Caretakers minimise risk of waste accumulation.

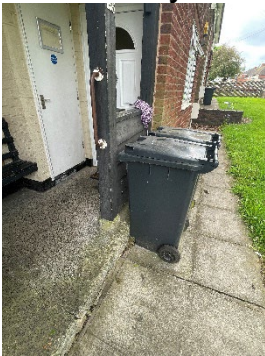
- 3) There is an 'Out of Hours' service in place to remove bulk items.
- 4) External bins located close to timber cladding. Bins to be located further way from building. Email sent to housing manager.

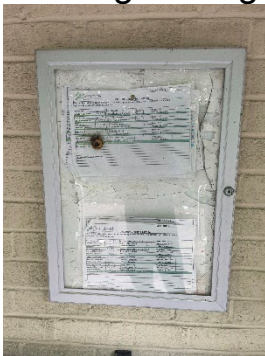
- 1) Regular checks are undertaken by Janitorial / Cleaning Teams which helps reduce the risk of arson.
- 2) Evidence of arson was noted within block 85-99. Email sent to housing manager.
