### Fire Risk Assessment

### **57 Edgbaston Road**

57, 57a, 57b, 57c Edgbaston Rd Smethwick B66 4LG

Date Completed: 04-08-23

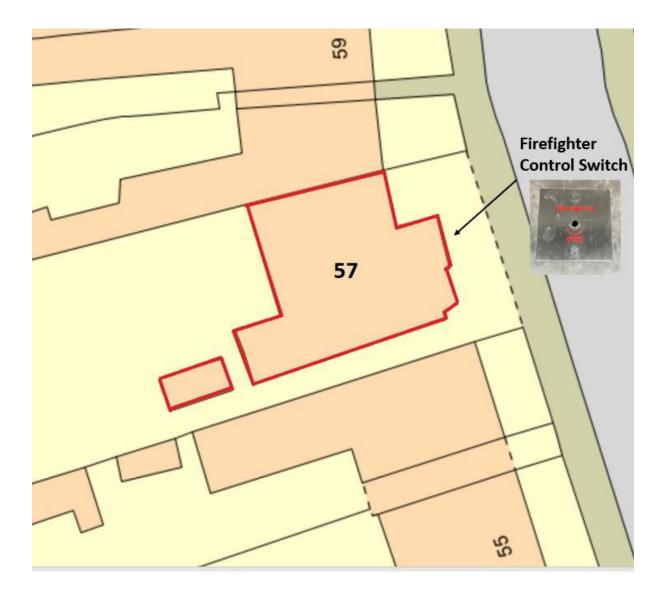
Access to the building is gained via the Firefighter override switch utilising a drop latch key. This is located to the right-hand side of the front entrance above the light.

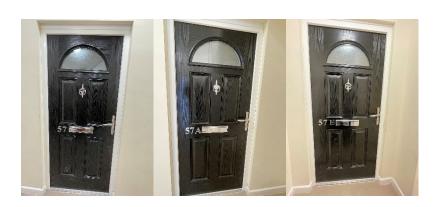
- 9) There is no means of access to the internal roof space from the common areas.
- 10) Individual flat doors are FD30s rated composite fire door sets manufactured by Nationwide. Two of the doors inspected have the BM Trada Q Mark identification plugs demonstrating that the doors are FD30s rated.
