Fire Risk Assessment

Sampson Close 1-6, 7-12, 13-18, 19-24

Sampson close, Tividale, B69 1NL

Date Completed: 05/09/2023

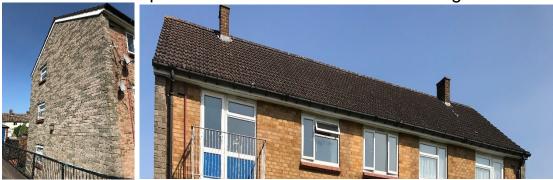
3) Each block has a pitched roof with concrete interlocking tiles.

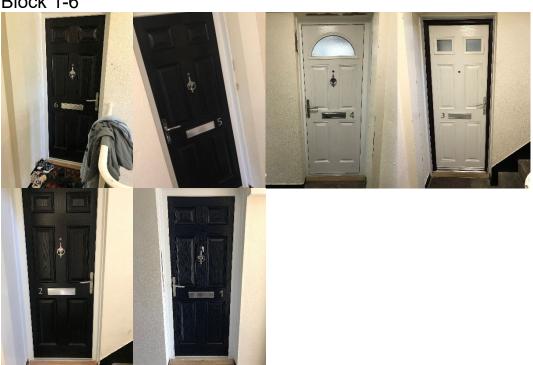
Block 1-6

13) Individual flat doors are a mixture of timber and composite FD30 nominal fire doors varying between blocks.

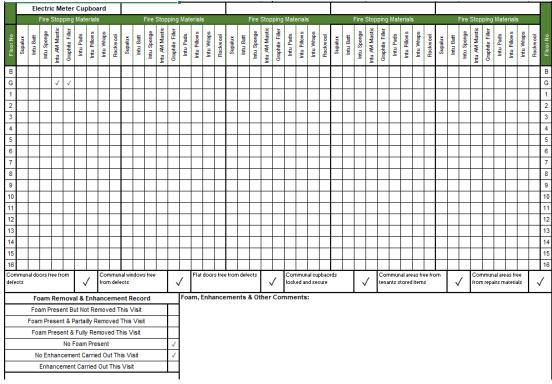
Block 1-6

- The building is designed to provide as a minimum 1-hour vertical fire resistance and 1-hour horizontal fire resistance around flats stairwells and lift shafts. All doors are 30-minute fire resistant with cold smoke seals, including those in 1-hour rated walls.
- 2) The premises do not have sufficient compartmentation to limit the travel and effect of smoke and flame in event of a fire in communal areas due to the open plan staircase.
- 3) service cupboards on the ground floor within the communal area is lockable secured with 138 suited lock, a mixture of timber and steel doors have been used
- 4) A variety of methods / materials have been used to achieve firestopping including Rockwool, and intumescent pillows.
