# Fire Risk Assessment

## Aston Street.

71-76, 77-82, 83-88, 89-94, 95-100

**Date Completed:** 31<sup>ST</sup> May 2024

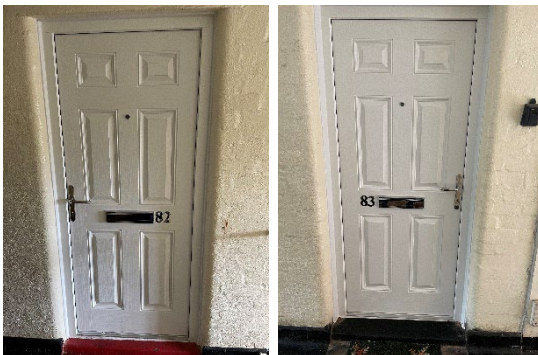
- 2) The means of escape are protected to prevent the spread of fire and smoke with predominately Nominal FD30s doors. Internal access to flats (82 and 83) was gained during the fire risk assessment.

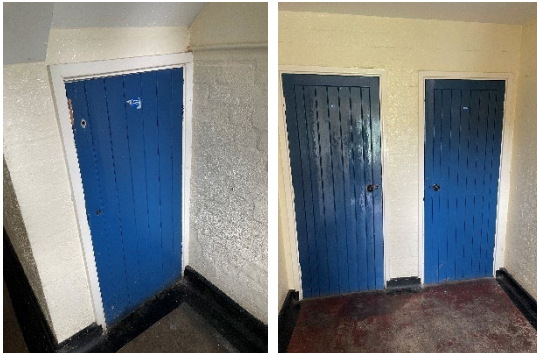
- 9) Ground floor service cupboards and storage cupboards on the first and second floor are not of fire resisting construction.

Future works programme should consider replacing the electrical intake timber door, within the ground floor staircase, and store cupboard doors on first and second floors within staircase, with 30 minutes certified fire resisting door sets.

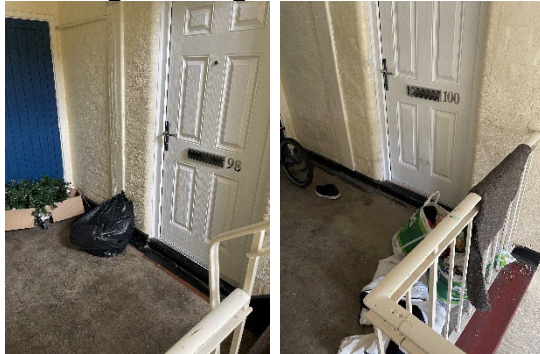
14) Combustible Items noted outside of flats 98 and 100. Email sent to housing manager. Communal area to be kept clear.

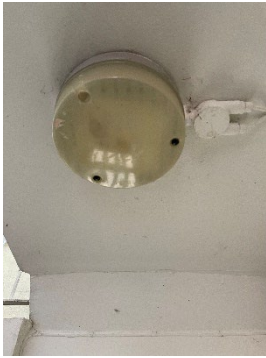
- 1) Blocks do not have an emergency / escape lighting system. This is deemed acceptable within a 3-storey block that has adequate conventional lighting installed.
-

Future works programme should consider the installation of emergency lighting within the staircase.

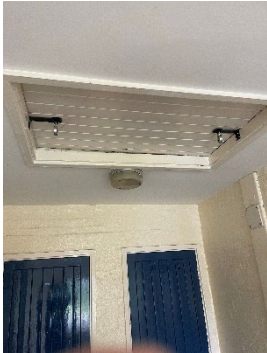
- 7) There is access to the internal roof space from the common areas via a padlocked roof hatch. Access was not gained during the fire risk assessment.

Arrangements to be made for rapid fire team to gain access to roof voids to allow inspection by the fire risk assessor.

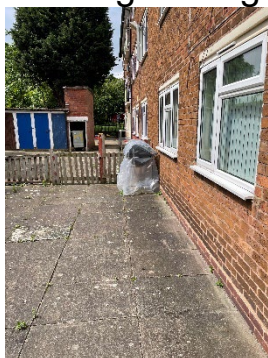
- 2) Hot working is not normally carried out. If essential maintenance requires the use of hot work processes, then corporate policies and procedures are to be followed.
- 3) Portable electrical equipment used as part of the Caretaking / Cleaning regime is subject to annual PAT Testing. This information is held by the Estate Services Manager Bryan Low.
- 4) A barbeque was noted at the rear of block 71-76. Email sent to housing manager as not permitted.

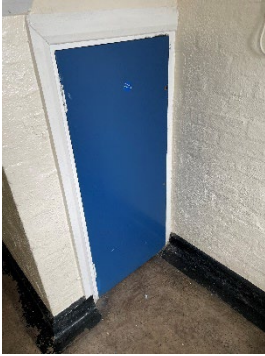
- 6) The electrical installation i.e., risers are contained within dedicated service cupboards and are in the entrance lobby. No access obtained during fire risk assessment.

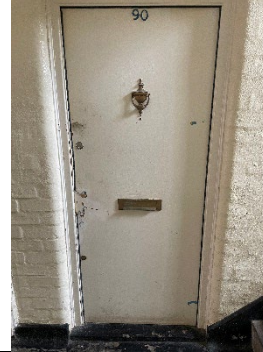
Future works programme should replace the timber entrance door to flat 90 with a certified self-closing FD 30s door set. Email sent to manager of door programme.
