Fire Risk Assessment

Manifoldia Grange

**Coyne Road, West Bromwich,
B70 7JU**

Date Completed: 13th June 2024

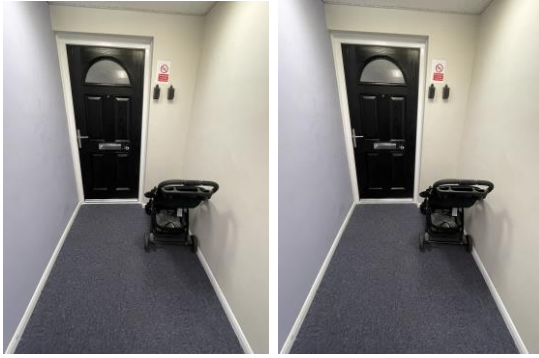
- 18) Pushchairs were noted in the communal corridors outside flats 36 & 38. The premise manager confirmed that residents are allowed to store their pushchairs in the corridor during daytime hours only. There are plans to convert the former communal bathrooms into a secure storage facility for the residents and their pushchairs however, until the works have been completed office staff walk the building each duty day and site security walk the building hourly during non-business hours to ensure that the means of escape are not obstructed. This is acceptable as part of a managed approach.
-

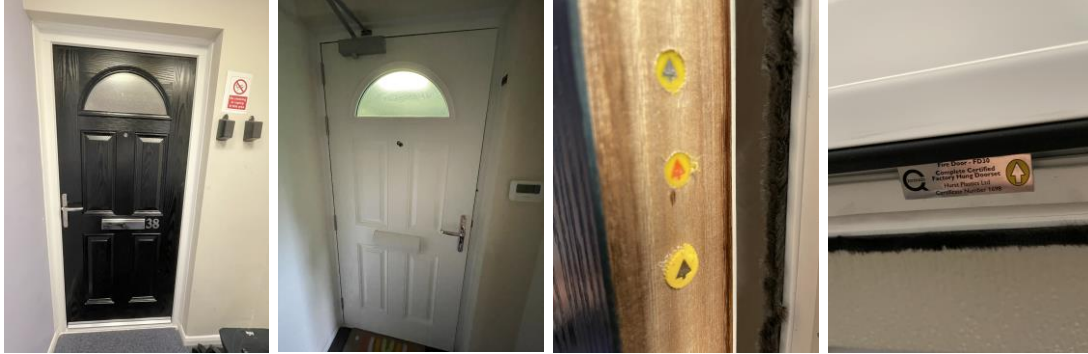
22) All individual flat doors have recently been installed by Sycamore Windows. The doors are manufactured by Hurst Plastics Ltd under the BM TRADA Q-Mark fire door manufacture scheme. The fire door identification plugs were noted in each of the sampled doors.

Flat doors to 11, 19 & 38 were checked and confirmed ok.

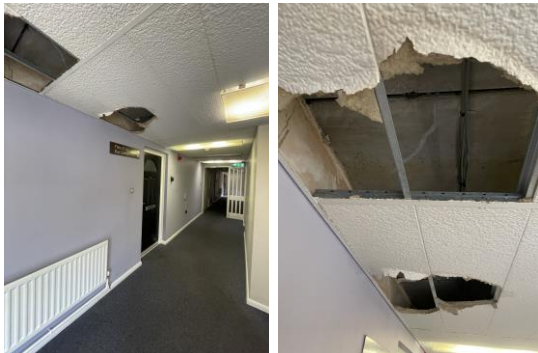
23) Some communal ceiling tiles within the wing containing flats 22 - 39 are generally in poor condition, replacements should be considered.

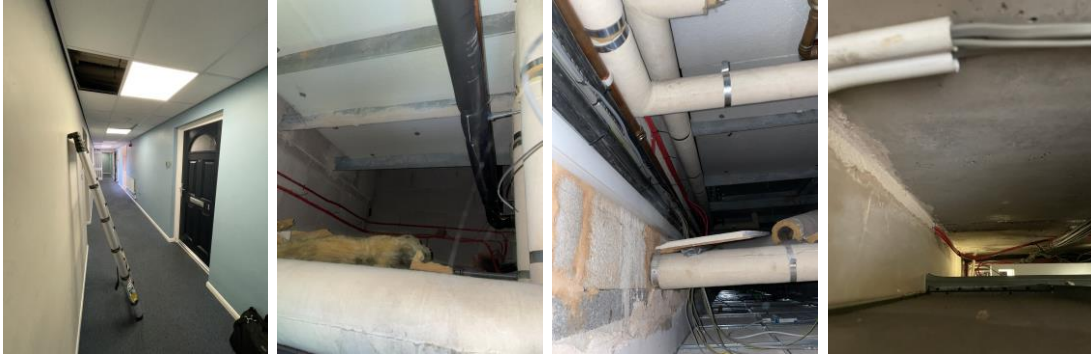
- 3) The premise has sufficient compartmentation to limit the travel and effect of smoke and flame in event of a fire. Whilst the existing fire stopping is fit for purpose, there is a cyclical programme to ensure fire stopping as not been compromised by third parties and where applicable enhance the fire stopping. During this FRA survey ceiling tiles were removed in communal corridors to confirm compartmentation between flats and corridors and above communal fire doors
-

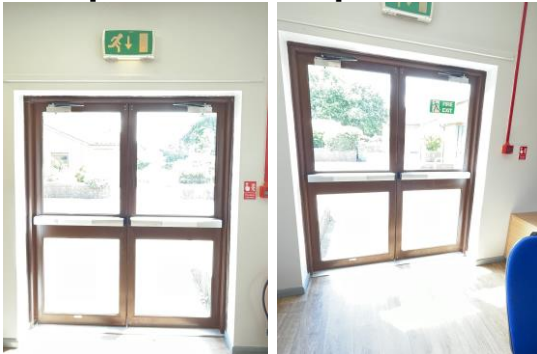
- 5) The two sets of exit doors in the former lounge / dining area with panic bars require Push Bar to Exit signage.

12/5	<p>Install push bar to exit adhesive signage on each final exit door in lounge / dining / meeting area. (4 x doors)</p> <p><i>Signage can be applied to upper glazed panels which are 680mm in width.</i></p>

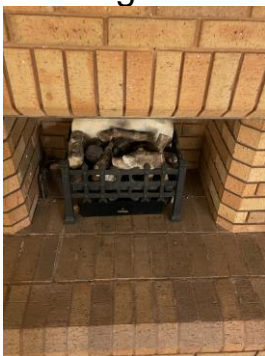
- 9) It was noted that the supply to the gas fire within the central office / meeting area has been isolated.

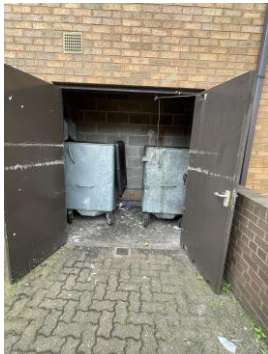
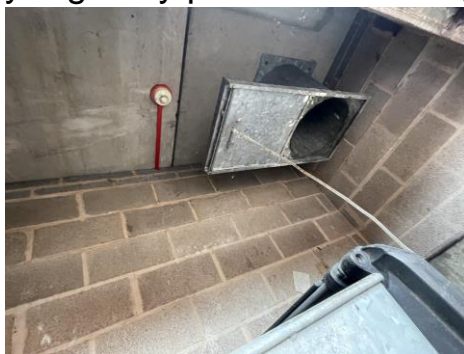
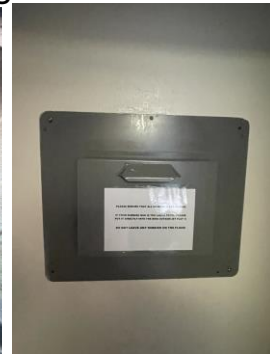
- 2) There are two bin stores containing refuse containers. Each store was noted as open during the survey. The premise manager confirmed that this is to allow residents to discard larger bags of waste which historically may have been left within the chute rooms or beside the bin stores. This is deemed as acceptable because fire detection linked to the fire alarm panel is present in each store and staff / security regularly patrol the building.
