Fire Risk Assessment

**Flats 8 – 9B
Sedgley Road West,
Tipton,
DY4 8DB.**

Date Completed: 02/07/2024.

Officer: A Jones Fire Risk Assessor.

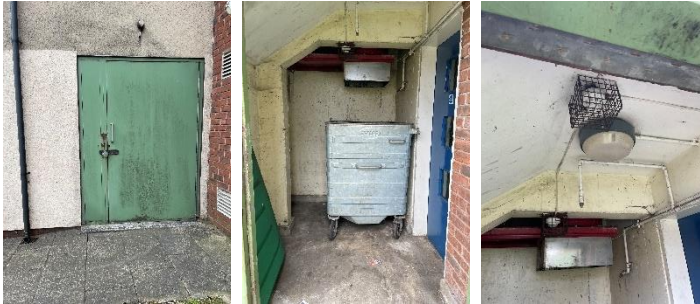
- 3) External access to the bin room is via the green doors adjacent to the front entrance. The bin room is protected by smoke detection and what appears to be a low-pressure water misting type system.

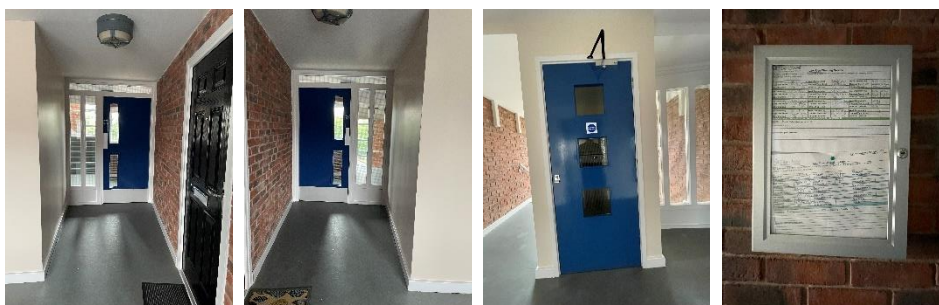
- 2) All communal doors are fitted with automatic closing devices that are checked on a regular basis by caretaking/cleaning teams as part of their checks. Any defective closing devices are reported to an external contractor.
- 3) The final exit doors have door entry systems installed. These systems are designed to fail safe i.e., door unlocked in the event of a power failure. This prevents residents being locked in or out of the building.
- 4) Communal areas should be kept free of flammable items. The communal areas should be checked on a regular basis by Caretaking / Cleaning teams and all items of rubbish removed.

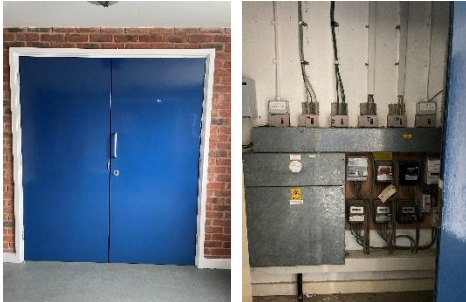
- 5) Service cupboards appeared to be FD30s rated and looked to be in good condition. These doors are maintained locked shut. Residents have been provided with a key for access to their electricity meters.

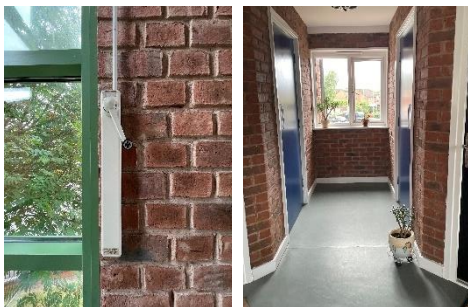
- 6) **However, some general maintenance is required to re-align service doors on the second floor, this is due to gaps in excess of 4mm.**
- 7) The means of escape are protected to prevent the spread of fire and smoke.
- 8) Automatic smoke ventilation is not commissioned, staircase/landing windows are openable and can be used for mechanical/forced ventilation if necessary.

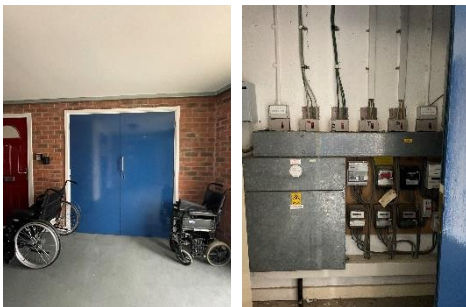
- 11) The electrical cupboard for the building is located on the ground floor, it opens onto the means of escape corridor. There were no issues to report.

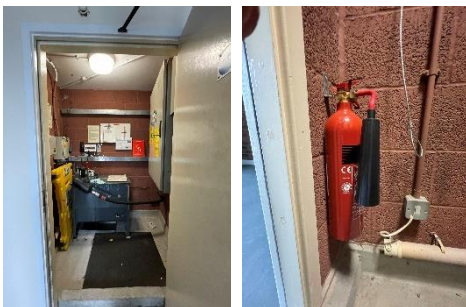
- 12) The Lift motor room is located on the ground floor, the room appeared to be in good order, service records are in place with the last service carried out on 07/06/2024, a CO₂ extinguisher is provided in the motor room, this is in service date with the date of the next test being October 2024.

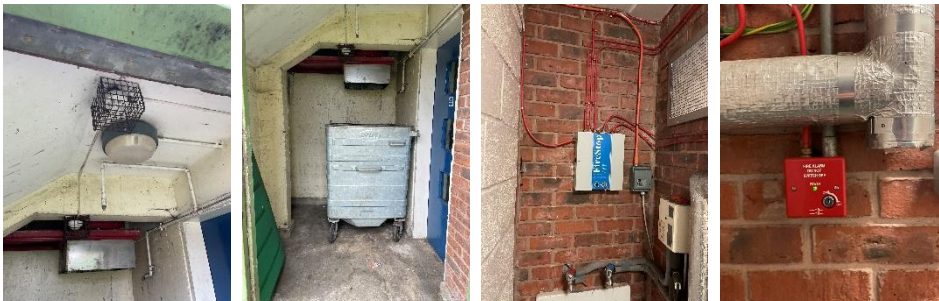
- 4) A fire alarm system is present in the bin store area with an alarm above door in communal area and an external neon warning light.
- 5) A water mist system/drencher is provided directly over the waste container in the refuse bin store. An approved contractor maintains the system. It is understood that the frequency for the maintenance checks is twice per each calendar year.

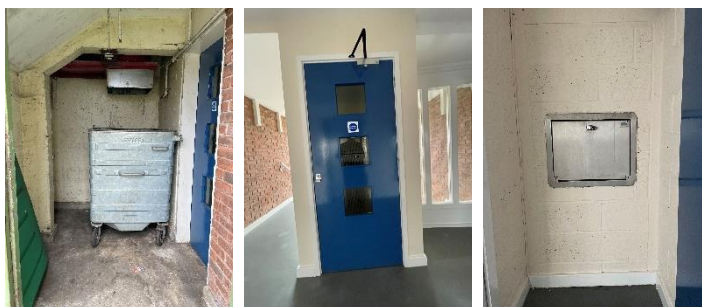
- 8) However, it was noted that some maintenance is required to re-align service cupboard doors on the second floor due to excess gaps greater than 4mm.
- 9) Residents utilise a refuse chute for the disposal of waste. The bin room, associated doors, and subsequent disposal chutes at upper floor levels are in good condition.

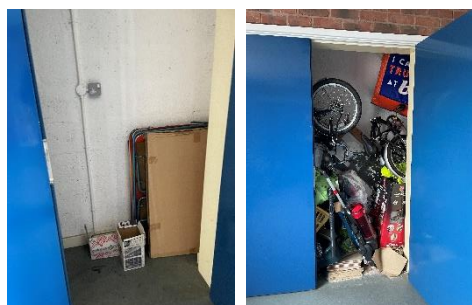
- 5) As per tenancy agreements, flammable liquids or gas cylinders should not be stored on site.
- 6) **On the second floor in what is thought to be a service cupboard, it was noted that storage of personal belongings had occurred. This was adjacent to flats 8B & 9B. Combustible items should be removed, and the cupboard maintained as sterile.**
