Fire Risk Assessment Manifoldia Grange

Coyne Road, West Bromwich, B70 7JU

Date Completed: 13th June 2024

Officer: Carl Hill Fire Risk Assessor

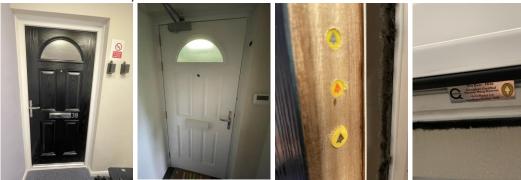
22) All individual flat doors have recently been installed by Sycamore Windows. The doors are manufactured by Hurst Plastics Ltd under the BM TRADA Q-Mark fire door manufacture scheme. The fire door identification plugs were noted in each of the sampled doors.

Flat doors to 11, 19 & 38 were checked and confirmed ok.
