Fire Risk Assessment

297-308, 309-320, 321-332 Dudley Port

Tipton

Date Completed: 03/07/2024

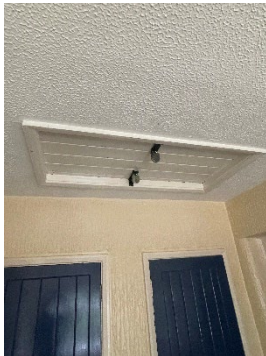
Internal access to the roof can be gained on the second floor. Residents do not have access to the roof space. No access was gained during the fire risk assessment as keys not available for the padlocks.

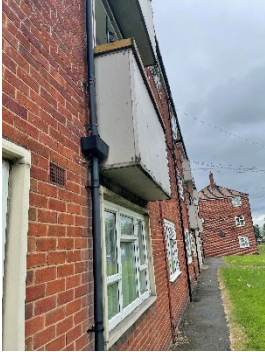
- 6) Flats located on the first and second floor have access to balconys at the front of the premise. Access to inspect the balcony material was not possible during the fire risk assessment. It is therefore recomended that during the next planned future works programme that this material is identified and if combustibile replaced with a non combustibile boarding. Please note current building regulations have no provision for any combustibility rating for a building of this type and height.

<p>As part of a future works programme the combustibility of the balcony material should be established. If appropriate upgrade to a non-combustible material.</p>	  A photograph showing the exterior of a brick building. The building is made of red brick and has a white window frame. A black downspout is visible on the side of the building. The sky is overcast.

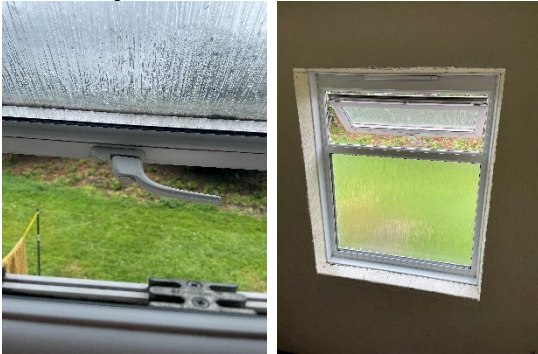
- 7) Automatic smoke ventilation is not employed. Windows along the means of escape/ communal areas can be opened without the use of a key.

As part of a future works programme consideration should be given to replacing the staircase windows with windows that provide a larger opening window of 1m² to aid smoke ventilation of the staircase.

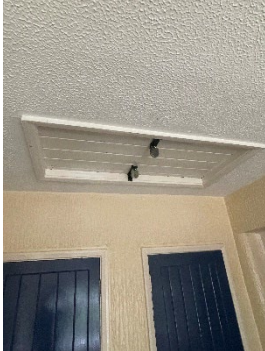
- 18) There is a loft hatch within the communal landing secured with two padlocks, access was not gained to inspect the roof fire stopping as keys not available for the padlocks.

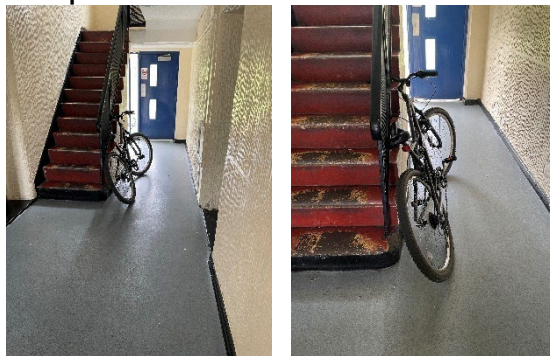
- 19) Block 297-308 and Block 321-332 have bikes stored within the staircase. These should be removed as potentially blocking the escape routes. Email sent to housing manager.

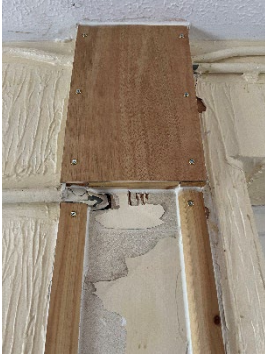
- 8) Any remedial works arising from the fire stopping / compartmentation check(s) will be actioned immediately by the Fire Safety Rapid Response Team.
- 9) Individual flat doors are a mixture of notional and composite FD 30s composite fire door construction see [section 7](#) for photos of flat entrance doors.
It is accepted that, in older blocks, fire doors, particularly flat entrance doors, do not meet current test standards for FD30S doors. However, these doors may still be acceptable if the doors remain in good condition, and they met the relevant standards at the time of construction of the block
- 10) Access panels appear to be constructed with timber. The timber should be removed and replaced with a fire resisting board as part of a future works programme.

Observations	
<p>As part of a future works programme consideration should be given to replacing the timber boxing within the staircase with a non-combustible board.</p>	  A close-up photograph showing a section of a staircase where the timber boxing is being replaced. The new board is a light-colored, non-combustible material, and the old timber is being removed or partially removed. The surrounding area is covered with white protective sheeting.
<p>As part of a future works door replacement programme consideration should be given to replacing the notional flat entrance doors to certified self-closing door sets to an FD 30s standard and the store doors to an FD30S standard.</p>	  Two photographs showing blue doors. The left photo is a close-up of a blue door with the number '307' on it. The right photo shows a hallway with two blue doors, one of which is partially open, and a black metal railing in the foreground.

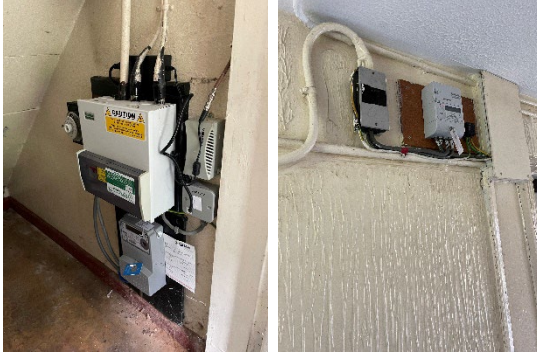
- 5) The electrical installations are contained within the service cupboard. One exposed meter noted at high level. This is deemed acceptable due to the low fire risk however a future works programme should relocate to a central protected point or encase in fire resisting construction.

As part of a future works programme electric meters should be relocated to a protected central point or encased in 60 minutes fire resistance.

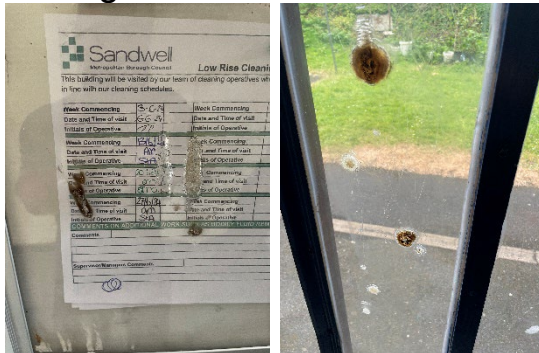
- 4) Historic signs of potential arson were noted. Email sent to housing manager to discuss this issue with tenants.

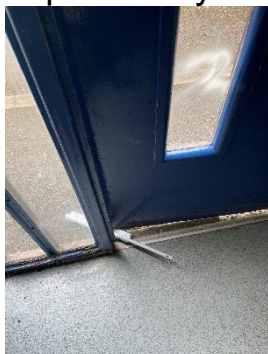
- 7) Rear exit/entrance doors are being wedged open. Email sent to housing manager to discuss and prevent residents from doing this as potentially allows uncontrolled access.
