Fire Risk Assessment

Compton Grange

**Whitehall Road,
Cradley Heath, B64 5BG**

Date Completed: 25th June 2024

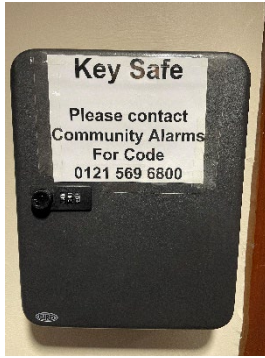
There is a key safe on the wall within the reception lobby. It was noted that the lock is defective therefore an email has been sent to the housing manager to replace the safe.

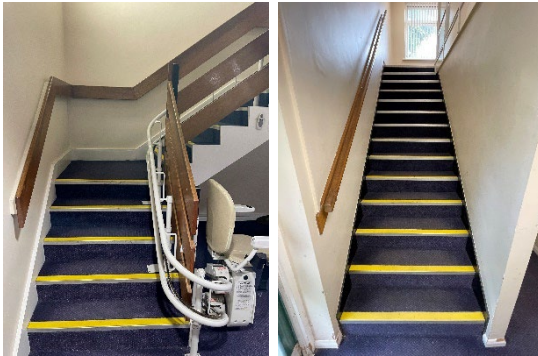
- 1) The site has four staircase's that provide a means of escape, all are 1030mm in width. The width of two staircase's is slightly reduced due to the installation of a stairlift.

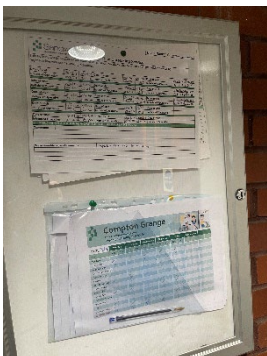
- 11) Communal areas are kept free of flammable items. The communal areas are checked on a regular basis by Caretaking / Cleaning teams 365 days per year and all items of rubbish are immediately removed. There is also an out of hour's service that allows combustible items of furniture / rubbish to be removed

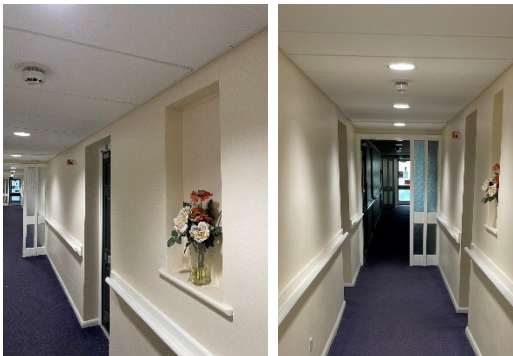
- 18) Decorative artificial flowers have been placed in some alcoves within some communal corridors. There is a building entry system in place and all corridors have smoke detectors therefor the risk is considered minimum.

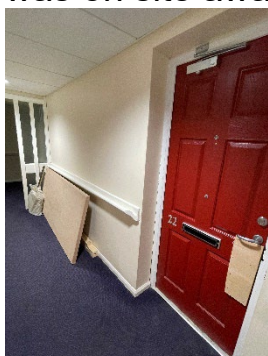
- 6) Flat 22 entrance door was noted as damaged but temporarily repaired due to a forced entry. A replacement timber fire door set was on site awaiting installation. Job number JM13907127.
