Fire Risk Assessment

**Flats 1- 6, 7 – 12, 13 - 18 & 19 - 24
Hickman Road,
Tipton,
DY4 9QB.**

Date Completed: 25/07/2024.

Officer: A Jones Fire Risk Assessor

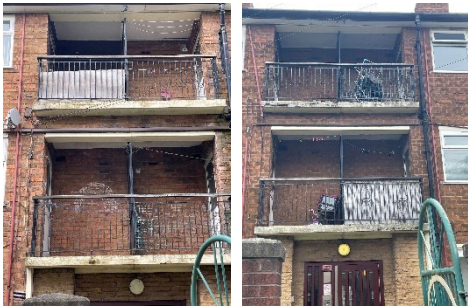
- 4) **All balconies should be free from combustible materials including any decorative screening. Therefore, all screening should be removed.**

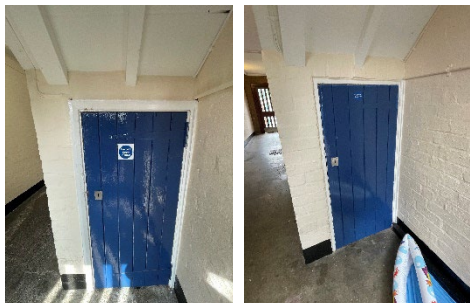
- 5) Electrical service cupboard doors should be replaced when any future upgrades take place, at this point, these doors should be upgraded to FD30s doors.

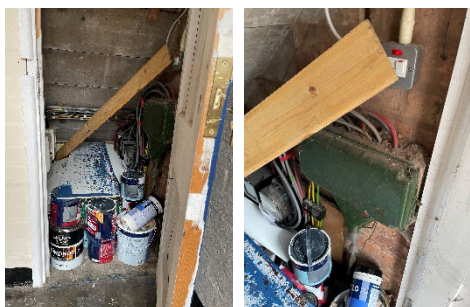
- 6) It was noted that combustible items are being stored in the electrical cupboard of Flats 13 – 18.

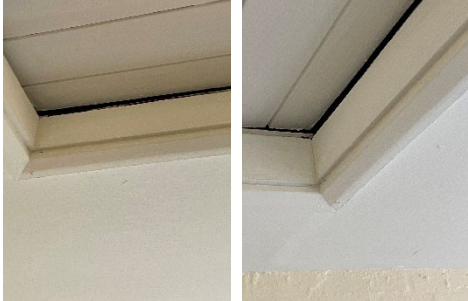
- 14) In block 7 – 12 the loft hatch was not seated correctly which leaves a gap greater than 30mm. Reseat or replace hatch with material that provides adequate fire resistance, this should be a minimum of 30 mins.**

07/14	Repair or replace loft hatch, currently not seating correctly.

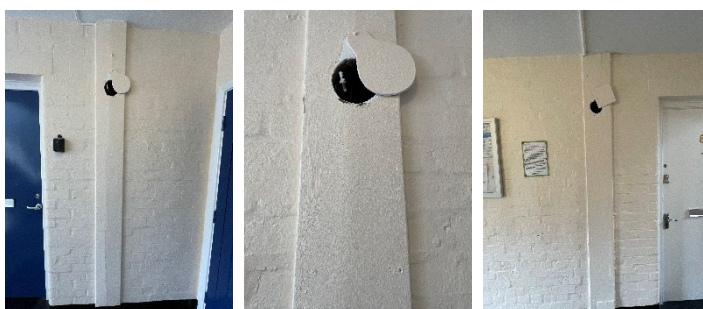
1. The building is designed to provide as a minimum 1-hour vertical fire resistance and 1-hour horizontal fire resistance around flats. All flat entrance doors are 30-minute notional/nominal doors, including those in 1-hour rated walls.
- 2) Generally, the means of escape is protected from flats with the use of nominal rated timber & composite doors. These doors should be upgraded to FD30's when the door replacement programme commences.
- 3) The fire stopping / compartmentation of the premises is subject to an annual inspection by the Fire Safety Rapid Response Team.
- 4) **In the communal areas, outside individual Flat entrance doors there is a section of service boxing that covers individual flat stop taps. It does not appear that adequate fire stopping is present within these sections of boxing.**

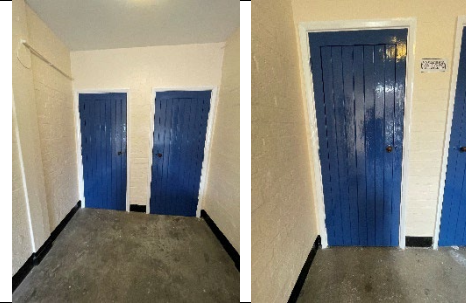
Internal service cupboards doors should be upgraded to FD30s as part of next improvement works programme.

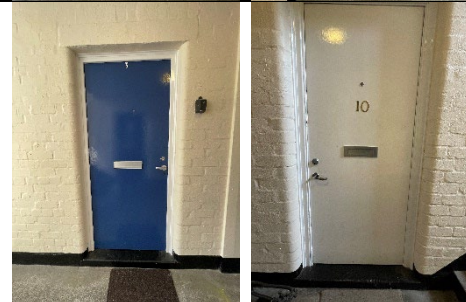
As part of any future upgrades or door replacement programme replace timber flat entrance doors for FD30s.
