# Fire Risk Assessment

**Flats 42 – 48  
Hackwood Road,  
Wednesbury,  
WS10 0DG.**

**Date Completed: 07/08/2024.**

**Officer: A Jones Fire Risk Assessor**

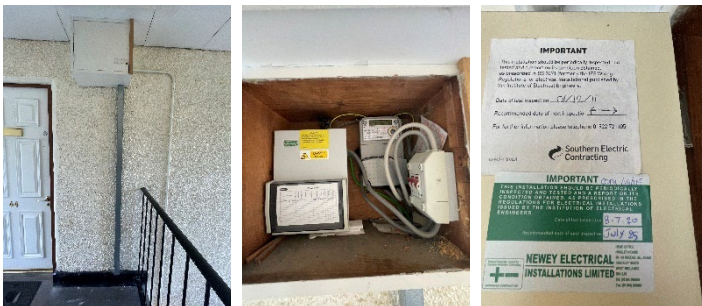
There is a small electrical cupboard located on the first floor outside flat number 44.

- 5) The same electrical service cupboard on the first floor should be upgraded to a fire resistant cabinet when any upgrades of the building are carried out.

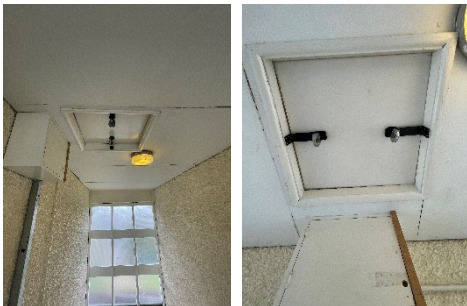
There is access to the loft space from the first floor landing area, the hatch is secured by padlocks.

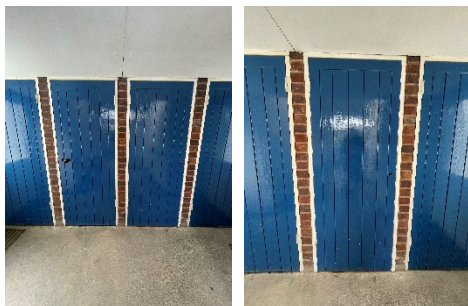
There are four internal store cupboards located on the ground floor, these are for storage of residents belongings.

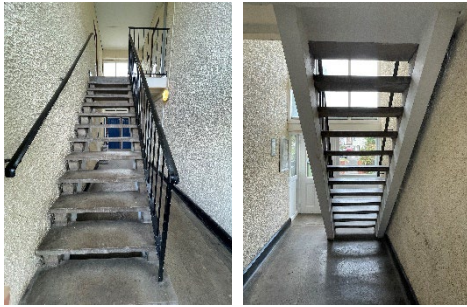
- 1) The building has a single staircase that provides the means of escape. The staircase is of adequate width (at least 950mm) and must be maintained clear to that width as a minimum.

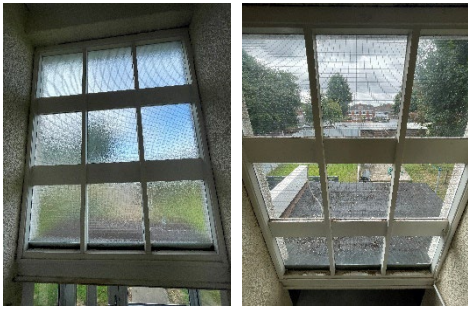
- 4) An automatic smoke ventilation is not commissioned, and staircase windows are non-openable.

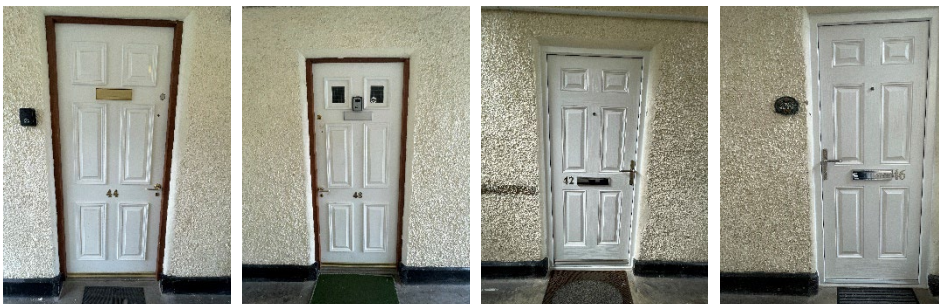
- 9) It was noted that a number of pairs of shoes were left outside flat 46, these should be removed or stored in a secure cupboard. (Email sent to housing).

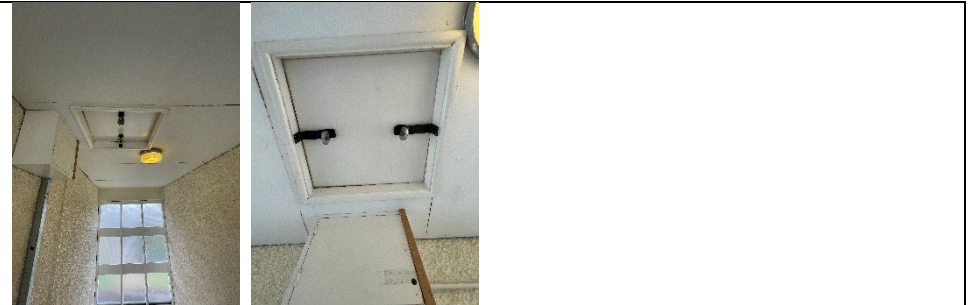
Access to the roof space could not be gained at the time of the assessment. A future date will be agreed where the Assessor will meet the trades team at the premise to carry out a survey of the Roof void.
