# Fire Risk Assessment

## Stonehouse Crescent

**Flats 9-15,25-31,26-32  
Stonehouse Crescent,  
Wednesbury,  
WS10 0DG.**

**Date Completed: 09/08/2024.**

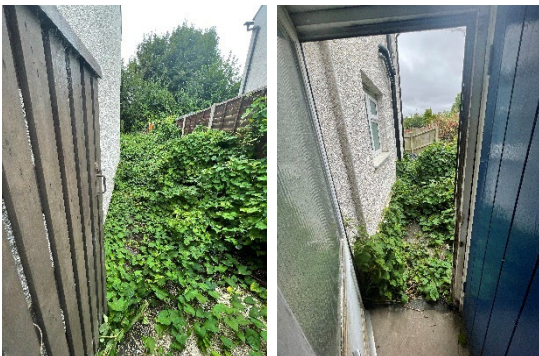
The rear garden is secured by fencing; there are access gates at each side of the building. The gardens are overgrown, and it is recommended that they are cleared as the vegetation obstructs egress from the rear doors of the staircase.

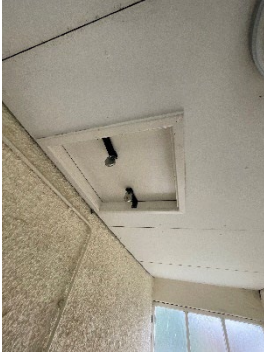
There is access to the loft space from the first floor landing area, the hatch is secured by padlocks. No access was gained into the roof during this fire risk assessment.

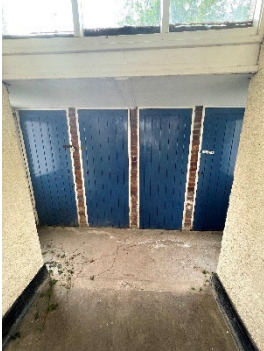
There are four internal store cupboards located on the ground floor, these are for storage of resident's belongings.

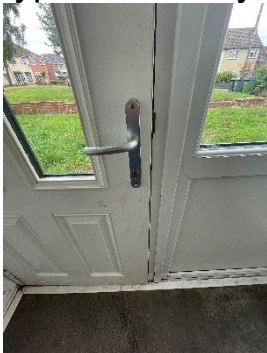
- 2) The final exit doors are not fitted with a door entry system or other type of security device.

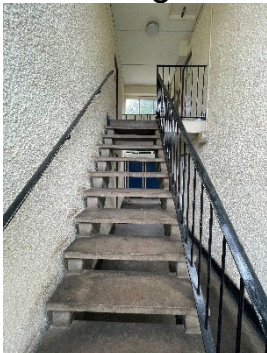
- 3) Communal areas should be kept free of flammable items. The communal areas should be checked on a regular basis by Caretaking / Cleaning teams and all items of rubbish removed.

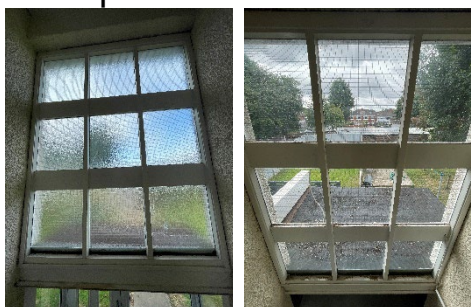
- 4) Automatic smoke ventilation is not present. Staircase windows are non-openable.

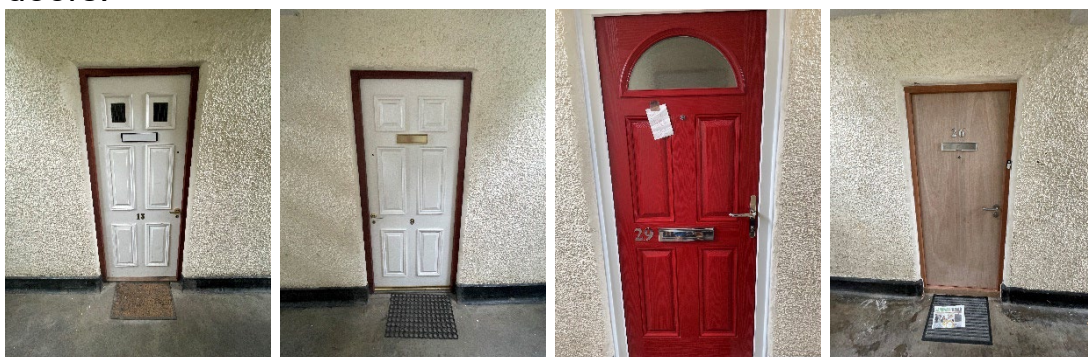
- 5) Surface coatings to the walls in the communal areas appear to be Class 0 rated.
- 6) The building has sufficient passive controls that provide effective compartmentation to support a Stay Put Policy Therefore residents are advised to remain in their flat unless the fire directly affects them.
- 7) The means of escape are protected to prevent the spread of fire and smoke with a combination of nominal composite/timber flat entrance doors.

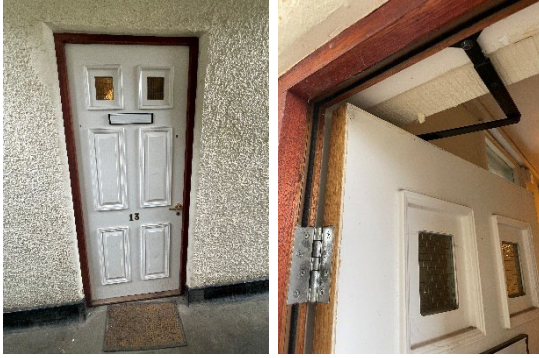
- 8) There are no corridors within the means of escape that form part of a dead end.
- 9) At the time of the fire risk assessment, the resident from flat 13 provided information on the front door, this was to establish whether the doors have not been tampered with by residents etc.

There were no issues identified with the front door, the resident confirmed that the self-closer was present and the door closed as required.

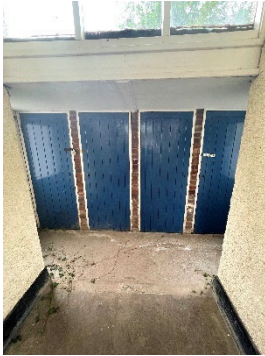
- 10) The premises do not have emergency lighting installed; however standardised lighting is present. This is deemed acceptable due to the height of the building.
- 11) Any communal fire doors are subject to an annual check by the Fire Safety Rapid Response Team.
- 12) When any future upgrades of the building are carried out, consideration should be given to upgrading the storage cupboard doors in the communal area.

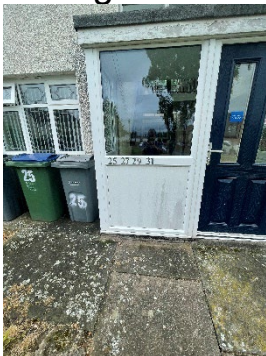
- 1) Refuse containers are emptied at regular intervals.
- 2) There is an 'Out of Hours' service in place to remove bulk items.
- 3) Refuse containers noted too close to the building. Email sent to housing officer.

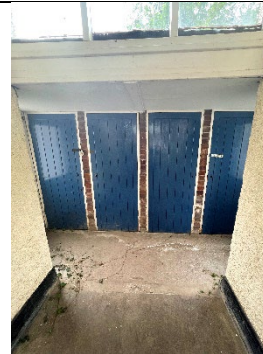
Internal store cupboards doors should be considered for replacement to certified FD30s door sets as part of next improvement works programme.

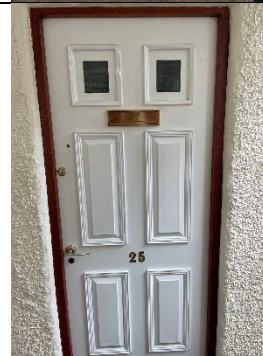
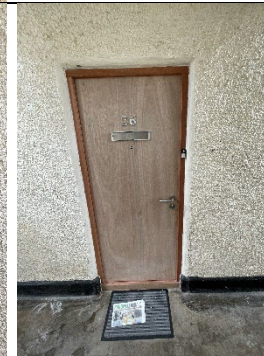
Flat entrance doors should be considered for replacement to certified FD 30S doorsets as part of the next improvement works programme.

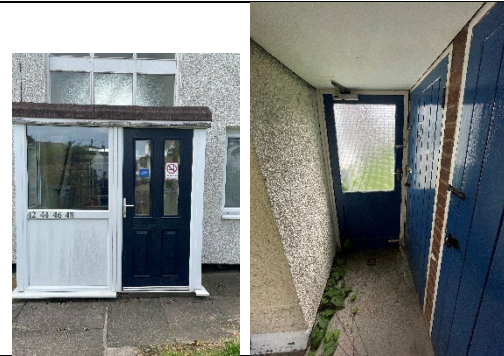
As part of any future upgrades or door replacement programme, consideration should be given to providing a suitable door entry system to offer greater security to the building and to replace the rear doors to the staircase to ensure suitable access and egress arrangements are present.

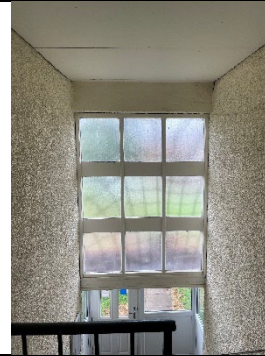
As part of any future upgrade works the installation of staircase ventilation should be considered.
