Fire Risk Assessment

Devon Road

**Flats 37-43, 45-51, 53-59, 69-75, 77-83, 85-91, 93-99
Devon Road,
Wednesbury,
WS10 0RU.**

Date Completed: 13/08/2024.

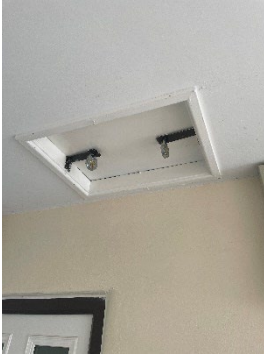
There is access to the loft space from the first floor landing area, the hatch is secured by padlocks. No access was gained into the roof during this fire risk assessment.

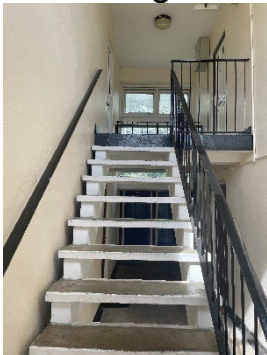
- 3) Communal areas should be kept free of flammable items. The communal areas should be checked on a regular basis by Caretaking / Cleaning teams and all items of rubbish removed.

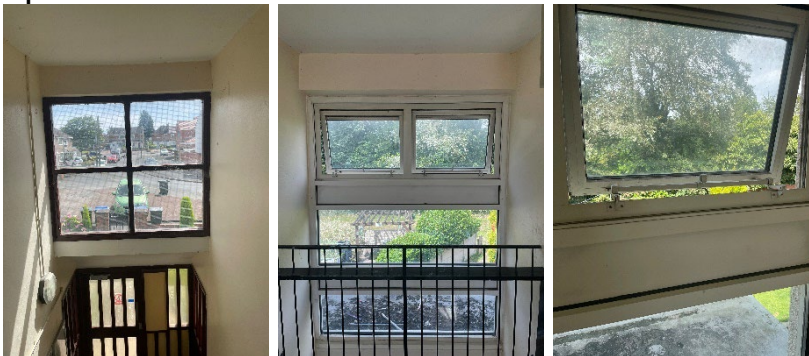
- 4) Automatic smoke ventilation is not present. Staircase windows are openable at rear.

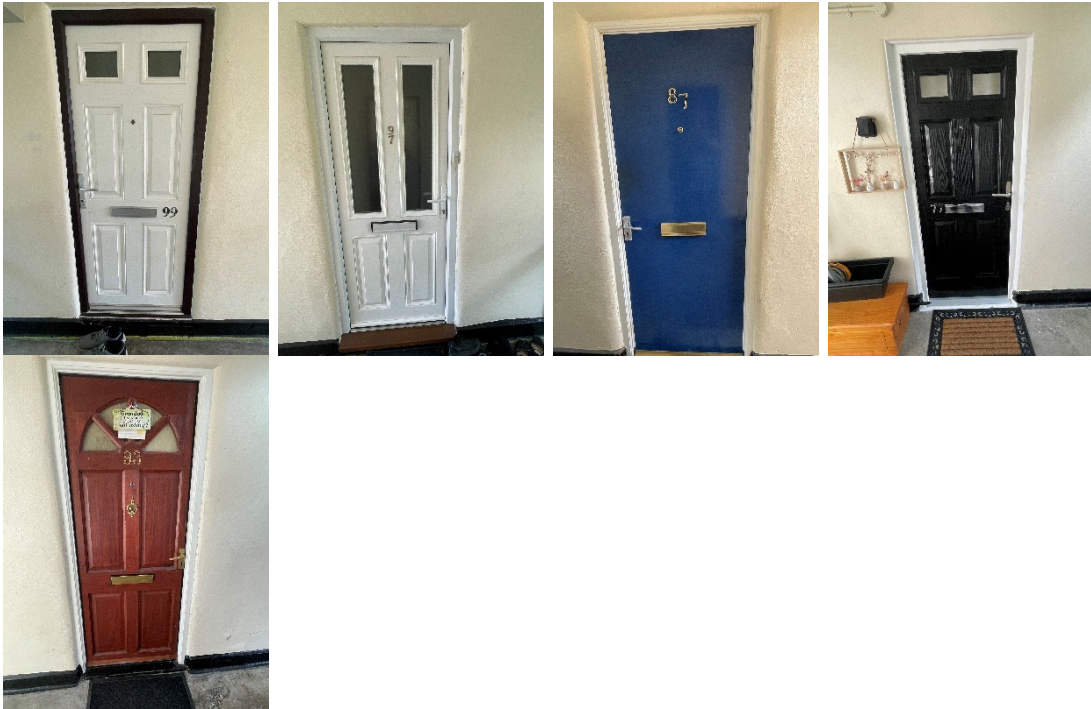
- 5) Surface coatings to the walls in the communal areas appear to be Class 0 rated.
- 6) The building has sufficient passive controls that provide effective compartmentation to support a Stay Put Policy Therefore residents are advised to remain in their flat unless the fire directly affects them.
- 7) The means of escape are protected to prevent the spread of fire and smoke with a combination of nominal composite/timber flat entrance doors. **Appears flat entrance door 93 is a standard timber door.**

Question/ Ref No	Required Action	Supporting photograph	Priority	Timescale and Person Responsible	Date Completed
07/7	Replace the non-fire resisting flat entrance door of flat 93 to a certified self-closing FD 30s door set.

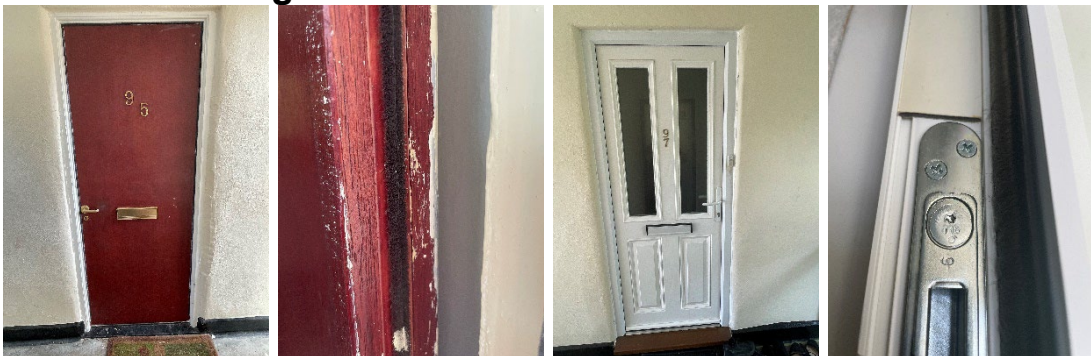
- 8) There are no corridors within the means of escape that form part of a dead end.
- 9) **At the time of the fire risk assessment, the residents from A) flat 95 and B) 97 provided information on the front door, this was to establish whether the doors have been tampered with.**

The self-closing devices had been removed from both doors.

P3	Repairs Within 3-6 Months	
07/9A	Self-closing device is required to flat entrance door 95.

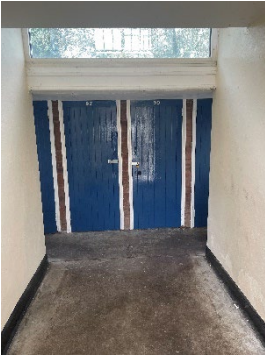
- 11) Any communal fire doors are subject to an annual check by the Fire Safety Rapid Response Team.
- 12) When any future upgrades of the building are carried out, consideration should be given to upgrading the storage cupboard doors in the communal area.

Internal store cupboards doors should be considered for replacement to certified FD30s door sets as part of next improvement works programme.

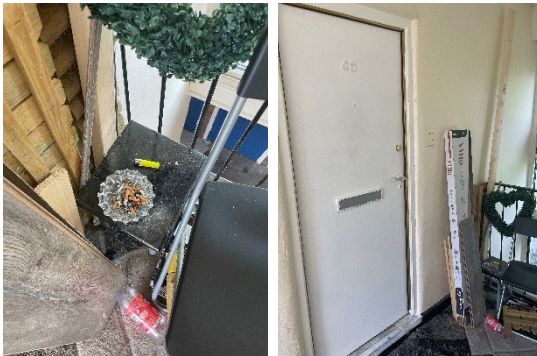
- 1) Smoking is prohibited within any communal parts of the building in line with Smoke Free England legislation. Signs of smoking were witnessed outside of flat 49. Email sent to housing officer.

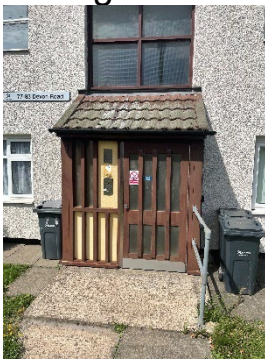
- 1) Refuse containers are emptied at regular intervals.
- 2) There is an 'Out of Hours' service in place to remove bulk items.
- 3) Refuse containers noted too close to the building. Email sent to housing officer.

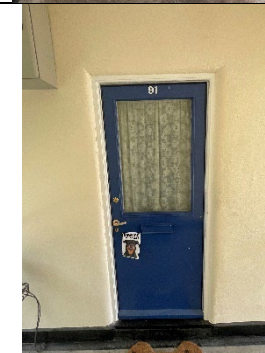
Flat entrance doors should be considered for replacement to certified FD30S doorsets as part of the next improvement works programme.

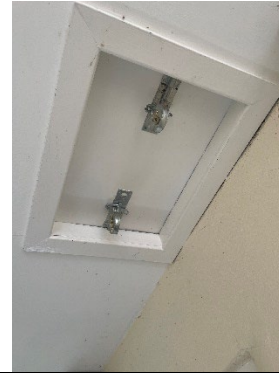
Access to the roof space could not be gained at the time of the assessment. A future date will be agreed where the Assessor will meet the trades team at the premise to carry out a survey of the Roof void.
