Fire Risk Assessment

Coronation Road

82-90, 94-102, 106-114

**Coronation Rd, Wednesbury,
WS10 0TJ**

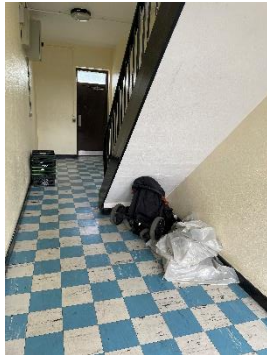
a) Block 106-114 – Pushchair stored under stairs ground floor.

Question/ Ref No	Required Action	Supporting photograph	Priority	Timescale and Person Responsible	Date Completed
7/8a	Block 106-114 – Remove pushchair from under stairs / ground floor means of escape.

P2	Within 1-3 Months Housing Manager

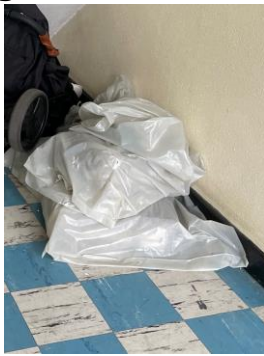
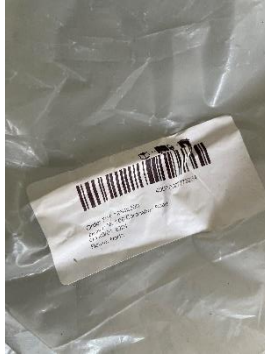
b) Block 106-114 – Bags of cement stored under stairs ground floor.

7/8b	Block 106-114 – Remove bags of cement from under stairs / ground floor means of escape.

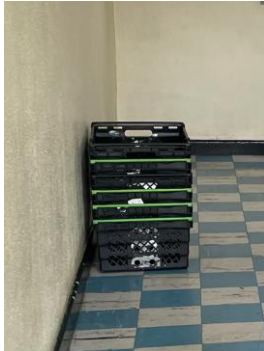
c) Block 106-114 – Asda home delivery baskets in ground floor means of escape.

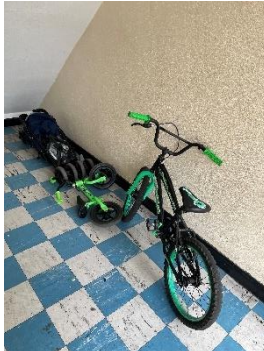
d) Block 94-102 – Bikes and pushchair under stairs

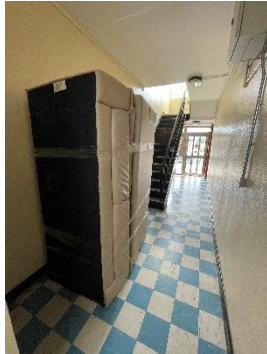
- e) Block 94-102 – Sofa in ground floor means of escape labelled awaiting collection by SMBC. *Caretaking services have been emailed for immediate removal. Update from Serco – Sofa will be collected 23/08/24*

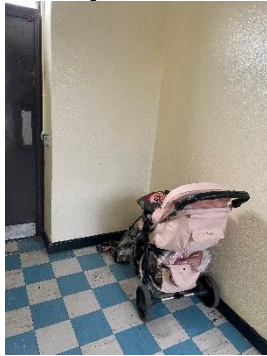
- f) **Block 82-90 – Pushchair in ground floor means of escape.**

7/8f	Block 82-90 – Pushchair to be removed from ground floor means of escape.

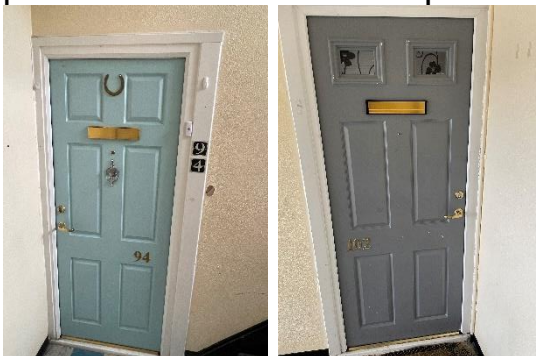
12) It was noted that entrance doors to flats 94 & 102 have been painted with an unknown paint.

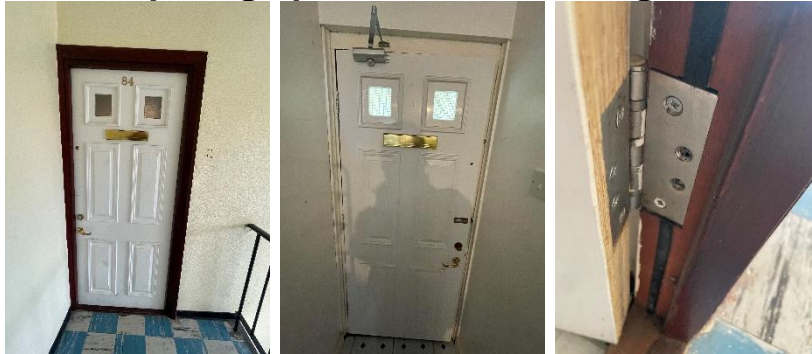
- b) Flat 84 – Door is failing to fully self-close because it fouls on the door frame. This is potentially due to a loose top hinge plus screws missing from other hinges.**

P2	Within 1-3 Months Housing Manager	
7/13b	Flat 84 entrance door – Replace missing screws to hinges and rehang door to ensure it fully self-closes.

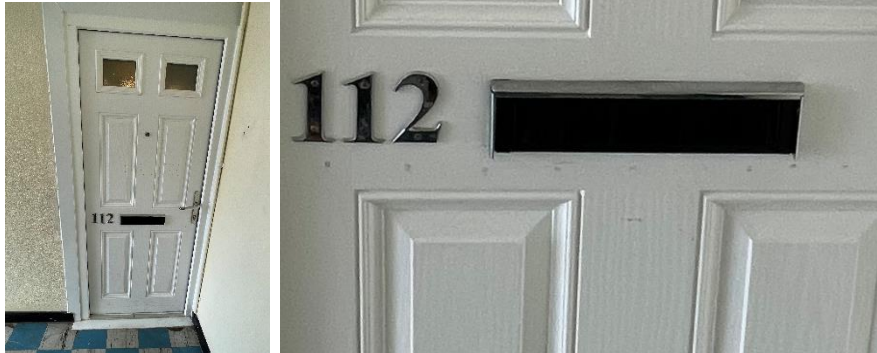
- c) Flat 112 – This door was not accessed however, the outer letterplate was noted as missing.**

P2	Within 1-3 Months Fire Rapid Response Team	
7/13c	Flat 112 entrance door – Replace missing outer letterbox plate.

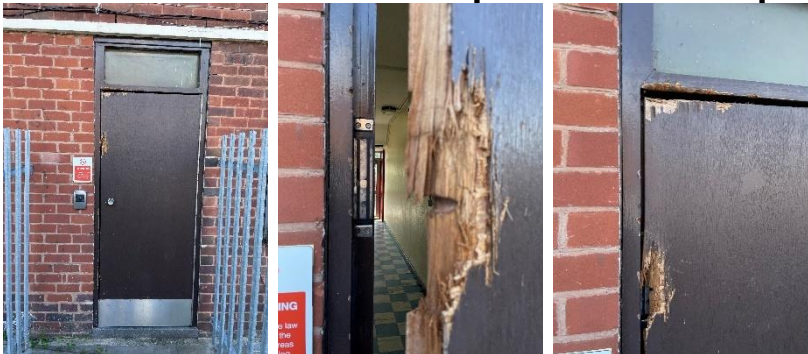
- 3) **The rear final exit door in block 82-90 has been damaged due to a forced entry by unknown persons. The door is no longer secured and therefore a replacement is required.**

<p>17/3</p>	<p>Block 82-90 – replace damaged rear final exit door. <i>Door leaf approximately 2020mm x 814mm</i></p>	 	<p>P3</p>	<p>Within 3-6 months Repairs</p>	
-------------	--	--	-----------	--------------------------------------	--
