# Fire Risk Assessment

## Trouse Lane

**26-48 Trowse Lane, Wednesbury,  
WS10 7HS**

**Date Completed: 30/08/2024.**

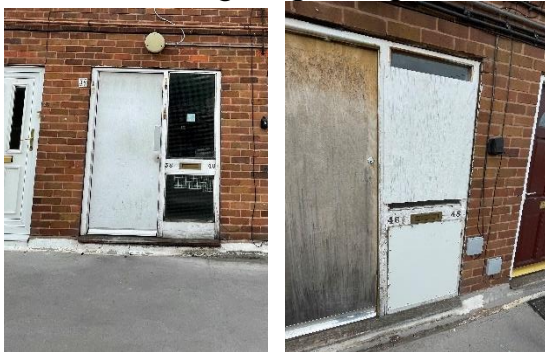
- 5) Rear entrance doors to stairs are timber doors with glazed combination frames. The combination frame to 46/48 was boarded dure to damaged glazing.

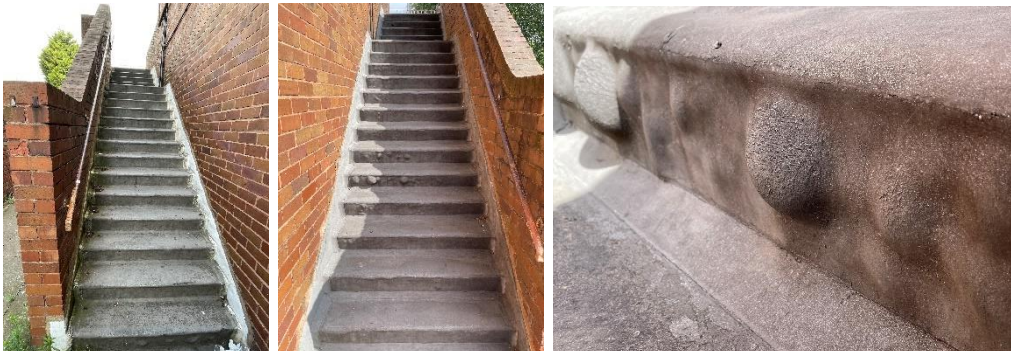
- 3) The external stairs to the 1<sup>st</sup> floor rear deck are 1190mm. Various bumps within the risers to the south facing elevation stairs have been noted as observations within section 19 of this FRA.

<b>Observations</b>	
Consider installing emergency lighting to the 3 x 2 <sup>nd</sup> floor stairwells.	
Consider work to the external south facing steps to remove bumps within the risers.

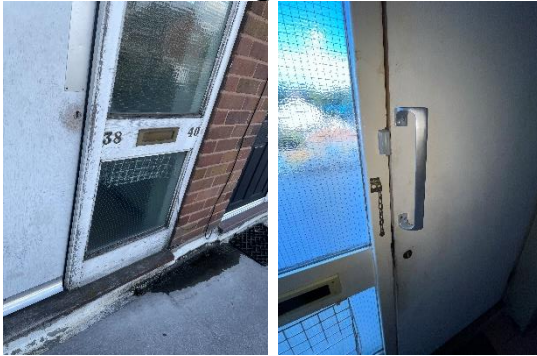
- 9) The final exit stairwell door for flats 38 & 40 requires a thumb turn lock for egress.

Question/ Ref No	Required Action	Supporting photograph	Priority	Timescale and Person Responsible	Date Completed
7/9	Block 38-40 - Remove mortice lock and install lock with internal thumb turn.

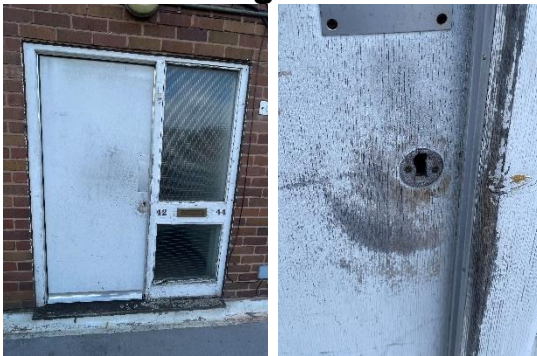
- 10) The final exit stairwell door for flats 42 & 44 requires a thumb turn lock for egress.

7/10	Block 42-44 - Remove mortice lock and install lock with internal thumb turn.

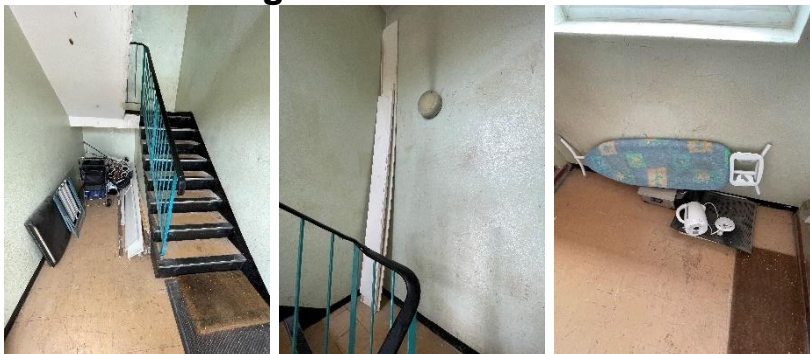
- 13) Personal items have been stored within the stairwell to flats 46 / 48 including uPVC boards on the half landing.**

P2	Within 1-3 months Fire Rapid Response	
7/13	Block 46-48 – Remove all personal items from communal stairwell. <i>(various items including, TV, Chair, Trolley, ironing board, timber and uPVC boards)</i>

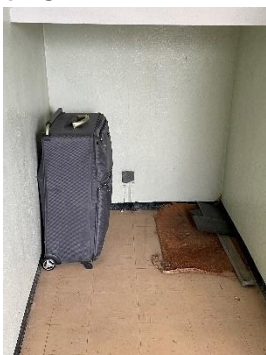
- 14) Personal items have been stored within the stairwell to flats 42 / 44. Occupier of flat 44 confirmed items didn't belong to them.**

7/14	Block 42-44 – Remove personal item from communal stairwell. <i>Suitcase, flat 44 confirmed it didn't belong to them.</i>

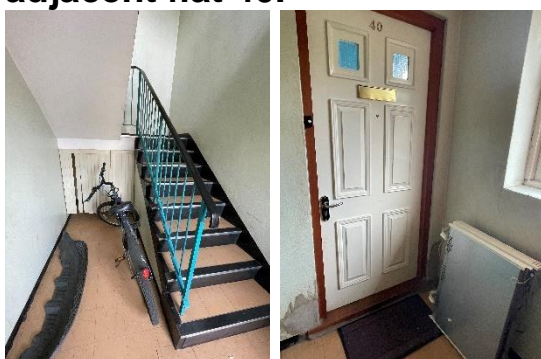
- 15) Personal items have been stored within the stairwell to flats 38 / 40 to include a car bumper, bicycle, and metal object adjacent flat 40.**

P2	Within 1-3 months Housing Manager	
7/15	Block 38-40 – Remove personal items from communal stairwell. <i>Bike, Car Bumper, Metal Object.</i> <i>Flat 38 is SMBC Flat 40 is leaseholder</i>

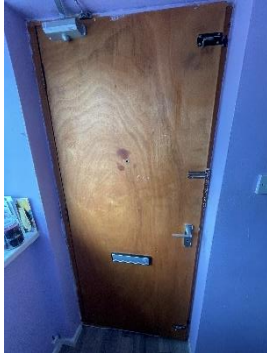
**a) Flat 44 – The door fails to reliably self-close and therefore requires adjustment.**

7/20a	Flat 44 – Adjust self-closer door not reliably closing fully.	 	P2	Within 1-3 months Fire Rapid Response	
7/20b	Flat 38 entrance door – Remove non fire door and install FD30s. <i>Approximate dimensions - door leaf 840mm x 1968mm and aperture (brickwork to brickwork) 910mm x 2133</i>	 	P2	Within 1-3 months Repairs

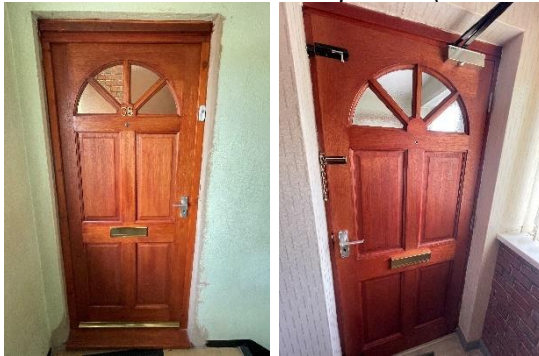
- b) Flat 38 – The door is a non-fire rated timber door with standard glazed panels and requires replacement with an FD30s fire door set. Door has been installed with a self-closer and intumescent strips.** *Approximate dimensions - door leaf 840mm x 1968mm and aperture (brickwork to brickwork) 910mm x 2133*

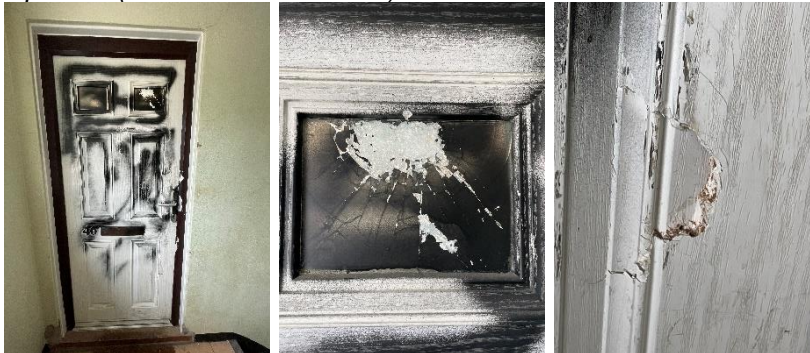
- c) Flat 46 – The door has superficial surface damage, broken glass and requires replacement.** *Approximate dimensions - aperture (brickwork to brickwork) 910mm x 2133.*

7/20c	Flat 46 entrance door – Replace damaged door with FD30s

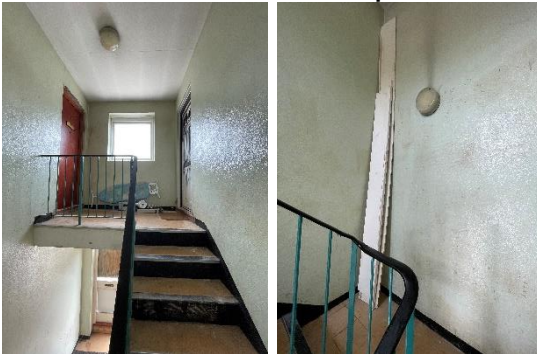
- 1) The premises should benefit from an emergency / escape lighting system. This has been noted within section 19 as an observation.
- 2) Conventional units are provided to the communal stairs.
