Fire Risk Assessment

Farley Street

**97 – 128, Farley Street
Tipton,
DY4 7LA.**

Date Completed: 19/09/2024.

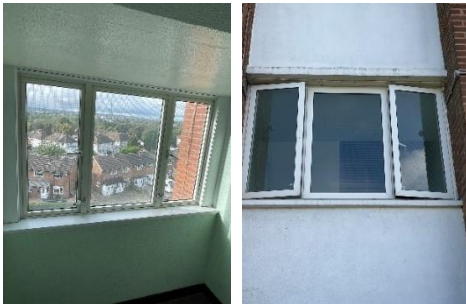
- 12) Communal windows are lockable however, windows were unlocked and open at the time of the assessment.

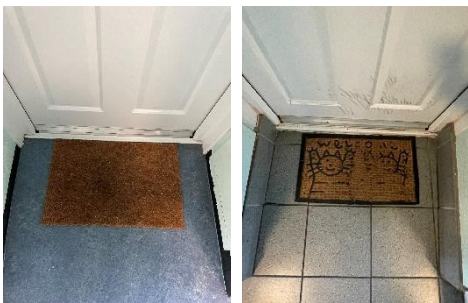
- 14) Individual floor mats were noted outside some flats. Fire rating of these mats is unknown but deemed to be of low risk.

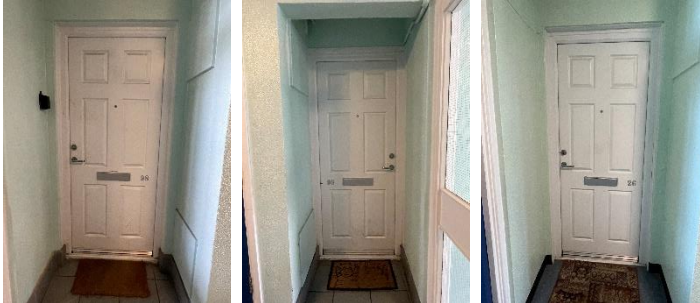
- 20) Individual flat doors are FD30s composite doors with the majority being manufactured by Permadoor, generally, these are in good condition. Flat 106 has an FD30s manufactured by Nationwide and flat 122 has an FD30s manufactured by IG Doors.

- 21) **The front entrance door to Flat 115 had been temporary repaired, this was noted in the previous FRA but to date this has not been repaired. This flat entrance door should be replaced as soon as practicable with a certified FD30s.**

Question/ Ref No	Required Action	Supporting photograph	Priority	Timescale and Person Responsible	Date Completed
7/21	Replace flat entrance door. This action has been outstanding since the previous FRA.

P2	Within 1-3 months. Repairs

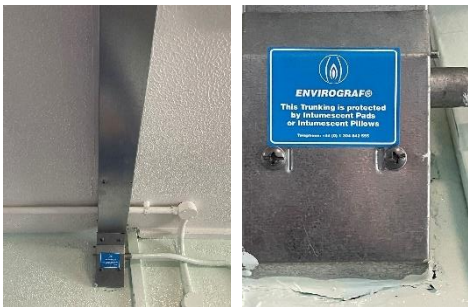
23) Most trunking for power cables in communal areas is of metal construction and contain intumescent pads or pillows.

24) However, a small amount of plastic trunking was visible, it is understood that this trunking provides telecommunications cables for flats.

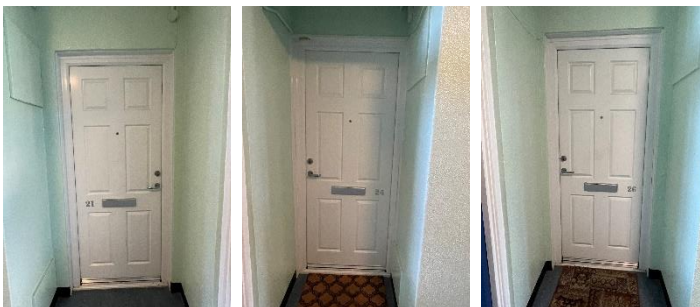
- 10) Individual flat doors are FD30s composite doors with the majority being manufactured by Permadoor. Flat 106 has an FD30s manufactured by Nationwide and flat 122 has an FD30s manufactured by IG Doors.

11) Flat 122 has a missing outer letterplate.

10/11	Replace missing outer letterplate for Flat 122

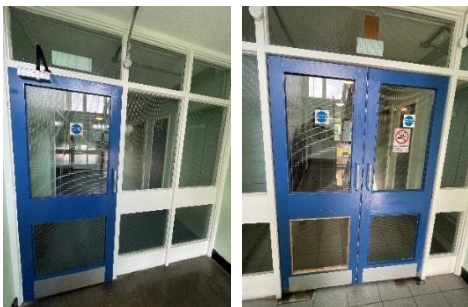
It is recognised that these doors do not meet today's benchmark of a certified FD30s fire door install however, because they were installed at the time of the buildings construction and to the standard of that time they are deemed as acceptable so long as the doors are free of damage and function as they were intended to do so.

It has been recognised that all of the landing / staircase notional doors in this block have been upgraded with combined intumescent strips & cold smoke seals to enhance their original design and minimise departures from today's standards.

Some notional communal landing doors show signs of wear and tear due to age. Consideration should be given to upgrade with certified FD30s door sets & combination frames.
