Fire Risk Assessment

Nelson House

**1 – 34 Nelson House
Upper Church Lane,
Tipton,
DY4 9PW**

Date Completed: 01/10/2024.

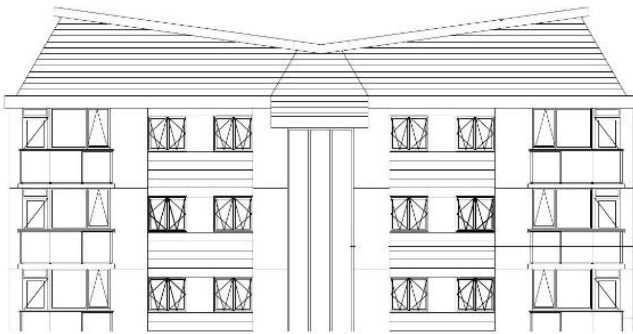
- 1) Nelson House has 4 separate areas of cladding consisting of;
 - Blockwork ground to first floor consisting of Ibstock Staffordshire Smooth Blue & Cheddar Golden brick slips.
 - Bauclad high pressure laminate panels manufactured by Euro Clad LTD 1st – 8th floors. Fire classification B-s2-d0
 - Wetherby EWI render system to the gable ends (fire classification A2) – 1st – 8th floors.
 - 2mm thick aluminium fascia's.
- 2) Mineral wool manufactured by Rockwool (classification A1) has been used to insulate the external wall system.
- 3) The pitched roof is a steel framed construction with aluminium standing seam with mineral wool core.

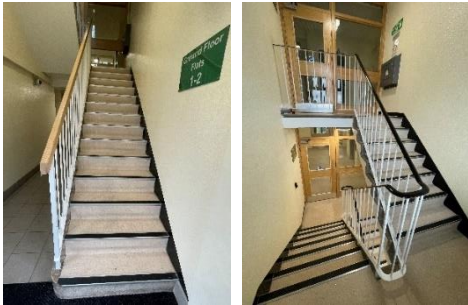
- 1) The site has 2 protected staircases that provide a sufficient means of escape. Each staircase in width is 1000mm from handrail to wall.

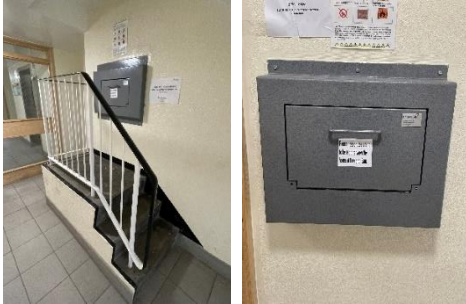
- 12) The refuse chute hoppers are fitted with intumescent strips and smoke seals. All hoppers are located in the rear stairwell.

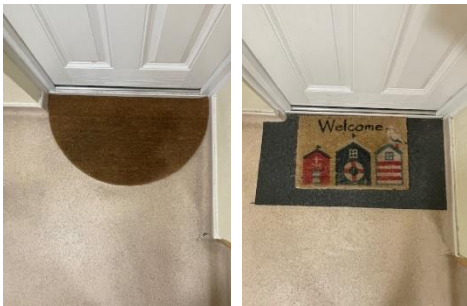
- 14) Individual floor mats were noted outside some flats. Fire rating of these mats is unknown but deemed to be of low risk.

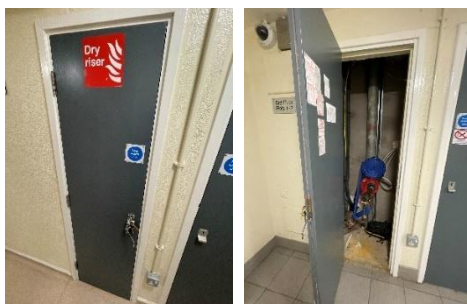
- 16) Dry riser inlet / outlets on lobbies are housed in cupboards with FD30s doors and secured by suited 54 key mortice locks. All outlet valves are secured in the closed position by cable tie.

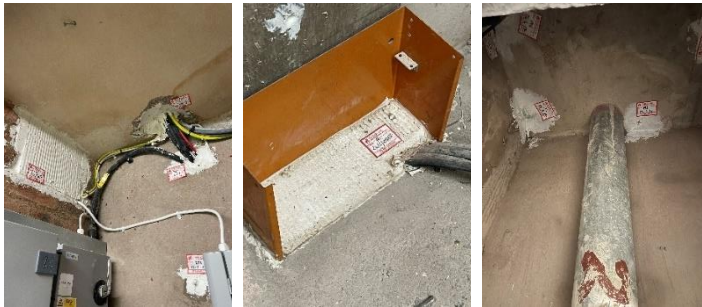
- 6) A variety of methods / materials have been used to achieve fire-stopping including Rockwool, fire rated sponge and intumescent pillows.

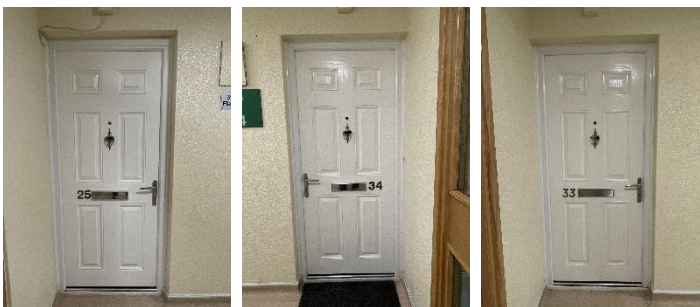
- 10) Individual flat doors are FD30s composite doors with the majority being manufactured by IG Doors. Door furniture appears to be in good condition.

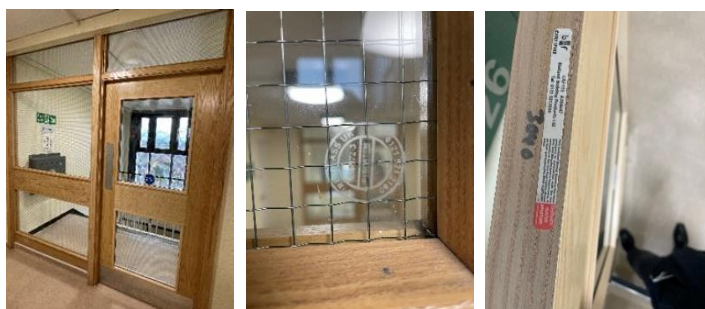
- 11) The communal landing & staircases are protected by use of FD30S timber doors with vision panels and combination frames. Fire resistant glazing has been installed to all vision panels.

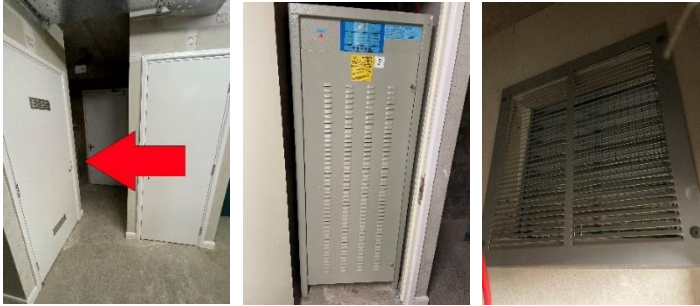
- 12) Central battery unit for the emergency lighting is housed in a cupboard with an FD30s door and vents with intumescent baffles.
