Fire Risk Assessment

Peartree House

**Flats 1 – 17
Peartree House
Vicarage Road,
Oldbury,
B68 8JD.**

Date Completed: 05/09/2024.

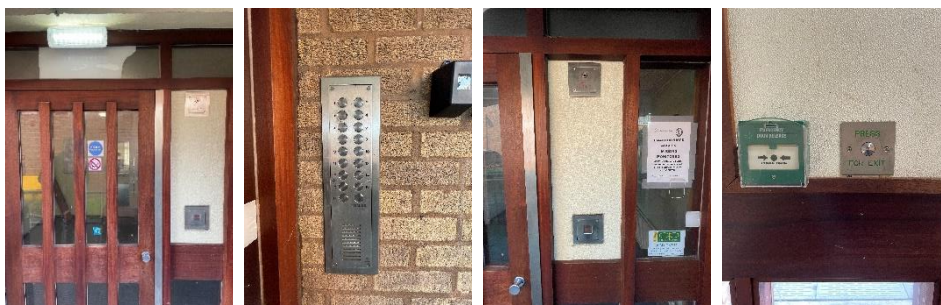
The main entrance is located at the right hand side elevation of the building & incorporates a secure entry system, fob reader, there is a fire service drop key for emergency/trade access. There are further exit doors located around the building.

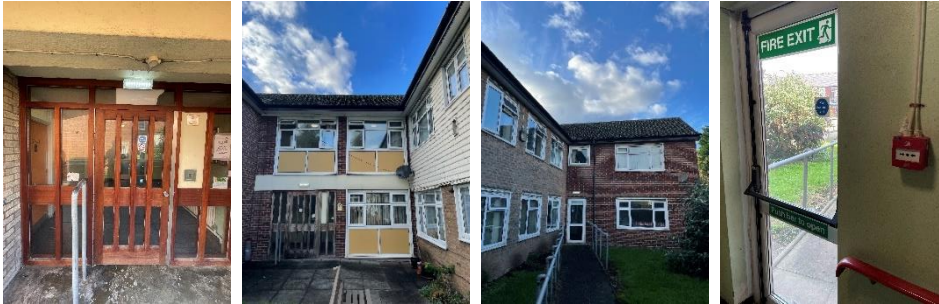
There is another access door located on the opposite side of the building. These doors are supplemented by additional emergency exit doors which are UPVC and have a 'push bar' mechanism to escape.

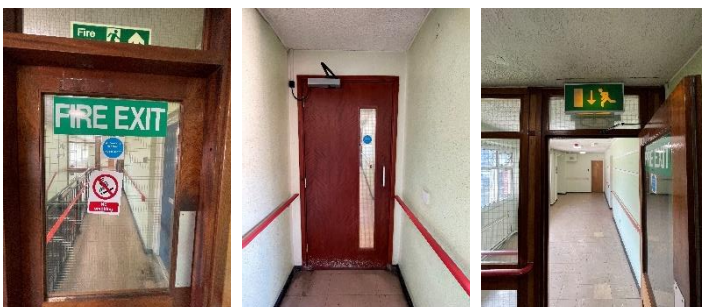
Cross Corridor doors and vision panels are timber construction with single glazed Georgian wired glass.

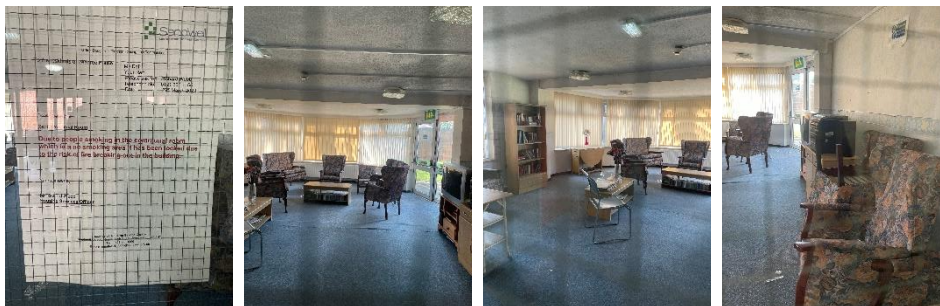
The Communal area (lounge) is presently locked as some residents were found to be smoking in this area.

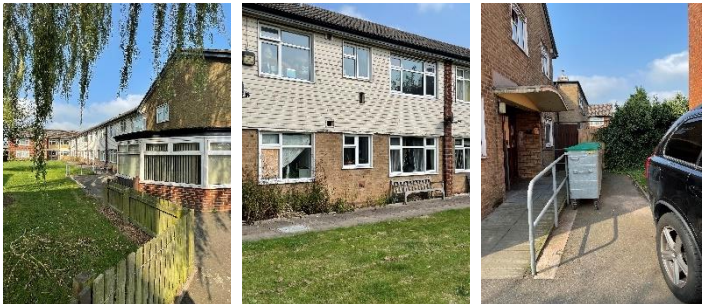
The gardens are secured by fencing, access point for the gardens is either timber side gate(s), which were unlocked at the time of the assessment or access through the main building using the rear door.

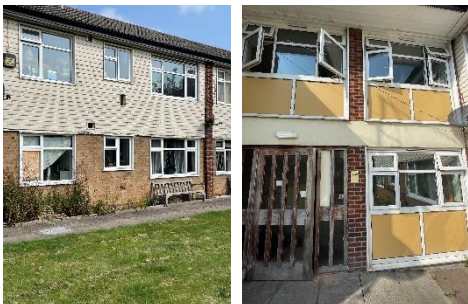
- 2) It was noted that part of the building was clad with timber, this was at first floor level on the left-hand side elevation. There were also combinations of timber and panelled walls.

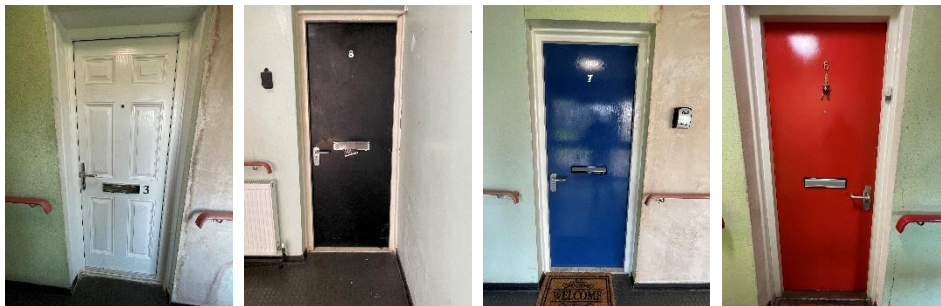
1. The building is designed to provide as a minimum 1-hour vertical fire resistance and 1-hour horizontal fire resistance around flats. All flat entrance doors are 30-minute notional/nominal doors, including those in 1-hour rated walls.
- 2) Generally, the means of escape is protected from flats with the use of notional rated timber/composite doors. These doors should either be upgraded to certified FD30's when any future upgrades of the building are carried out or, FD30s certification of the current doors should be provided.

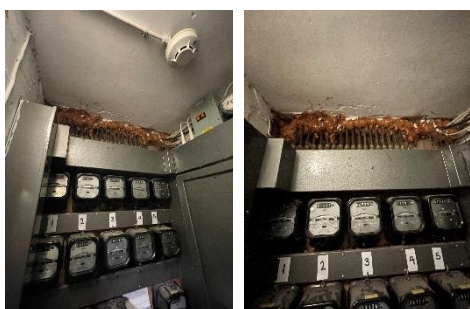
- 4) In the electrical cupboard on the ground floor expanding foam has been used to seal voids above electrical equipment & cabling. This is poor practice and should be rectified using appropriate fire stopping materials at the earliest opportunity.**

| 10/04 | In the electrical cupboard on the ground floor, remove expanding foam and replace/enhance with appropriate fire stopping materials. | A photograph showing the interior of an electrical cupboard. The top of the cupboard is filled with a large amount of orange expanding foam, which is not fire-stopping material. Below the foam, there are several electrical components, possibly circuit breakers or switches, arranged in rows. | P2 | 1 -3 months Fire Rapid Response. | 05/11/2024 |

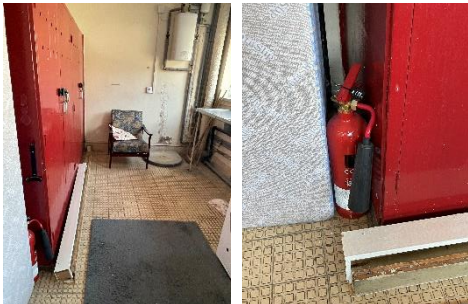
- 2) It was noted the Fire Extinguisher in the Laundry was partially obscured. If extinguishers are required, this extinguisher should be relocated by the exit door which provides egress from the room. (rectified whilst onsite).

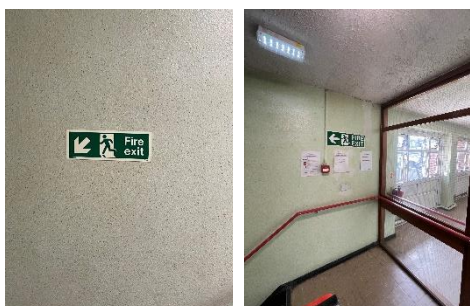
- 1) Exit Signage consists of various signs and is deemed acceptable. However, when any refurbishment work take place consideration should be given to reviewing this signage throughout the building. This is based on location and number of signs.

When any new communal door sets are fitted, review existing exit signage throughout the building. In areas, there is too much signage which could cause confusion.

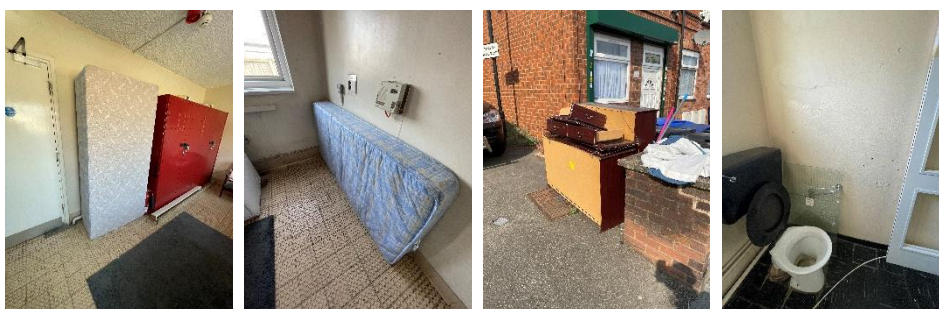
- 1) Smoking is prohibited within any communal parts of the building in line with Smoke Free England legislation.
- 2) Combustible items were noted in several areas of the building. These include: - (Email sent to Prabha Patel/Richard Webb).

The Laundry – Old Bed frame, mattress & armchair.
Outside main reception – old furniture.
Ladies Toilet – Door, glazing & other items.

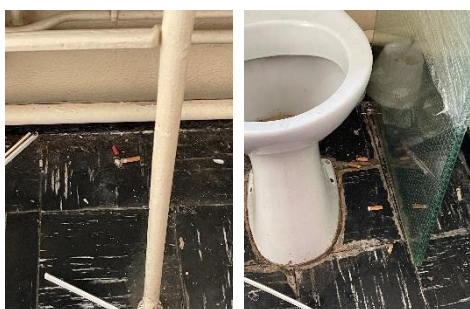
- 3) There is evidence of Smoking in the Ladies toilet as discarded cigarettes were noted on the floor. (Email sent to Prabha Patel/Richard Webb).

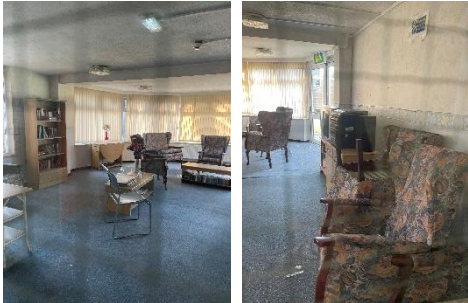
- 6) Should the communal lounge be brought back into use all furniture should be inspected to ensure they comply with current Fire Safety regulations. Such as, the furniture and furnishings (Fire Safety) Regulations 1988 (amended 1989, 1993 & 2010).
