Fire Risk Assessment

**Flats 1 - 12 – 19 - 30
Howard Street.
Tipton,
DY4 8UF.**

Date Completed: 08/11/2024.

Officer: A. Jones Fire Risk Assessor.

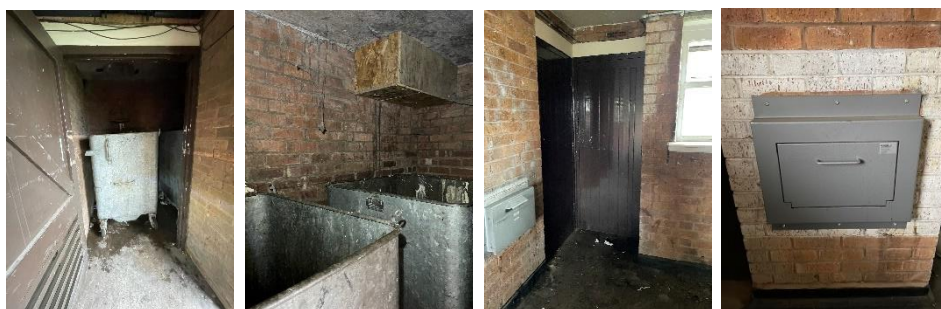
To dispose of rubbish, residents utilise waste containers secured behind a timber door on the ground floor and a waste chute on the first floor.

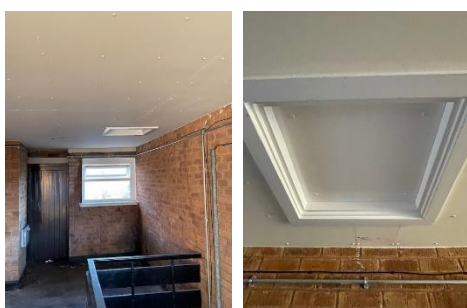
There is an access panel to the communal roof space on the first floor landing area, this space was not accessed at the time of the assessment.

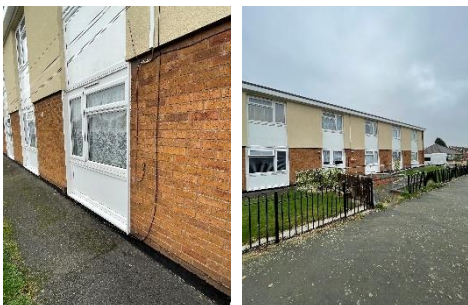
- 2) A number of combination UPVC windows and UPVC panels are evident on the front elevation of the building.

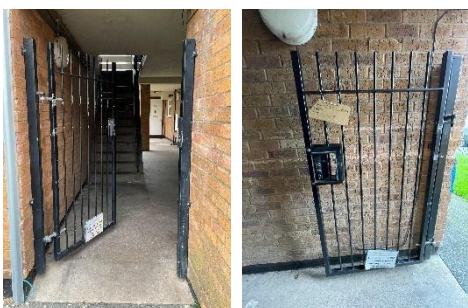
- 4) There are steel security gates that have combination locks to secure the building. These can be opened from inside without the use of a key.

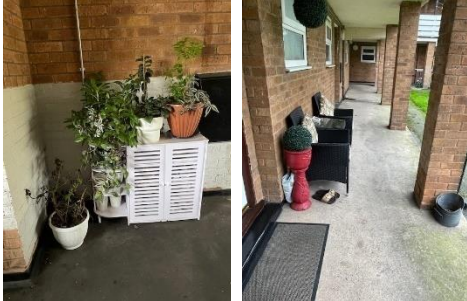
- 12) There were examples of combustible items, furniture and plants being left outside flat entrance doors, in one case outside flat 9, a shoe cabinet had been left on the first-floor landing. (Email sent to housing).

- 11) All means of escape areas should be maintained as sterile areas. (Email sent to housing).
-

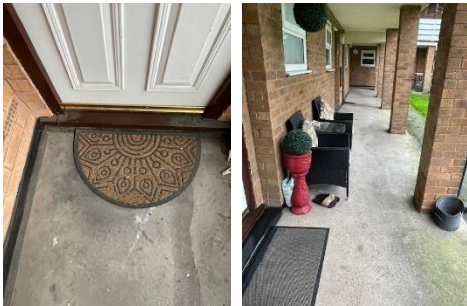
- 7) It was noted that some front entrance doors had floor mats in place, the fire rating of these mats is unknown but deemed to be of low risk.

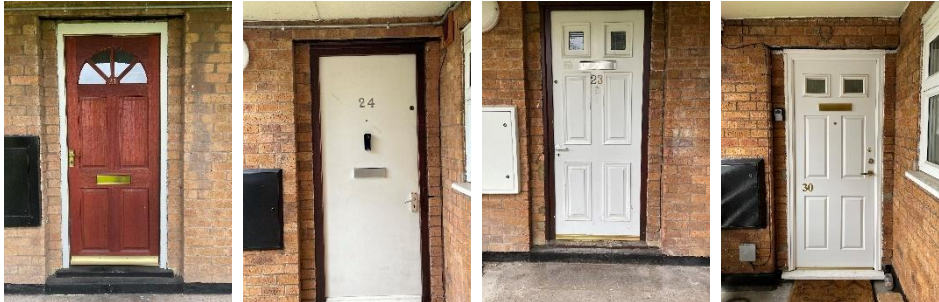
- 6) Generally, the means of escape is protected from flats with the use of notional & nominal doors. These doors should be upgraded to FD30's when the door replacement programme commences.

Observations	
As part of any future upgrades, replace timber flat entrance doors for FD30s.

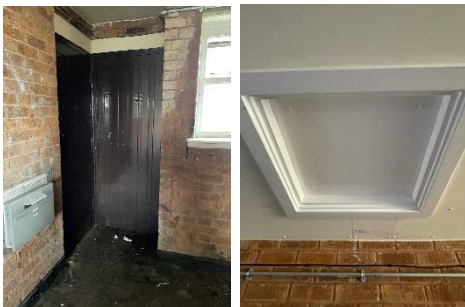
- 7) There are store cupboard doors adjacent to bin chute on the first floor, these should be updated to FD30s when any planned upgrades take place. There are no other communal doors to the buildings.

As part of any future refurbishments internal store cupboard doors should be upgraded to FD30 fire doors. to provide adequate protection on the means of escape.

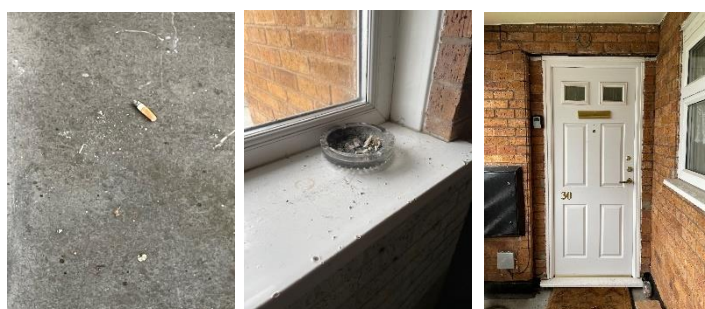
- 1) Smoking is prohibited within any communal parts of the building in line with Smoke Free England legislation.
- 2) There was evidence of smoking in communal areas, and this should cease with immediate effect. (Email sent to Housing)
