Fire Risk Assessment

Bennitt Close

1-2a, 3-6a, 7-10a, 11-12a
Bennitt Close, West Bromwich.
B70 7ER

Date Completed: 28/11/2024.

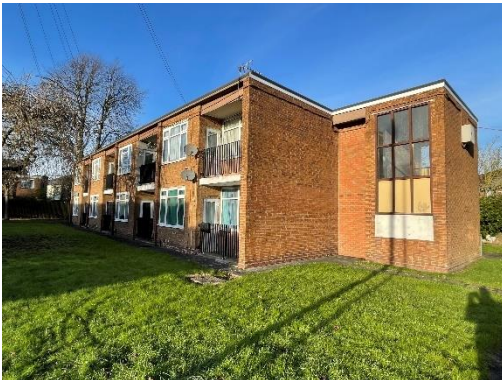
- 1) The external walls of the blocks are a brick masonry.

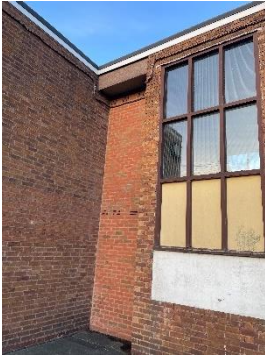
- 4) Communal windows in stairwells are timber framed units with additional panels presumed to be formed from plastic based material.

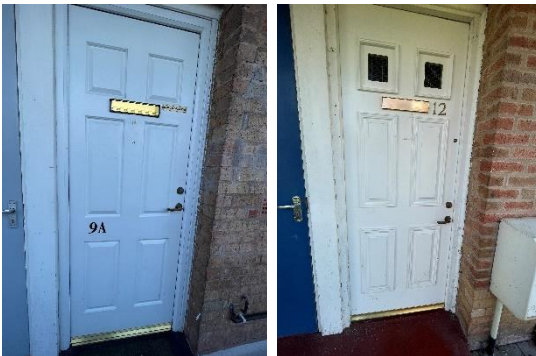
- 6) Flat entrance doors are nominal fd30s composite fire doors.

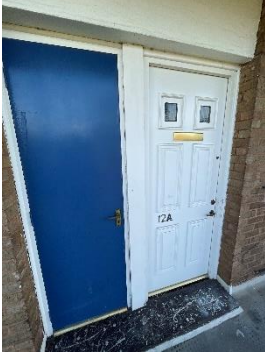
- 8) Storage cupboard doors for flats timber non fire rated doors.

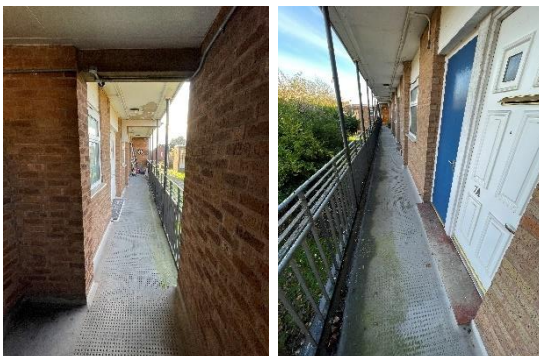
- 2) There are no internal communal corridors. Open deck corridors at 1st floor level are of adequate width at 1200mm wide however, this is reduced to 1000mm at the narrowest points.

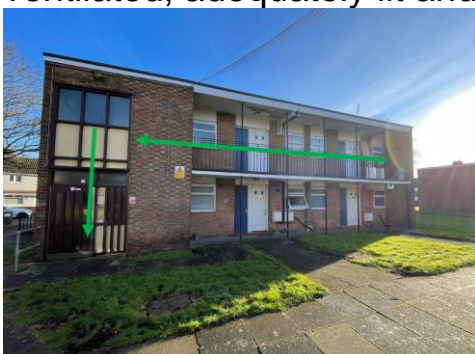
- 3) There are dead end situations on first floor deck corridors however, the corridors are open to the elements, therefore sufficiently ventilated, adequately lit and therefore acceptable.

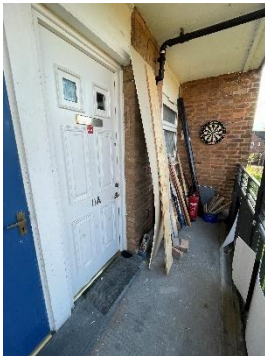
There are a number of items stored including combustible materials, outside flat 11a on the means of escape. Email sent to the Leasehold Manager to Liaise with the owner.

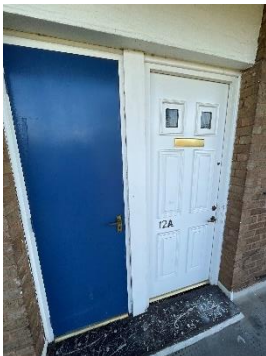
- 7) Each flat has an external storage cupboard adjacent the flat entrance door. The cupboard doors are non-fire rated timber doors.

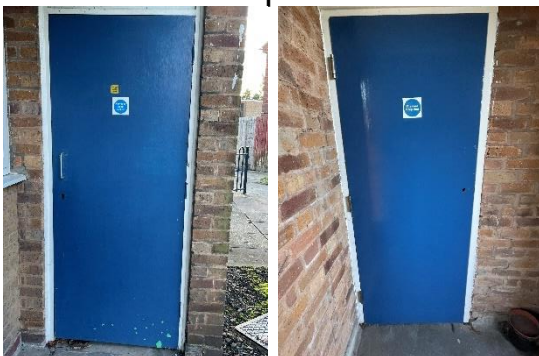
- 8) Service cupboard doors are 54mm nominal fire doors with intumescent strips and secured with 54 key suited mortice locks.

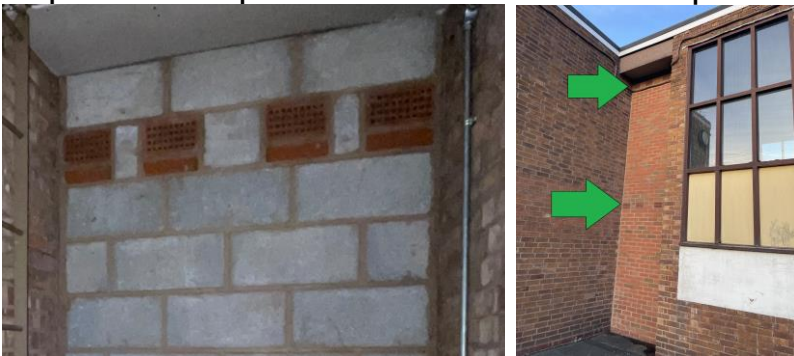
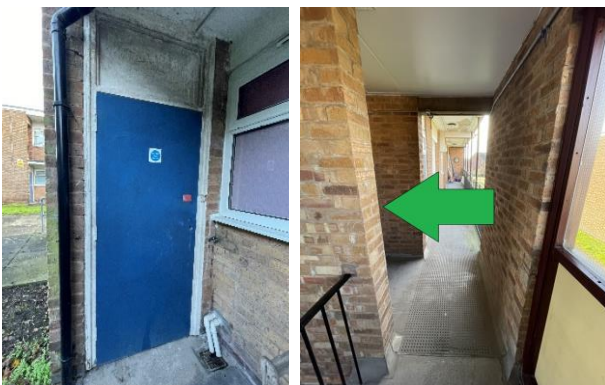
- 11) Fire stopping to 1st and 2nd floor service cupboard airbricks is not required as cupboards and airbricks are open to the elements.

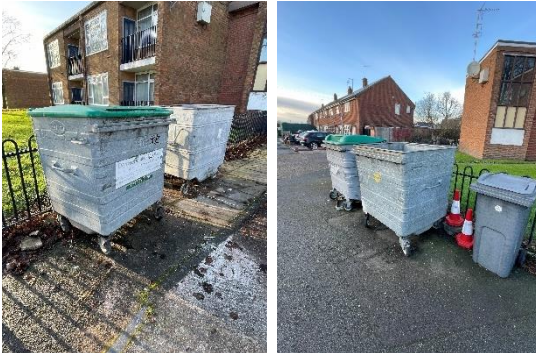
- 1) Refuse containers for the blocks are stored externally at a safe horizontal distance.

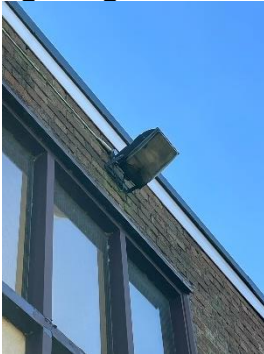
- 3) There are no CCTV provisions at the block.
- 4) The perimeter of the premises is well illuminated with exterior lighting and borrowed lighting from streetlights.
