Fire Risk Assessment

Trinity House 1-18

**Florence Road,
West Bromwich.**

Date Completed: 21/11/2024.

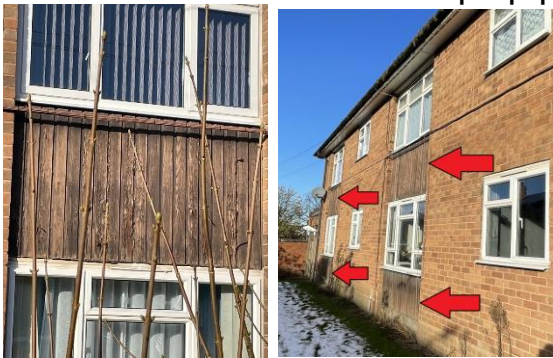
- 3) There are seven areas beneath ground and first floor flat windows that are clad with timber shiplap panels.

Observations	
Replace timber cladding above / beneath flat windows with non-combustible alternative.

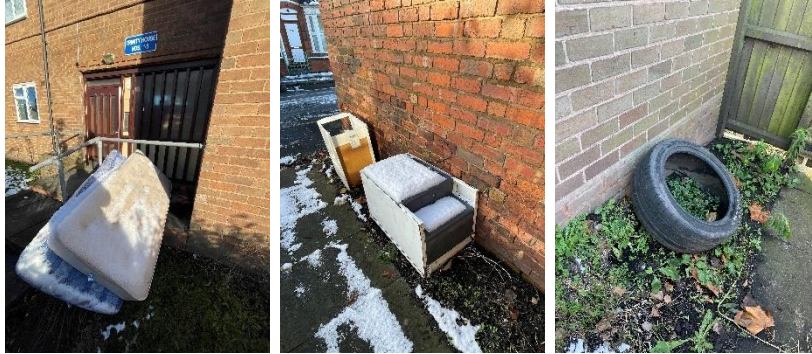
- a) Discarded mattresses, fridge, storage unit and tyre near a final exit door and side gate. Email sent to external caretakers for removal 26/11/24

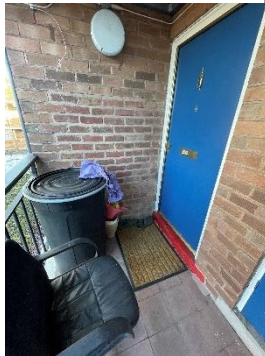
- b) **Plastic barrel and office chair outside flat 8 on 1st floor means of escape.**

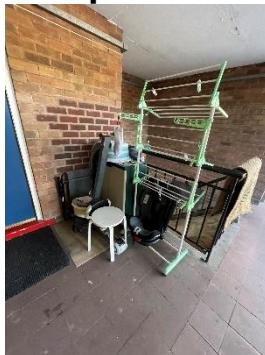
- c) **Several items outside flat 6, 1st floor, adjacent the stairs including a stool, storage unit, car seat, clothes dryer, chair, gym equipment, plastic bowls on the means of escape.**

<p>7/9c</p>	<p>Flat 6 – several items stored outside flat door next to communal stair on the means of escape to be removed.</p>

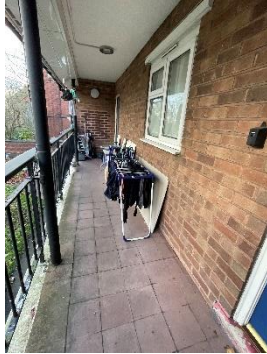
- d) Flat 18 1st floor - Table and chairs, clothes drying equipment and other equipment outside flat on means of escape.**

<p>P3</p>	<p>Within 3-6 months Housing Manager</p>	
<p>7/9d</p>	<p>Flat 18 – table and chairs, clothes dryer to be removed from the communal means of escape.</p>

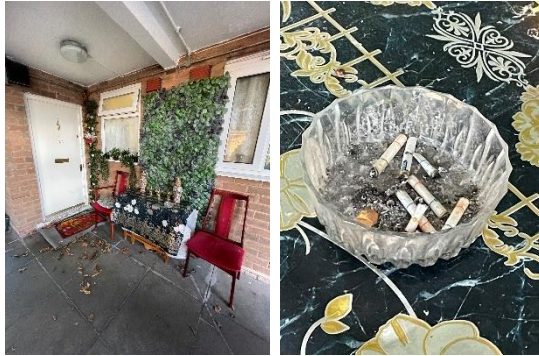
- e) Flat 12a ground floor - Table and chairs, plastic decorative screening, evidence of smoking all outside flat beneath / next to windows.**

<p>P3</p>	<p>Within 3-6 months Housing Manager</p>	
<p>7/9e</p>	<p>Flat 12a – table and chairs, plastic decorative screening, ash tray to be removed from the communal means of escape.</p>

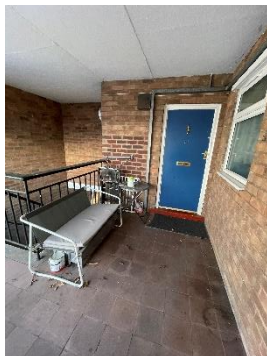
- f) Flat 14 1st floor – table, chairs, garden sofa and other items stored on means of escape adjacent stairwell.**

7/9f	Flat 14 – table, chairs, garden sofa and other items to be removed from the communal means of escape / adjacent stairs.

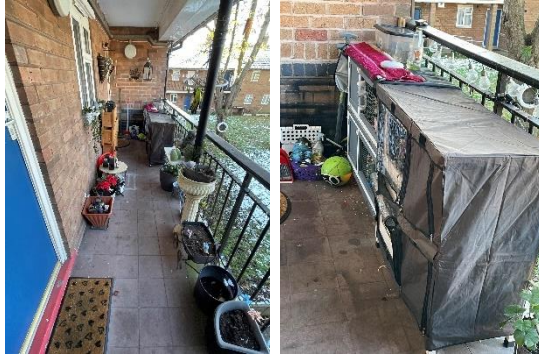
- g) Flat 10 1st floor – Rabbit hutch and number of plant pots and tubs reduce the width of the means of escape.**

P3	Within 3-6 months Leasehold Management	
7/9g	Flat 10 – Rabbit hutch to be removed and number of planters should be reduced to an acceptable level that doesn't excessively compromise the width of the means of escape / open communal corridor.

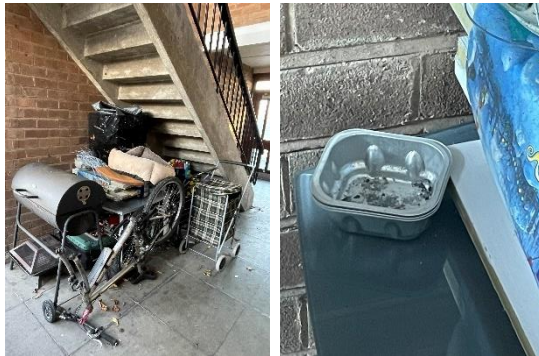
- h) A number of items and potential ignition sources are stored beneath the communal staircase adjacent the entrance for flats 9-18 including, BBQ, fire pit, table, bicycle, shopping trolley, dog bed, ash tray and other items.**

<p>7/9h</p>	<p>All items that are stored beneath the communal stairs adjacent the entrance for flats 9-18 to be removed. Note - flats 12a & 14 are Leasehold but items could belong to flat. (BBQ, Fire Pit, Table, Bicycle, Shopping Trolley, dog bed, and other combustible items including ashtray).</p>

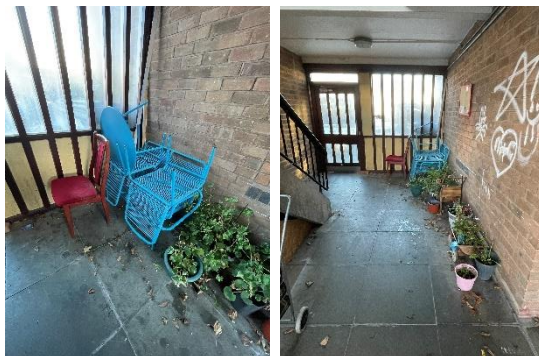
- i) Table and chairs, plants stored inside main entrance for flats 9-18. Noting that these items currently do not adversely compromise the means of escape here however the potential remains for the number items to increase as evident in other areas at this block.**

<p>P3</p>	<p>Within 3-6 months Housing Manager</p>	
<p>7/9i</p>	<p>Table, chairs plant pots stored inside the block entrance for flats 9-18 to be removed.</p>

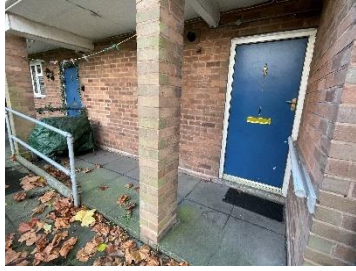
- j) What appears to be a covered BBQ was noted outside flat 1 within the enclosed slab area that doesn't form part of the means of escape for other flats.**
-

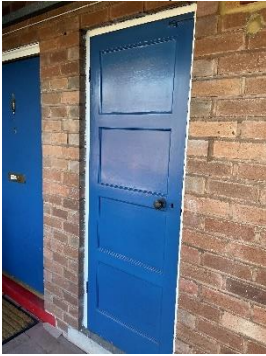
- 6) There is a single storage cupboard adjacent flat 6a on the first floor open deck corridor. Access to this door was not possible due to the tenant not being home however the door appears to be non-fire rated. (noted as an observation)

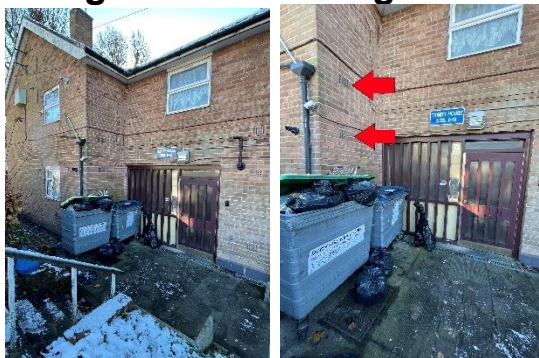
b) Two further euro bins are located at an unsafe distance outside the main entrance for flats 9-18. If the bins were alight then the products of combustion could easily enter the surrounding flats via the nearby airbricks, flue, and flat windows. The bins should be relocated to the recognised bin storage area in the rear yard.

15/1b	Euro bins to be removed from the block entrance for flats 9-18 and relocated to dedicated bin storage area in the gardens accessed via the gate on Mary Rd.
