Fire Risk Assessment

Kynaston House

**Rydding Lane, Millfield's,
B71 2HD**

Date Completed: 16/01/2025.

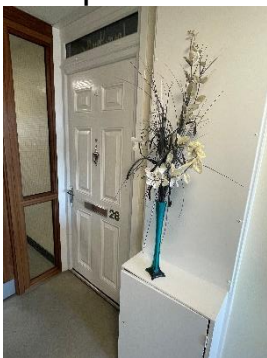
16) Bags of clothes and toys were noted in the ground floor front entrance lobby. The occupants of flat 1 agreed to remove the items and began to do this immediately.

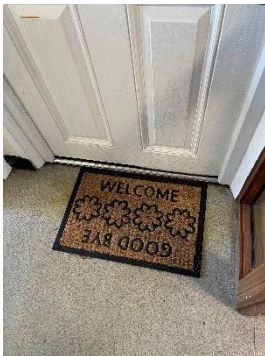
- 20) Door mats were noted outside some flat entrance doors. The fire rating of the mats is unknown however, it is deemed to be of sufficient low risk.

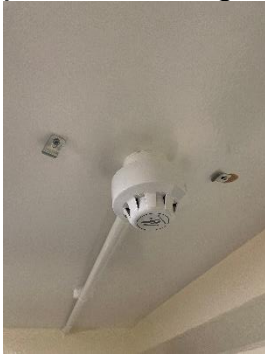
- 6) 1st floor landing smoke detector for AOV system is missing its protective cage. The contractor has been notified to replace this.

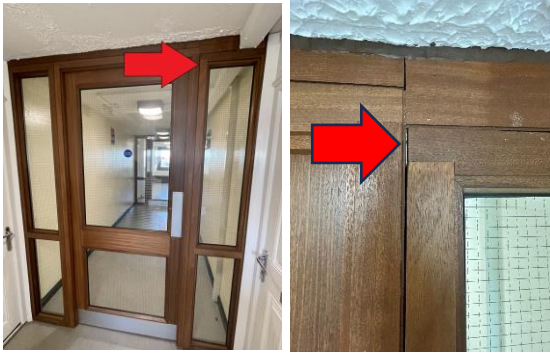
- 19) 10th floor lift lobby door by flat by flat 38 – small gap in frame to be suitably fire stopped.

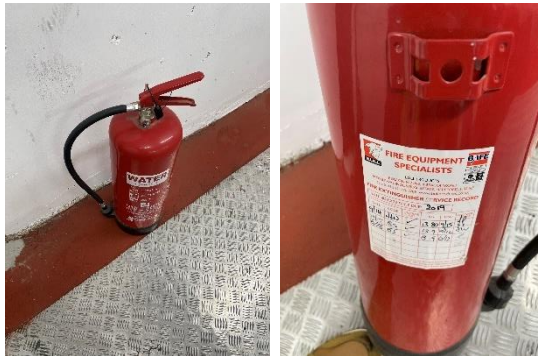
- 5) A decommissioned portable water fire extinguisher was noted in the lift motor room and has now been removed.

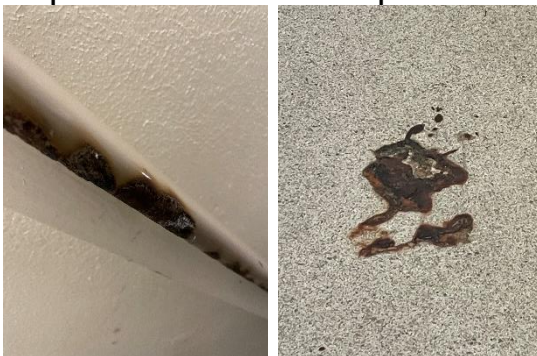
- 5) There was further evidence of arson to the 10th floor stairwell handrail and landing floor. The housing manager has been requested to make enquiries with all flats on the 10th floor.
