# Fire Risk Assessment

## Greenford House

**Maria Street, West Bromwich,  
B70 6DX**

**Date Completed:** 20/12/2024.

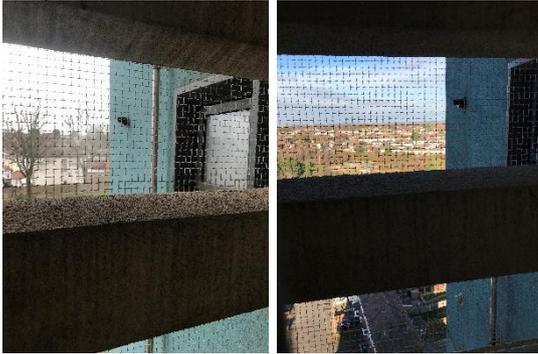
- 8) Open air natural ventilation Along the bin chute lobby area made of concrete construction along the rear elevation, it was noted that netting was present along this section of the premise. The netting does not run down to the ground level and does not have easy access combined with sufficient compartmentation and the stay put unless policy reasonable measures have been made to reduce the risk. However an alternate option should be explored when future improvement works are conducted.

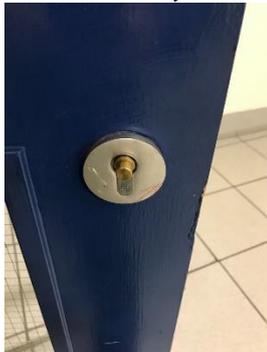
- 29) **Damaged thumb turn to door on ground floor leading to the bin chute, is in need of repair / replacement.**

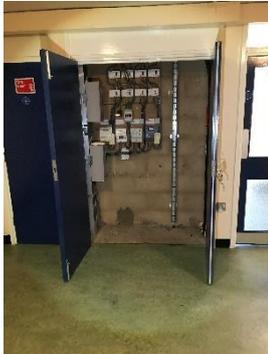
- 16) The use of expanding foam was present within the communal cupboards around cabling as part of the fire stopping knowing that intumescent pads and a concrete slab is present and this foam is only used as an enhancement it is deemed tolerable. This should be enhanced as part of future works to the building and replaced with intumescent mastic to improve fire stopping.

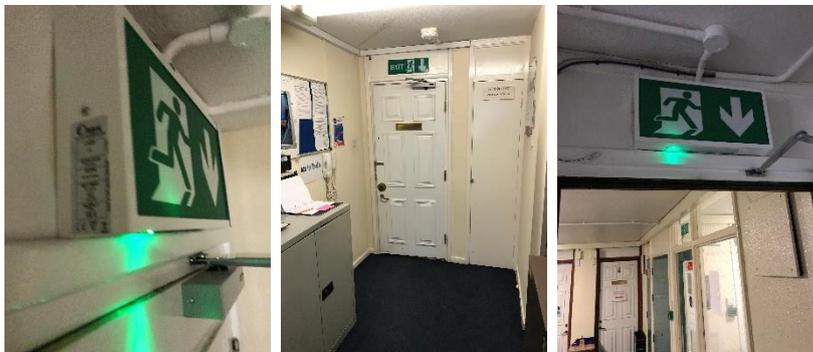
- 11) Emergency escape signage is used within the office spaces along the means of escape. Some signage on the ground and 1<sup>st</sup> floor directs occupants to a now redundant escape route and has since been removed.

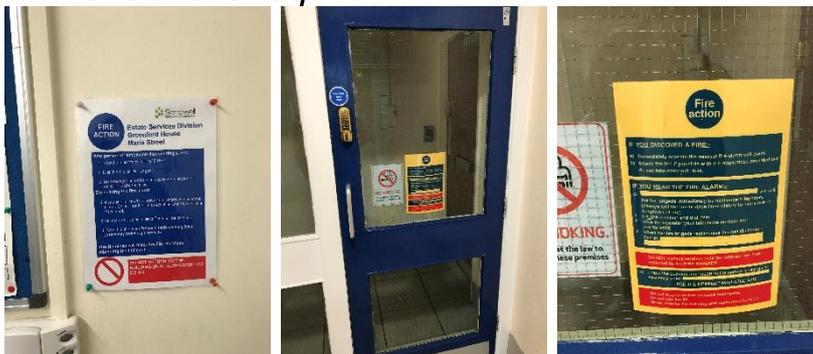
- 12) Fire action notices are strategic placed along the means of escape depicting what to do in the event of a fire. Sign displayed on ground floor door should be removed as it may cause confusion to residents or visitors at the block, the sign also depicts incorrect information. *Caretakers have removed incorrect signage, so no further actions required.*

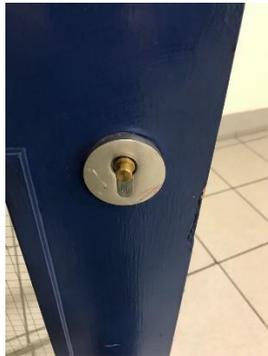
Question/ Ref No	Required Action	Supporting photograph	Priority	Timescale and Person Responsible	Date Completed
07/29	Replace damaged thumb turn to ground floor bin chute door.

P2	1-3 months Fire Rapid Response
