Fire Risk Assessment

99-110 Walsall Street

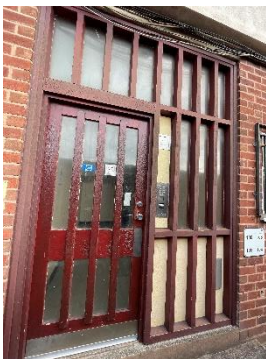
- 5) The final exit doors have door entry systems installed. These are designed to fail safe i.e. door unlocked in the event of a power failure. This prevents residents from being locked in or out of the building.

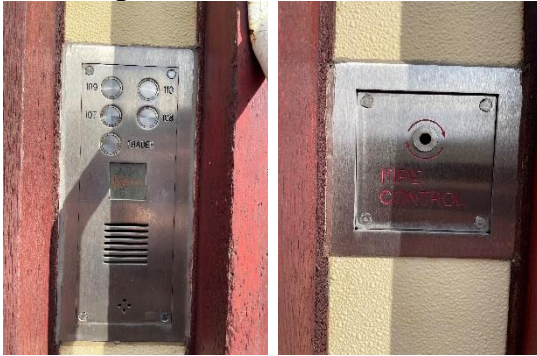
- 6) Each final exit door has a levered handle to exit.

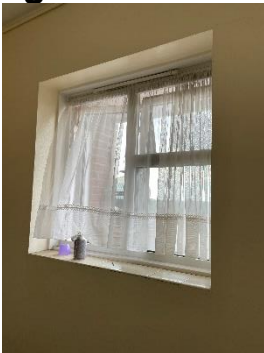
- 12) Adjacent flat 106 evidence of burning lighting candles and burning incense sticks in communal landing. All associated items along with personal items stored outside flat door to be removed,

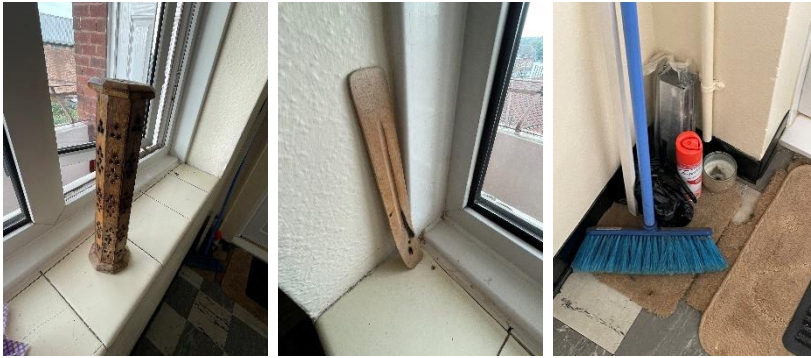
13) Adjacent flat 99 combustible net curtain on communal window should be removed.

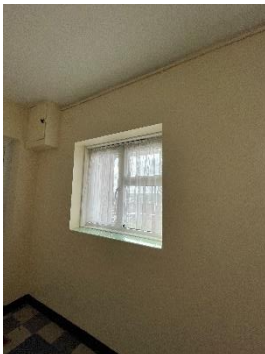
- 16) Block 99-102, two x compressed gas cylinders containing Nitrous Oxide were found stored in the service cupboard housing electrical intake equipment. Nitrous Oxide is not a flammable gas but will support combustion so, therefore, should not be stored near to potential ignition sources. Compressed gas cylinders are forbidden in flatted accommodation and communal areas as per the tenancy agreement (except for prescribed medical oxygen). Both cylinders were removed during the assessment.

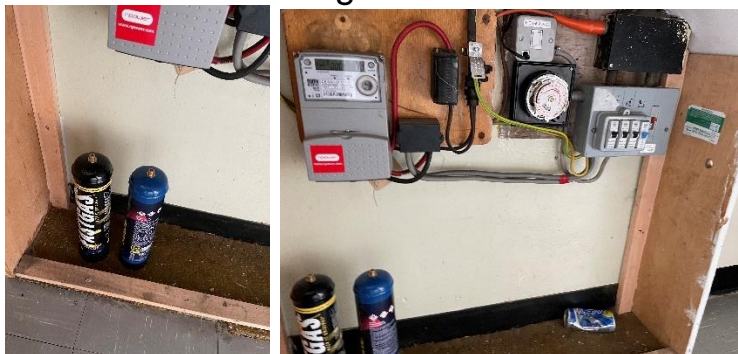
Good housekeeping is fundamental to reducing risk in blocks of flats. Controlling the presence of combustibles and ignition sources not only reduces the potential for accidental fires to start and develop in the common parts, it also significantly reduces the scope for deliberate fires. It also ensures escape routes are free of obstructions that might hinder the evacuation of people from the building and access for fire-fighters.

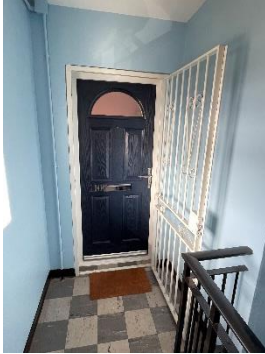
- 21) Attempts were made to access individual flat doors as part of this fire risk assessment to ensure the doors have not been tampered with by residents etc. Despite best endeavour access could only be gained to flats 103 & 108.

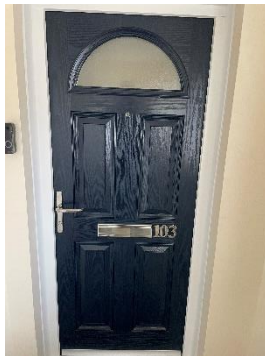
- b) Flat 108 – Door was correct.

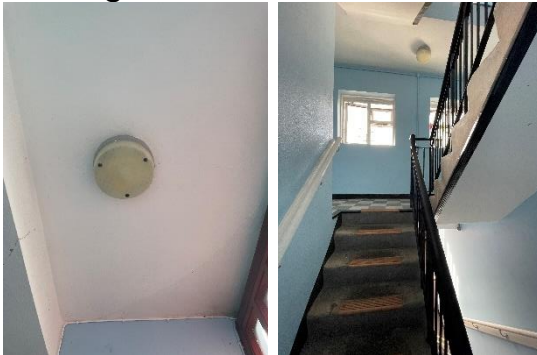
- 1) The premises should benefit from an emergency / escape lighting system. This has been noted within section 19 as an observation.
- 2) Conventional units are provided to the communal stairs and landings.

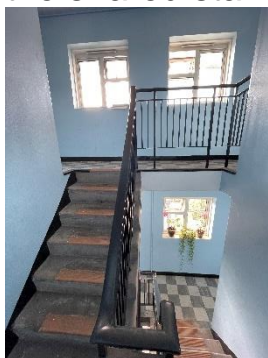
- 4) There is a cyclical programme (annually) to ensure fire stopping has not been compromised by third parties and where applicable enhance the fire stopping.
 - 5) Any remedial works arising from the fire stopping / compartmentation check(s) will be actioned immediately by the Fire Safety Rapid Response Team.
-

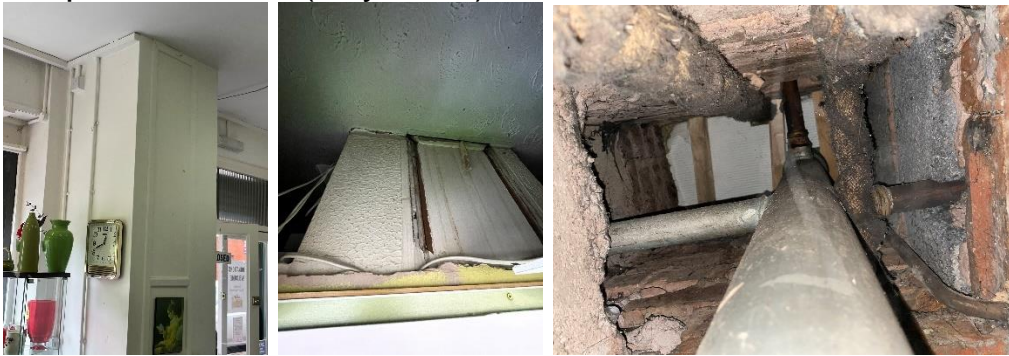
- 7) The only communal doors are the final exit doors. These are fitted with automatic closing devices that are checked on a regular basis by Caretaking Teams as part of their checks. Defective closing devices are replaced either by the Caretaking Team(s) or the in-house repairs team(s).
- 8) The only service cupboard with the communal parts is under the ground floor stairs in block 99-102. The cupboard contains the landlords electrical supply, is constructed from timber batons and board, and is not secured by lock. Observations have been recorded in section 19.

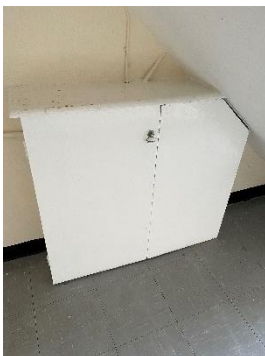
- 9) Resident's storage sheds are accessed externally to the rear elevation and secured with locked timber ledge and braced doors. There is no requirement for these doors to be fire rated.
- 10) Individual flat entrance doors are a combination of non-fire doors and nominal FD30s timber or composite fire door sets. Since the
-

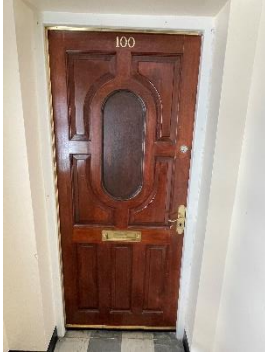
- b) Flat 105 (leaseholder) – Entrance door to be upgraded to FD30s standard.**

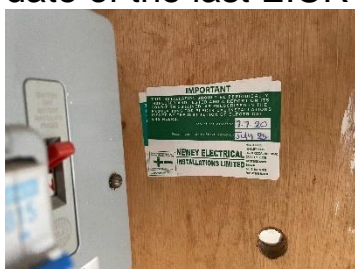
- 5) Portable heaters are not allowed in any common parts of the premises.
- 6) Gas appliances and pipework (where installed) are subject to annual testing and certification. This cyclical contract is managed by the in-house Gas Team. Mains gas pipework is partially external to the rear elevation.

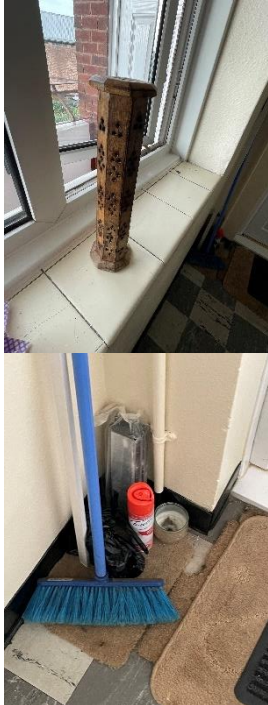
<p>P2</p>	<p>Within 1-3 months Housing Manager</p>	
<p>7/13</p>	<p>Remove net curtain from communal window adjacent flat 99</p>

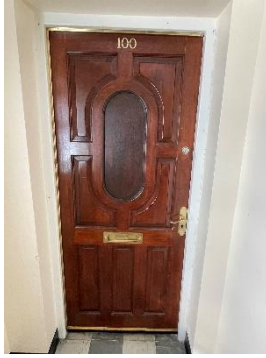
<p>P4</p>	<p>Within 1-3 months Leasehold Manager</p>	
<p>10/10b</p>	<p>Flat 105 entrance door (leaseholder) to be replaced with FD30s door set.</p> <p>Comments from previous FRA Emailed EC 08/07/2022 response within 28 days</p>

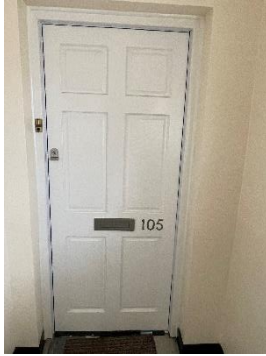
<p>P4</p>	<p>Within 1-3 months Leasehold Manager</p>	
<p>10/10c</p>	<p>Flat 109 entrance door (leaseholder) to be replaced with FD30s door set.</p> <p>Comments from previous FRA 5/8/22 <i>Email from leaseholder management to JB, leaseholder has instructed SMBC to install FD30s composite door set. (This Leaseholder is the owner of both 100 & 109)</i></p>

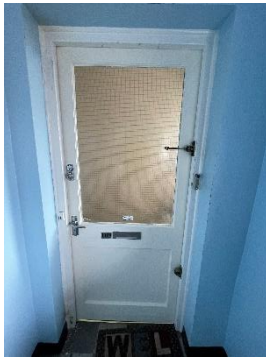
<p>P4</p>	<p>Within 1-3 months Leasehold Manager</p>
