Fire Risk Assessment

Manifoldia Grange

**Coyne Road, West Bromwich,
B70 7JU**

Date Completed: 15th June 2022

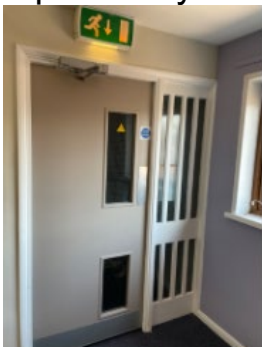
- 7) The self-closing device is missing from the office door within the central building adjacent the toilets.

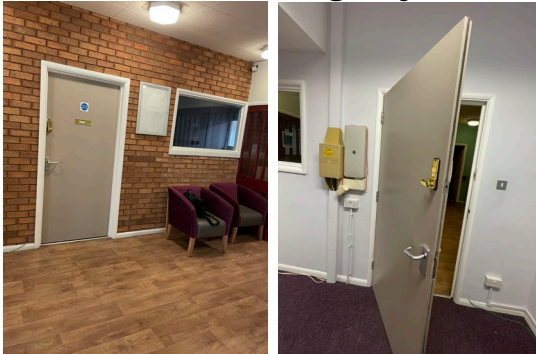
- 8) The automatic self-closing device to the kitchen door has been disconnected and should be reinstated.

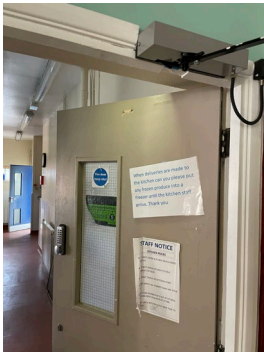
- 9) Front office door doesn't self-close into frame and requires adjustment. Cold smoke seal is partially missing and fire door keep shut signage should be applied.

3	August 2022 Electrical Repairs. JM9551398	26/09/2022
07/09	Front office door doesn't close into frame requires adjustment plus new cold smoke seal along lock edge and fire door keep shut signage.

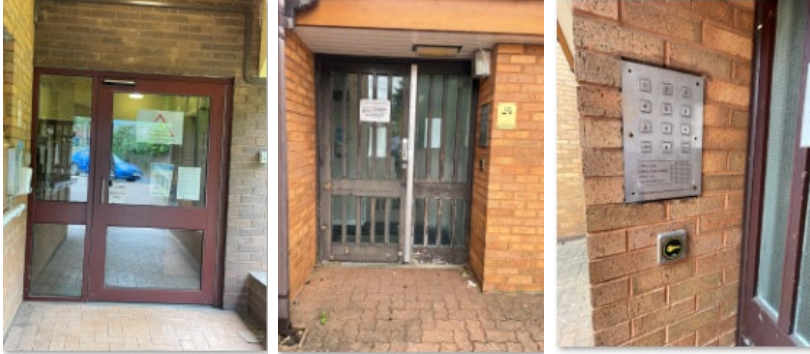
10) The final exit doors have door entry systems installed. These systems are designed to fail safe i.e. door unlocked in the event of a power failure. This prevents residents being locked in or out of the building.

11) There is an alternative final exit door within the wing formally known as Blue Block which leads into a relatively enclosed garden area adjacent Coyne Road. Although occupants escaping via this exit door could locate at a safe distance greater than the height of the building a simple modification to the gates would allow direct access to the street.

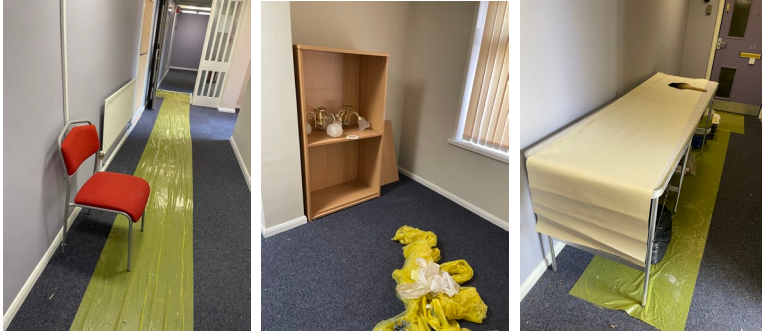
- 14) At the time of the FRA the building was being re-purposed and therefore there are a number of trades persons working. All associated protected covers, tools and rubbish should be removed from the means of escape before the building is occupied by residents.

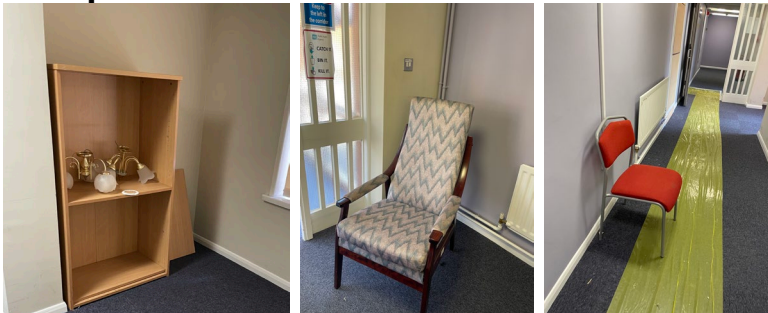
- 15) Various items of redundant furniture within the residential communal corridors should be removed from the means of escape.

07/14	All redundant furniture to be removed from communal corridors.

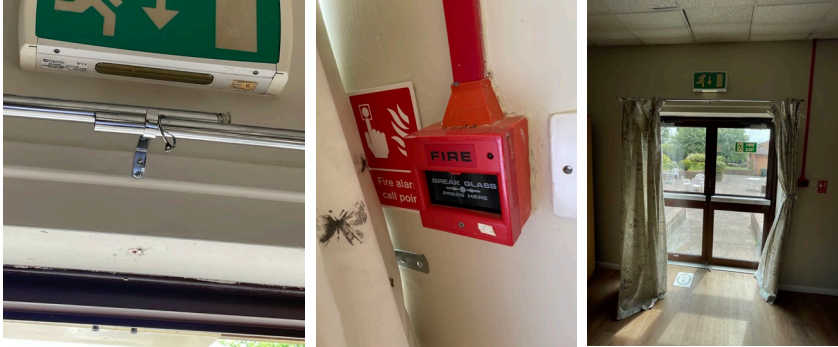
- 27) Curtain pole above final exit door in central office space is not sufficiently secured at the centre of the pole, could collapse and curtains are not ideal above a final exit. The right-hand curtain obstructs the Fire Alarm Call Point Sign. Remove all curtains from above final exit doors in main office area.

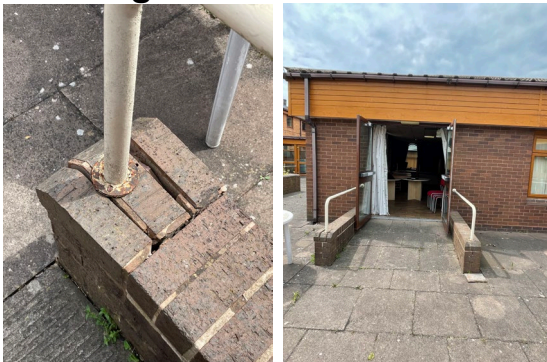
- 28) Brickwork to ramp outside exit door from central office space to rear garden is loose which makes the hand rail insecure.

<p>07/27</p>	<p>Make good loose brickwork / handrail outside fire exit /communal garden.</p>

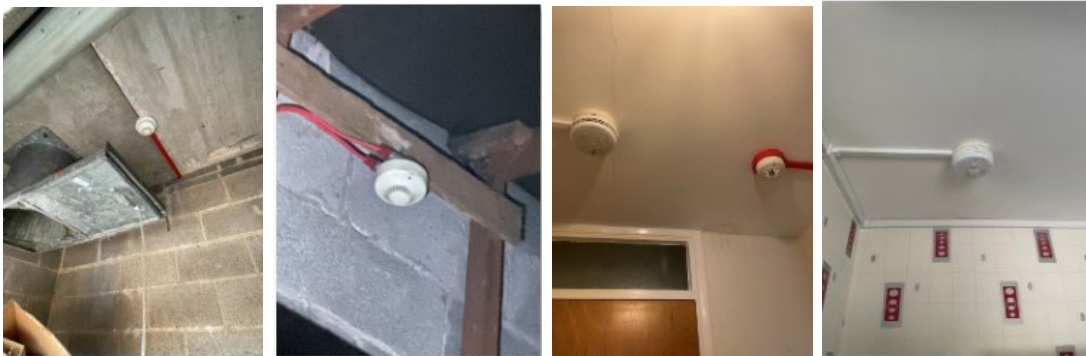
- 5) Hard wired smoke and heat detectors are located on every floor to include communal corridors, offices, individual flats, bin room and boiler house (including roof void above). This is not extended to the loft space area however this is not essential as this area is protected by sufficient compartmentation within the loft space.

It would be good practice to consider when the fire alarm system requires replacement, consideration given to upgrade the system and extend protection into the loft space (accessed via loft hatches from communal toilets and within flats 12,14, 15, 16,17, 18, 19, 20, 21, 33, 34, 35, 36, 37, 38, 39, 40, 41)

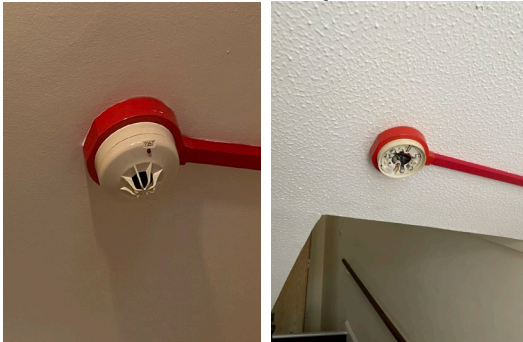
- 7) Each flat has a heat detector located in the hallway that is connected to the communal alarm system. **The heat detector head within flat 1 (former wardens house) is missing.**

08/02	Formulate plan for the weekly testing / recording of fire alarm equipment including those call points within resident's flats.	No photo	3	August 2022 Premise Manager	05/07/2022
08/07	Replace missing heat detector head in flat 1.

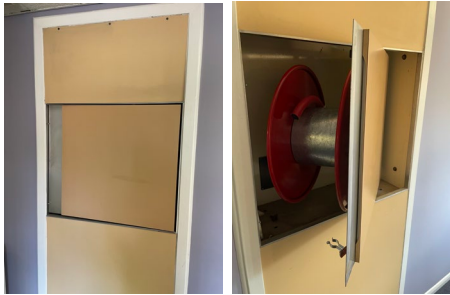
- 3) It was noted that the fire-fighting hose reels have been decommissioned, signage removed, and cupboards have been secured.

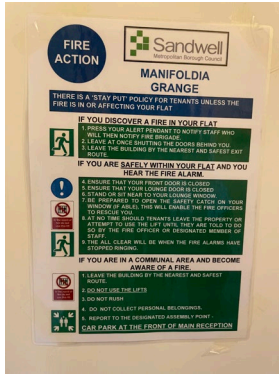
- 3) **Alternative fire action notices are displayed in the majority of flats and in some communal corridors but refer to the use of Alert Pendants & members of staff. They will need to be removed or replaced / updated to reflect the anticipated occupancy of the building.**
-

3	August 2022 Electrical Repairs email JN	29/09/2022
12/03	Fire actions notices within flats & some corridors with information relating to the previous tenants are to be removed and or updated.

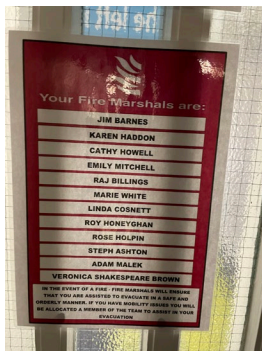
- 5) Signage throughout the building depicting designated Fire Marshalls relates to the former occupiers of the building and should be removed.

<p>12/05</p>	<p>Fire Marshall signage relates to previous occupiers and should be removed and or updated.</p>

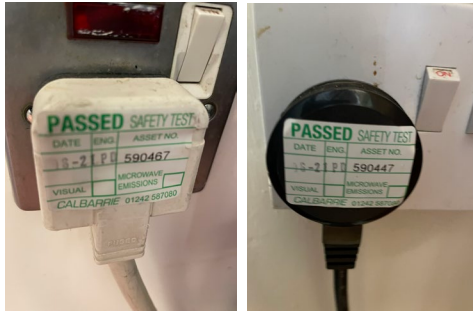
- 4) **There is no evidence of a recent PAT having been completed on the Lincat water boiler within kitchen of the central building.**

<p>3</p>	<p>August 2022 Premise Manager</p>	<p>10/08/2022</p>
<p>14/04</p>	<p>Lincat water boiler in kitchen requires PAT.</p>

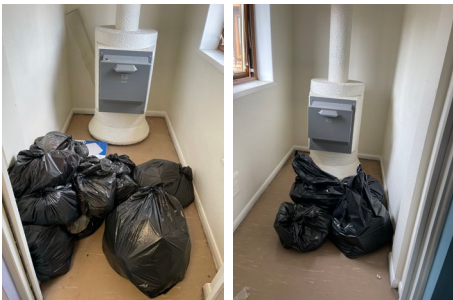
- 1) There are provisions for refuse disposal within the two wings set for residential accommodation by means of internal refuse chutes which serve bin stores. **Refuse has been allowed to accumulate around the internal communal chutes which requires immediate removal.**

14/05	Fixed electrical installation test may be overdue. Confirmation of last test date required.	No Photo	3	August 2022 Electrical Repairs email JN	07/09/2022
15/01	Refuse to be removed from chute rooms in both wings

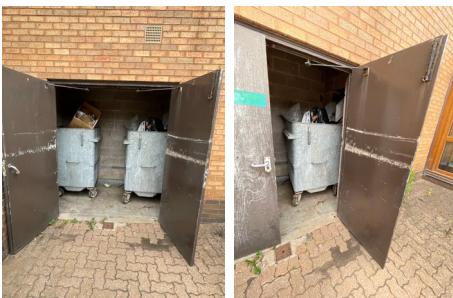
- 2) Refuse containers within bin store were found to be full and require emptying. This is why refuse has been left around the communal chutes. Also the bin store was found open but should be secured shut when not in use.

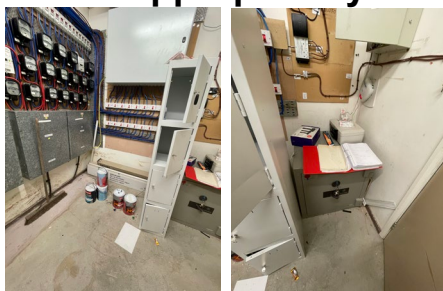
- 4) All store cupboards are kept locked.
- 5) There are no flammable liquids or gas cylinders stored on site.
- 6) **It was noted that some items were being stored in the electrical mains room. These items should be removed and stored appropriately.**
