Fire Risk Assessment

Peartree Lane, Blocks 13-18 & 19-24

**Peartree Lane,
Cradley Heath, B64 6EH**

Date Completed: 16/03/2023

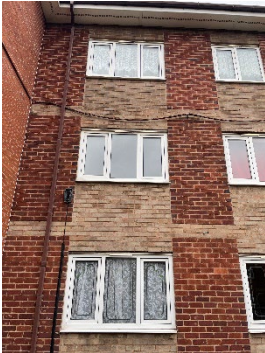
2. Windows to the individual flats are UPVC double glazed units.

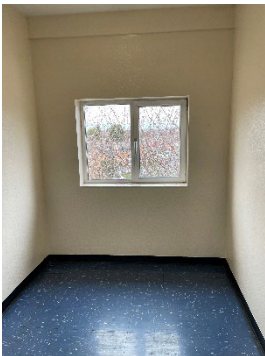
3. Windows to the communal stairwells are UPVC double glazed units.

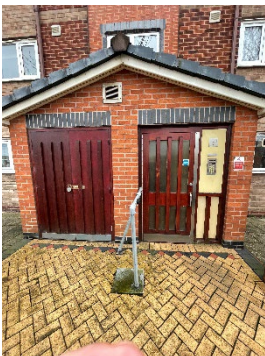
4. Doors to the entrances and bin storage rooms are of timber construction.

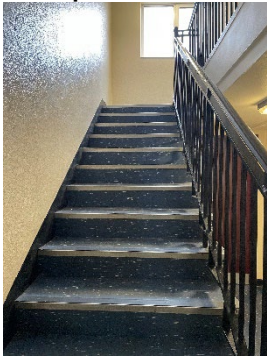
- 1) The site has a staircase within each block that provides a means of escape and is 1000mm in width.

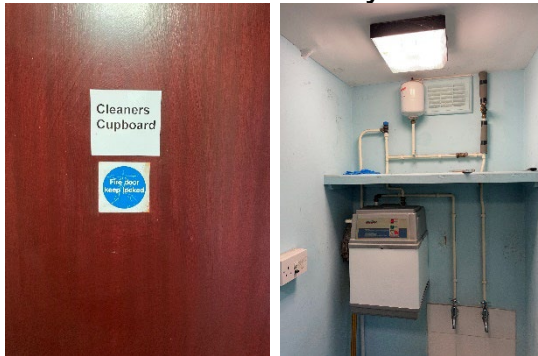
- 6) These doors provide compartmentation between the bin store and front exit to the front elevation and a cleaner's store cupboard and rear exit to the rear elevation.
- 7) The cleaners store cupboard is protected by an FD30 fire door. The door is secured by a suited type 54 mortice lock and key.

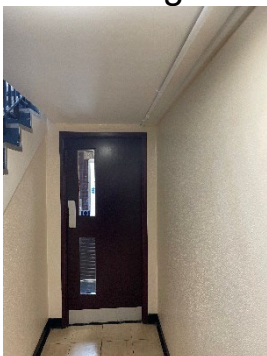
- 8) All communal doors are fitted with automatic closing devices that are checked on a regular basis by Caretaking Teams as part of their checks. Defective closing devices are replaced either by the Caretaking Team(s) or the in-house repairs team(s).

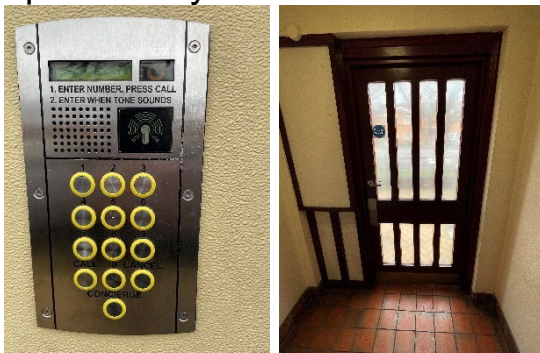
- 9) The final exit doors to the front of the building have door entry systems installed. These systems are designed to fail safe i.e. door unlocked in the event of a power failure. This prevents residents being locked in or out of the building. All final exit doors are openable by means of a levered handle.

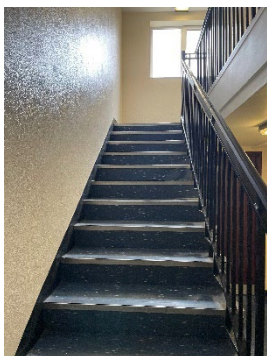
- 1) The building is designed to provide as a minimum 1-hour vertical fire resistance and 30 minutes horizontal fire resistance between dwellings.
- 2) The premise does not have sufficient compartmentation to limit the travel and effect of smoke and flame in event of a fire in the communal areas due to the open plan staircase.

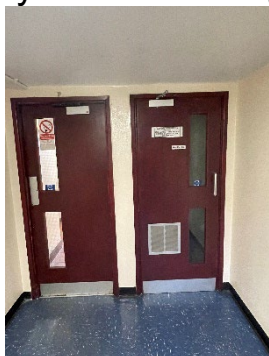
- 3) There are communal doors fitted with automatic closing devices. These are checked on a regular basis by Caretaking Teams as part of their checks. Defective closing devices are replaced either by the Caretaking Team(s) or the in-house repairs team(s).

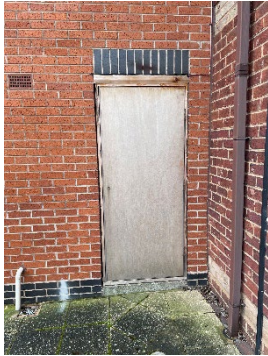
- 6) The service cupboards located below the stairs are accessed externally to the rear of each of the blocks. The door is FD30 rated and is secured with a suited type 54 mortice lock.

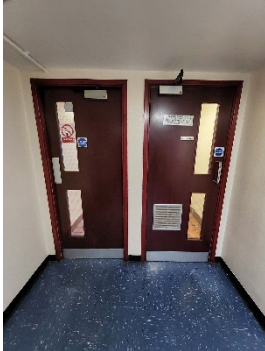
- 7) Communal doors to the ground floor lobbies are timber FD30s with vision panels. There are no communal doors to the upper floors.

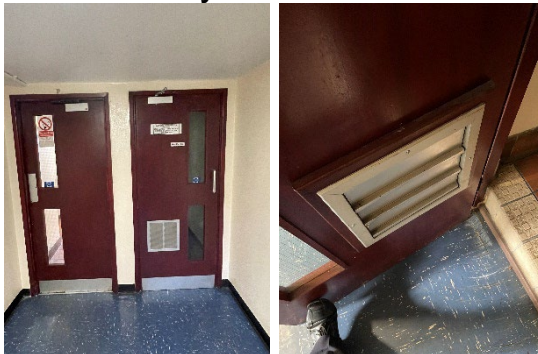
- 8) The door to the bin store from the ground floor lobby is FD30s and is additionally fitted with a ventilation panel with intumescent baffle.

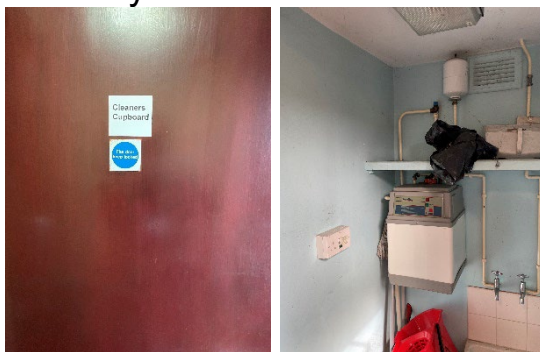
- 9) The cleaner's cupboard in each block has a timber FD30 door secured with a suited type 54 mortice lock and is located on the ground floor between the rear final exit door and communal door to the lobby.

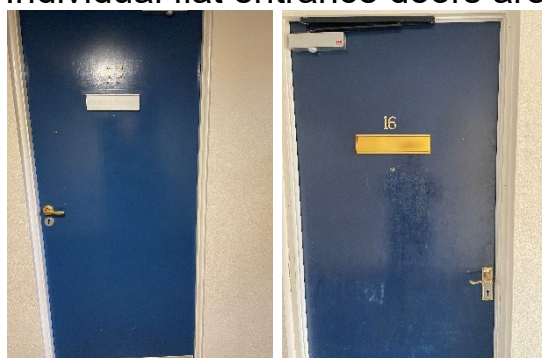
- 10) Individual flat entrance doors are timber FD30s rated.

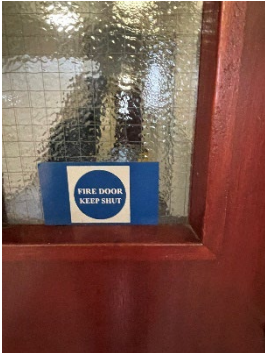
- 1) All fire doors display “Fire Door Keep Shut” where appropriate.

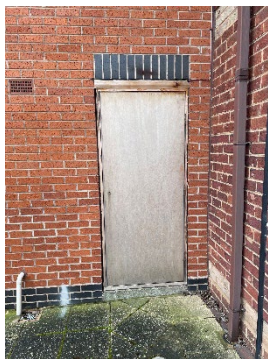
- 5) The electrical installation i.e. risers are contained within dedicated service cupboards that are secure and protected by means of a FD30 door which are accessed externally to the rear of the blocks.
