Fire Risk Assessment

1-6 Park Court

**Rowley Village, Rowley Regis,
B65 9ER**

Date Completed: 16-06-23

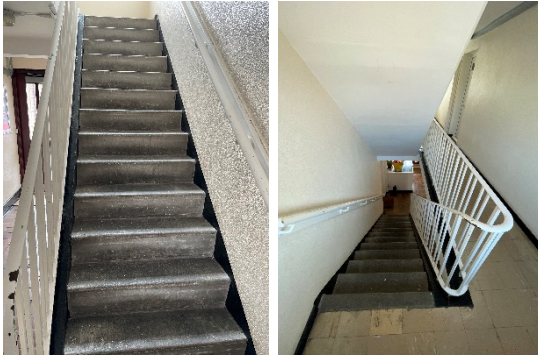
- 1) The site has a single staircase that provides a suitable means of escape. The staircase is of timber construction and is 960mm in width.

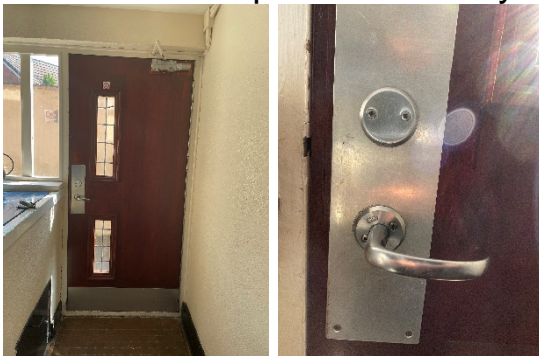
- 7) The final exit door to the rear is secured by cylinder type lock which can be opened internally with a levered handle.

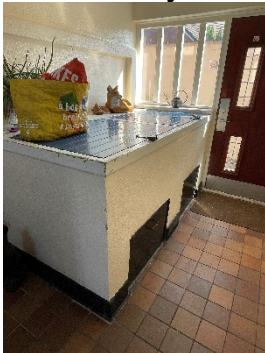
- 14) There are two former coal bunkers on each floor. The bunkers are on the communal lobbies and are now utilised by residents as storage. Each bunker is accessed via a timber hatch/door and is secured by residents own padlock.

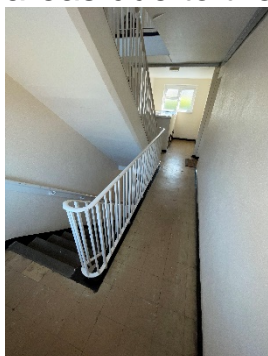
- 1) The building is designed to provide as a minimum 1-hour vertical fire resistance and 1-hour horizontal fire resistance around flats stairwells. All doors are 30-minute fire resistant with cold smoke seals, including those in 1-hour rated walls.
- 2) The premise does not have sufficient compartmentation to limit the travel and effect of smoke and flame in event of a fire in communal areas due to the open plan staircase.

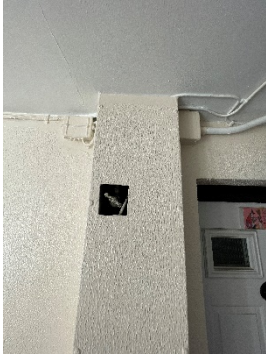
8) Stop taps to flats are located on each landing. Pipework is enclosed behind ply boarding which is painted with the same class 0 covering as applied to the walls and ceilings. Sampling didn't reveal any requirement for additional firestopping.

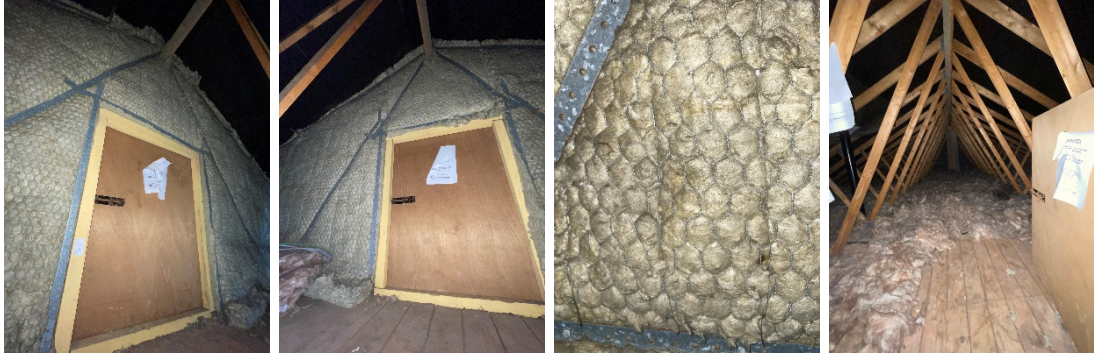
- 10) The common roof space is accessed via a hatch to the 2nd floor landing. There are no access hatches from within resident's flats. Compartmentation walls/curtain comprising of rockwool (A1 rated) with access doors have been installed to prevent fire spread through the roof void.

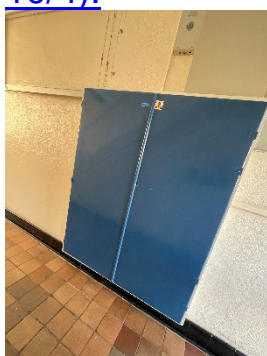
- 5) The electrical installation i.e. risers are contained within dedicated service cupboards located in the entrance lobby ([refer to section 10/4](#)).
