Fire Risk Assessment

1-6 Chandler House

**Shelsley Avenue, Oldbury,
B69 1BW**

Date Completed: 4th August 2022

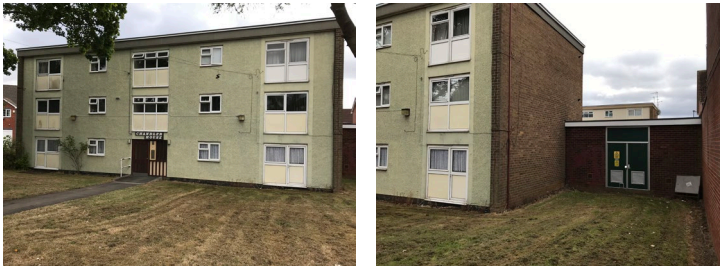
- 1) The external surface of the building is a traditional concrete masonry construction with a Rendered finish to the front and rear elevations and a brick finish to the sides of the building with a flat roof and fascia boards along the roof line.

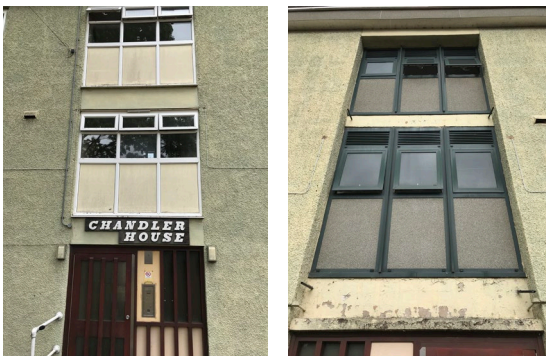
- 2) UPVC double glazed units are installed to each flat including the front elevation of the communal stairwell. The windows to the rear elevation communal stairwell are aluminium framed units with louvred vents above.

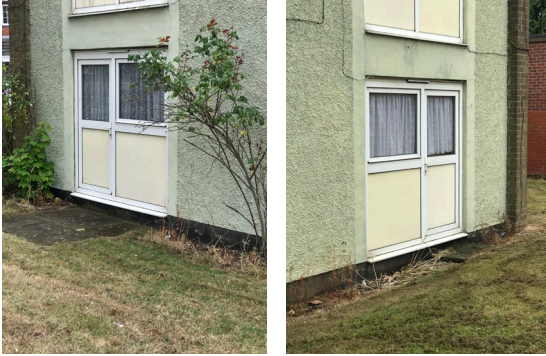
- 3) The ground floor flats (1 & 2) have rear access doors that lead to the outside of the property.

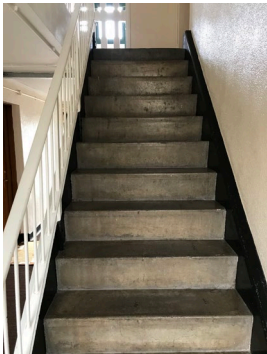
- 4) The site has a single staircase that provides a means of escape and is 1020 in width.

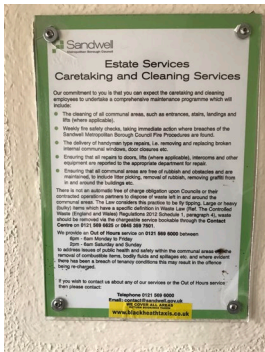
- 11) Communal areas are kept free of flammable items. The communal areas are checked on a regular basis by Caretaking / Cleaning teams 365 days per year and all items of rubbish are immediately removed. There is also an out of hour's service that allows combustible items of furniture / rubbish to be removed.

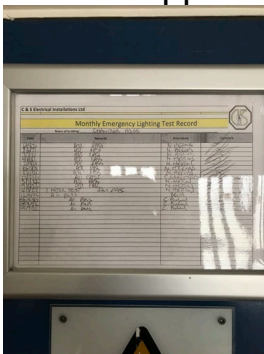
- 12) Emergency lighting is provided to communal landings and stairs. Checks are done monthly by Sandwell MBC in house electrical team or approved contractor.

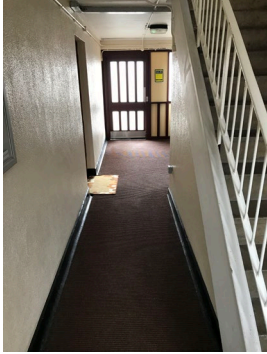
- 14) The surface coatings to the communal areas have previously been painted by SMBC and are Class 0 rated.
- 15) All floors have S.M.B.C. fitted carpet. Due to the fact SMBC specified and managed the installation of the carpets it has been presumed they are Class 0 fire rated.

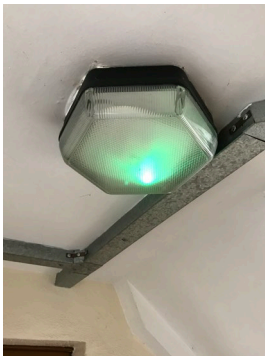
- 1) The premises have a sufficient emergency / escape lighting system in accordance with BS 5266 and has test points strategically located.
- 2) The combined units are provided to the communal landings and stairs.

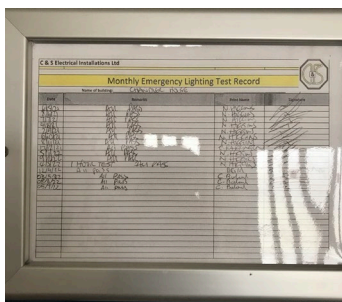
- 3) All installed equipment is checked and tested monthly by Sandwell MBC in house electrical team or approved contractor, in accordance with current standards.

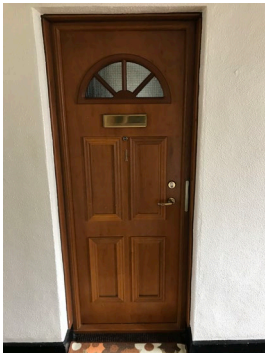
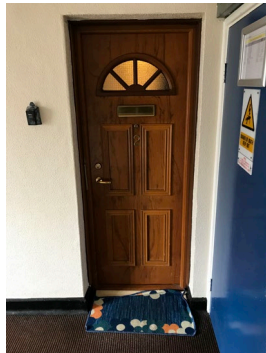
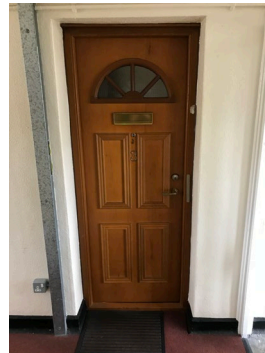
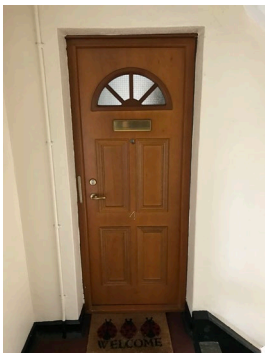
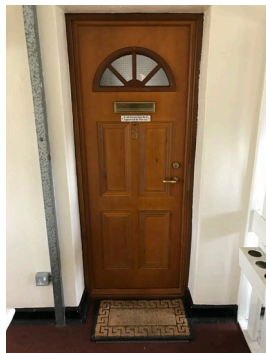
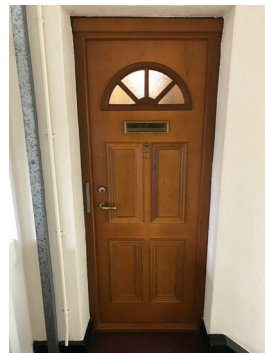
BL43400CH48	1 Chandler House;Shelsley Avenue;Oldbury;West Midlands;	Composite Carolina	Glazed
BL43400CH48	2 Chandler House;Shelsley Avenue;Oldbury;West Midlands;	Composite Carolina	Glazed
BL43400CH48	3 Chandler House;Shelsley Avenue;Oldbury;West Midlands;	Composite Carolina	Glazed
BL43400CH48	4 Chandler House;Shelsley Avenue;Oldbury;West Midlands;	Composite Carolina	Glazed
BL43400CH48	5 Chandler House;Shelsley Avenue;Oldbury;West Midlands;	Composite Carolina	Glazed
BL43400CH48	6 Chandler House;Shelsley Avenue;Oldbury;West Midlands;	Composite Carolina	Glazed

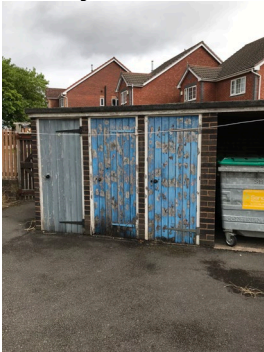
- 1) Residents instructed not to bring L.P.G cylinders into block.
- 2) The tenancy conditions, Section 7 – Condition 5.6 stipulates “If you live in a flat or maisonette, you, people living with you and any visitors to your property must not keep or use paraffin oil, petrol, bottled gas appliances or any other explosive, FLAMMABLE or dangerous material in the property. This restriction also applies to any storage facility situated in or attached to the block, which has been provided for your use.”
- 3) Residents have access to lockable storage facilities located in the rear yard.
