Fire Risk Assessment

Applewood Grove Blocks 1-6 & 7-12

Cradley Heath, B64 6EW

Date Completed: 28/03/23

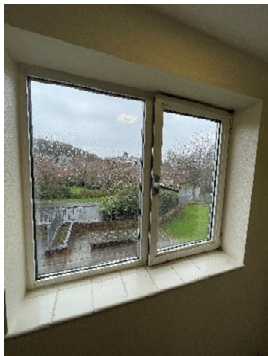
- 10) Communal windows are lockable however it was noted that keys were not present. All windows were however unlocked at the time of the FRA.

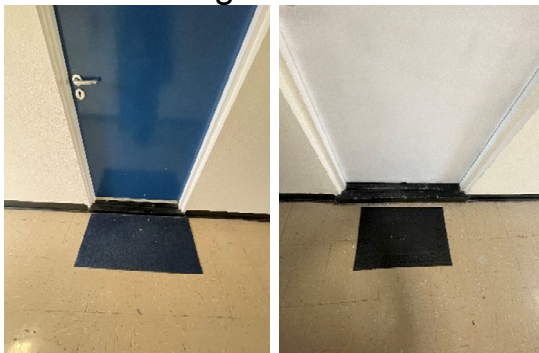
- 11) The fire rating of individual floor mats is unknown.

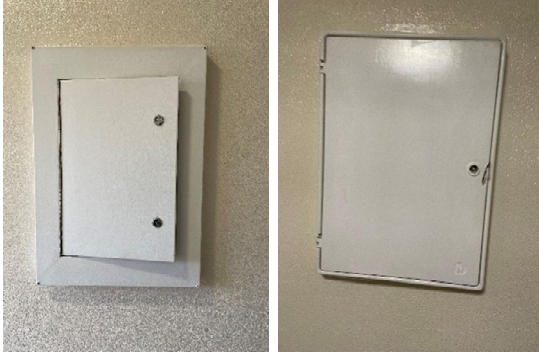
15) Individual flat electricity meters are located adjacent flat entrance doors on communal landings. The meters are within either GRP modular or steel wall mounted units fitted with budget locks. The fire rating of these units is unknown. The GRP units have previously been recommended for upgrade as part of a future works upgrade program.

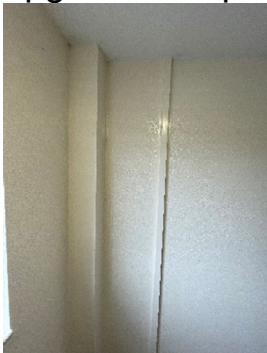
- 19) There is a small amount of plastic trunking within the communal landings. This was previously recommended on the last FRA to be upgraded as part of a future programme which is to be confirmed.

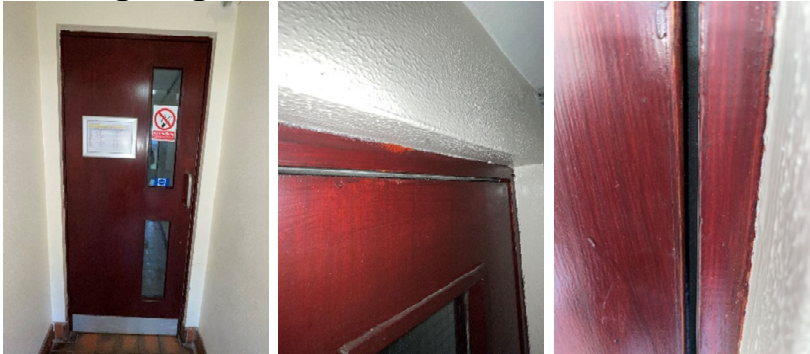
- 21) In block 7-12 the communal door between the front entrance and ground floor lobby has excessive gaps to the head and leading edge.

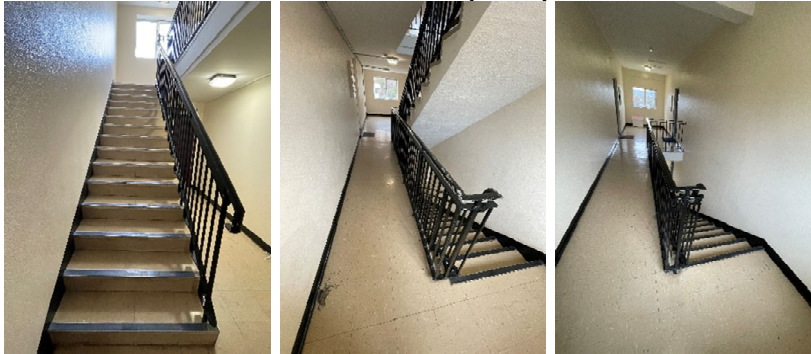
- 1) The building is designed to provide as a minimum 1-hour vertical fire resistance and 30 minutes horizontal fire resistance between dwellings.
- 2) The premise does not have sufficient compartmentation to limit the travel and effect of smoke and flame in event of a fire in the communal areas due to the open plan staircase.

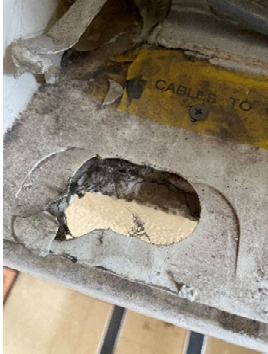
07/15e	Flat 9 meter cupboard – fire stop hole within bottom panel.

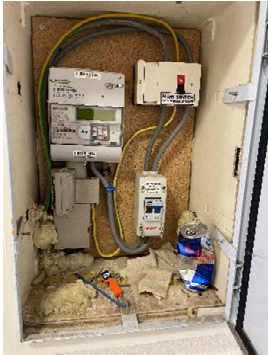
- g) Flat 11 meter cupboard – general expanding foam has been used and should be removed and replaced with a suitable product for fire stopping.**

<p>07/15g</p>	<p>Flat 11 meter cupboard remove foam and fire stop where required</p>
