Fire Risk Assessment

Macauley House

**Glover Street,
West Bromwich, B70 6DY**

Date Completed: 12th December 2024

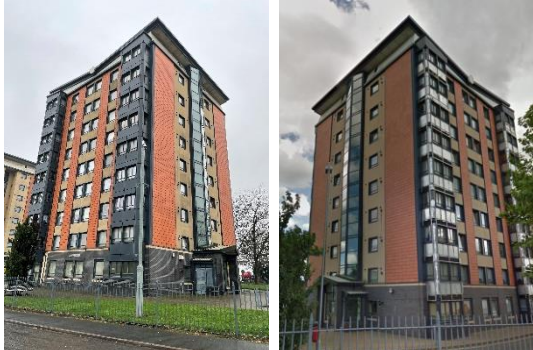
(Right – 2017 historic image showing removal of ACM)

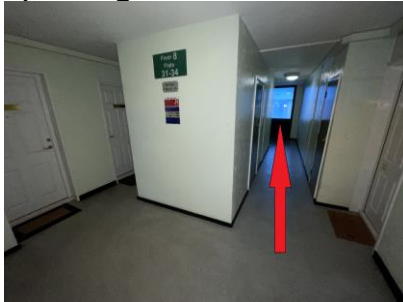
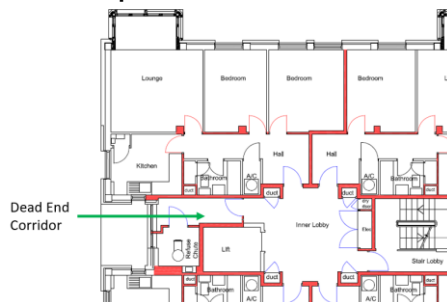
- 2) All corridors are of adequate width (at least 960mm) and will be maintained clear to that width as a minimum.
- 3) There are dead end corridors on all floors from the 1st to 8th. The dead end corridors are between the lift lobbies and the chute room. All are 1050mm wide, 6 metres long and benefit from an Automatic Opening Vent therefore are acceptable.

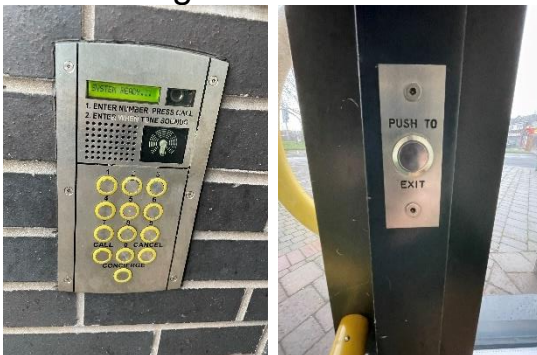
- 7) All communal doors are fitted with automatic closing devices that are checked on a regular basis by Caretaking Teams as part of their checks. Defective closing devices are replaced either by the Caretaking Team(s) or the in-house repairs team(s).
- 8) All communal fire doors are subject to a 12-week check by the Fire Safety Rapid Response Team.
- 9) The final exit doors have door entry systems installed. These systems are designed to fail safe i.e. door unlocked in the event of a power failure. This prevents residents being locked in or out of the building.

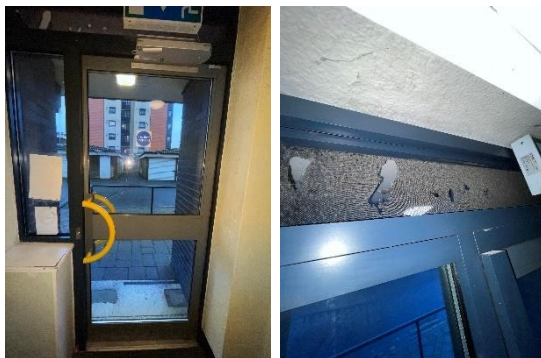
- 10) There's a ventilation grill installed above the rear exit door.
-

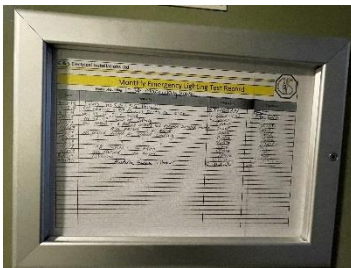
- 3) All installed equipment is checked and tested on a monthly basis by Sandwell MBC in house electrical team or approved contractor, in accordance with current standards. The last monthly inspection stated multiple failures (1 hour). Email from the electrical compliance team confirmed contactors were scheduled to attend 16/12/24 to conduct tests & repairs.

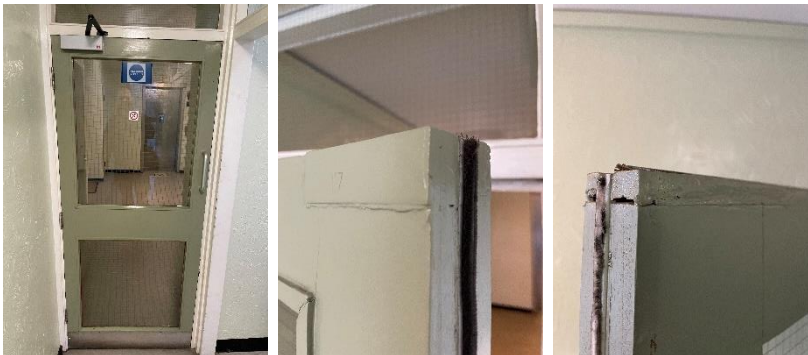
- 12) The landings & staircase from the first floor up are protected by use of notional self-closing 44mm 30-minute timber fire doors (accept 7th floor / nominal door) upgraded with combined intumescent strips & cold smoke seals to enhance their original design and minimise departures from today's standards. However, it was evident that each landing door on floors 1, 2, 3, 4, 5, 6 & 8 have been previously repaired but some of those repairs have failed. Short term, it is recommended that a temporary repair is made to those with failed repairs but a full replacement FD30s door should be installed as soon as reasonably practicable to all doors that have had repairs. These recommendations are recorded at the end of this section.

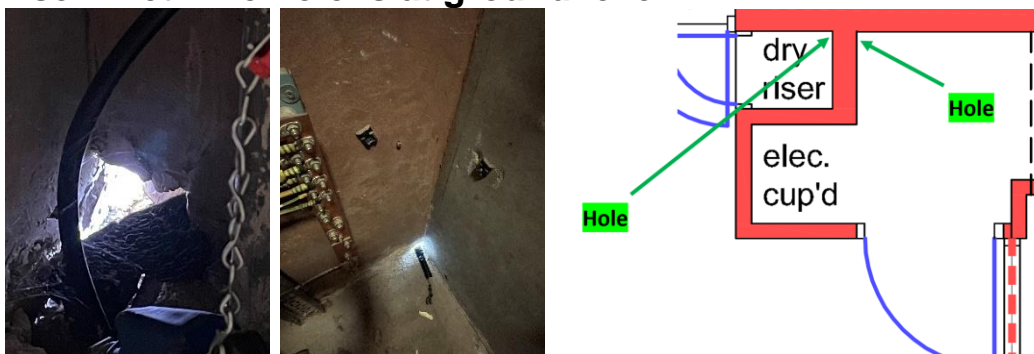
21) Ground floor - Fire stop hole between service cupboard and riser inlet. The hole is at ground level

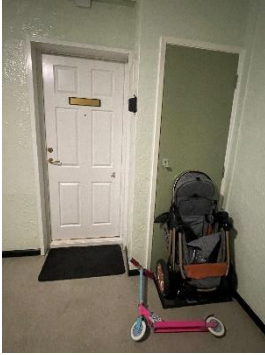
Question/ Ref No	Required Action	Supporting photograph	Priority	Timescale and Person Responsible	Date Completed
07/18	Pushchair and children's scooter outside flat 4 to be removed from the means of escape.

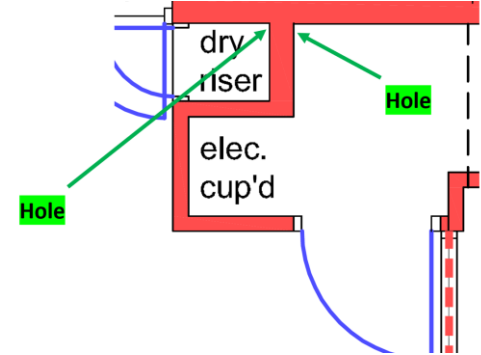
P2	Within 1-3 months Fire Rapid Team	
10/21	Ground floor – fire stop hole between service cupboard riser cupboard.

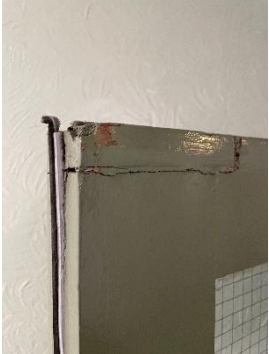
22) 6th floor – Landing door leaf previously damaged and repaired. The repaired section has failed and should be redone as a temporary measure. Replacement door will be requested.

P2	Within 1-3 months Fire Rapid Team	
10/22	6 th floor – previous damage/repair to landing door leaf needs repair

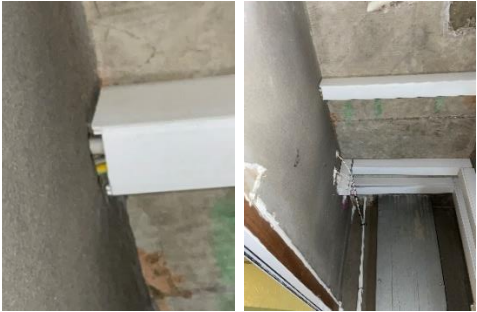
23) 6th floor service cupboard – Fire stop cables in plastic trunking at penetration.

10/23	6 th floor service cupboard – fire stop cables in plastic trunking at penetration

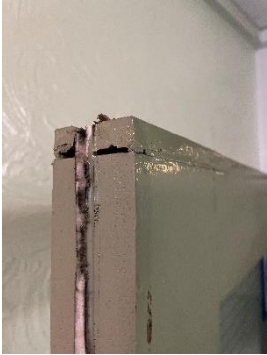
24) 5th floor – Landing door leaf previously damaged and repaired. The repaired section has failed and should be redone as a temporary measure. Replacement door will be requested.

P2	Within 1-3 months Fire Rapid Team	
10/24	5 th floor - previous damage/repair to landing door leaf needs repair

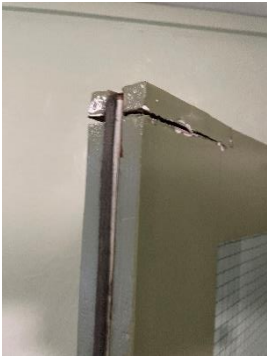
- 25) 3rd floor – Landing door leaf previously damaged and repaired. The repaired section has failed and should be redone as a temporary measure. Replacement door will be requested. Also, excessive gap on handle side to be reduced.**

P2	Within 1-3 months Fire Rapid Team	
10/25	3 rd floor - previous damage/repair to landing door leaf needs repair. Also, excessive gap handle side to be reduced

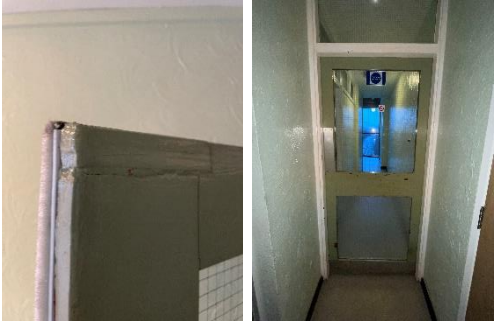
- 26) 8th floor – Notional landing door leaf previously damaged and repaired. Repairs are prone to failure therefore the door should be replaced with an FD30s self-closing fire door.**

10/26	8 th floor landing door which is damaged / previously repaired to be replaced with FD30s. <i>Approximate door leaf size 870 x 1975mm.</i>

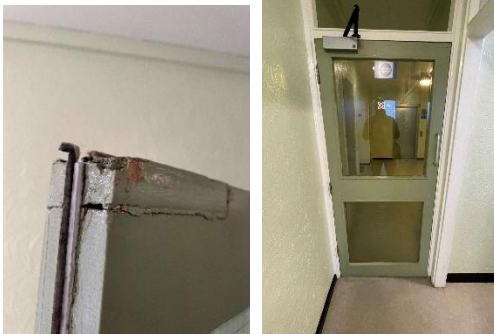
- 27) 6th floor - Notional landing door leaf previously damaged and repaired. Repairs are prone to failure therefore the door should be replaced with an FD30s self-closing fire door.**
-

P4	P4 Programmed Work Repairs	
10/27	6 th floor landing door which is damaged / previously repaired to be replaced with FD30s. <i>Approximate door leaf size 870 x 1975mm.</i>

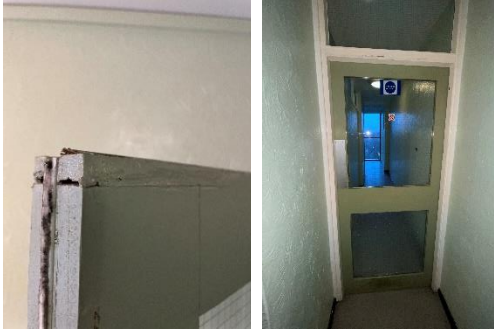
28) 5th floor - Notional landing door leaf previously damaged and repaired. Repairs are prone to failure therefore the door should be replaced with an FD30s self-closing fire door.

P4	P4 Programmed Work Repairs	
10/28	5 th floor landing door which is damaged / previously repaired to be replaced with FD30s. <i>Approximate door leaf size 870 x 1975mm.</i>

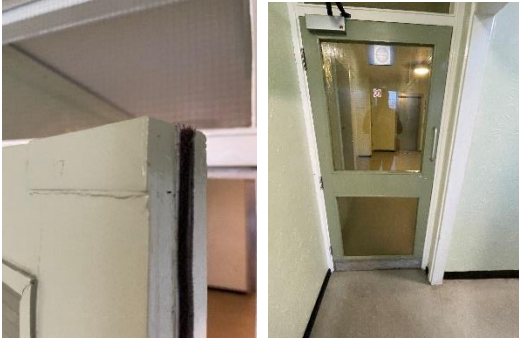
29) 4th floor – Notional landing door leaf previously damaged and repaired. Repairs are prone to failure therefore the door should be replaced with an FD30s self-closing fire door.

10/29	4 th floor landing door which is damaged / previously repaired to be replaced with FD30s. <i>Approximate door leaf size 870 x 1975mm.</i>

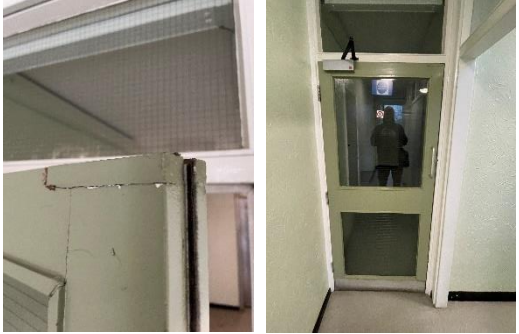
30) 3rd floor - Notional landing door leaf previously damaged and repaired. Repairs are prone to failure therefore the door should be replaced with an FD30s self-closing fire door.

P4	P4 Programmed Work Repairs	
10/30	3 rd floor landing door which is damaged / previously repaired to be replaced with FD30s. <i>Approximate door leaf size 870 x 1975mm.</i>

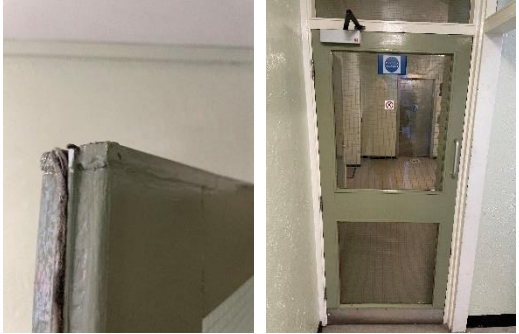
31) 2nd floor - Notional landing door leaf previously damaged and repaired. Repairs are prone to failure therefore the door should be replaced with an FD30s self-closing fire door.

P4	P4 Programmed Work Repairs	
10/31	2 nd floor landing door which is damaged / previously repaired to be replaced with FD30s. <i>Approximate door leaf size 870 x 1975mm.</i>
