Fire Risk Assessment

Holly Court

**Acacia Avenue, Yew Tree Estate,
WS5 4BN**

Date Completed: 22/02/2024.

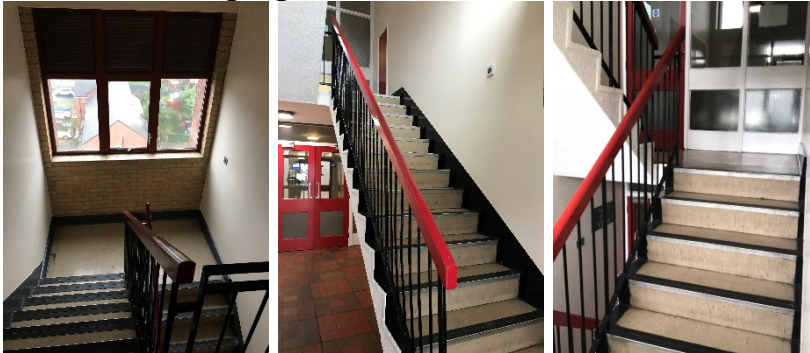
- 1) The site has two sets of staircases that provides a means of escape located at the front and the rear of the building with stairwells ranging from 980mm - 1000mm

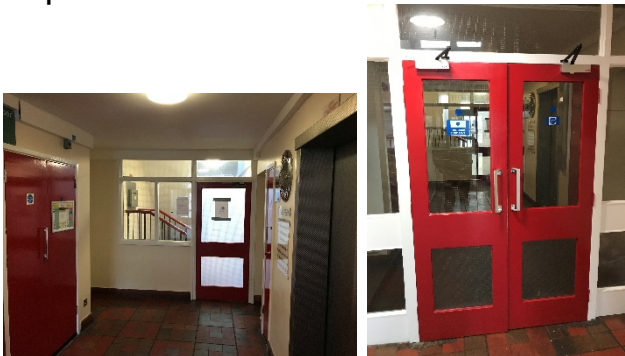
- 2) All corridors are of adequate width (at least 1050mm) and will be maintained clear to that width as a minimum.
- 3) There are no corridors that form a part of the means of escape that are a dead end.
- 4) The means of escape are protected to prevent the spread of fire and smoke by means of notional fire doors and good compartmentation between lobby areas, staircases, and dwellings.
- 5) The communal landing / staircases are protected by use of self-closing 44mm notional 30-minute timber fire doors with vision panels. All doors have been upgraded with combined intumescent strips / cold smoke seals.

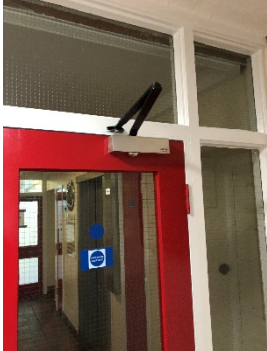
- 6) All communal doors are fitted with automatic closing devices that are checked on a regular basis by Caretaking Teams as part of their checks. Defective closing devices are replaced either by the Caretaking Team(s) or the in-house repairs team(s).

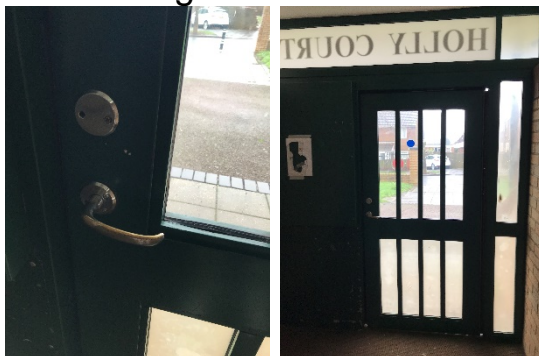
- 7) All communal fire doors are subject to a 12-week check by the Fire Safety Rapid Response Team.
- 8) The final exit doors have door entry systems installed. These systems are designed to fail safe i.e. door unlocked in the event of a power failure. This prevents residents being locked in or out of the building.

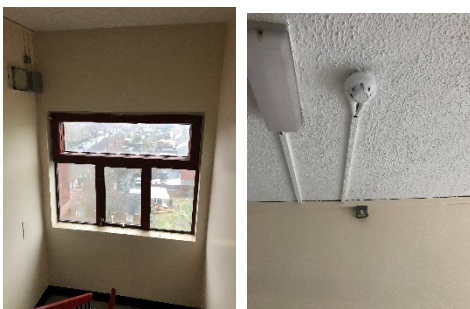
- 9) Automatic smoke ventilation is employed. This is tested, inspected and maintained by a competent procured contractor in accordance with BS7346. The frequency for the maintenance checks are twice per year (April and October) of each calendar year. AOV's are located at the top of the front staircase. Detection for the AOV's within the communal areas.

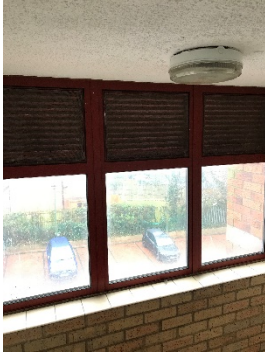
- 10) There is ventilation to the block by the means natural louvre vent / screens within the rear staircase along the communal windows, as well as opening widows along the front staircase.

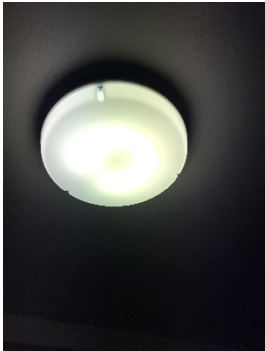
- 13) Emergency lighting is provided to communal landings and stairs. Checks are done on a monthly basis by Sandwell MBC in house electrical team or approved contractor.

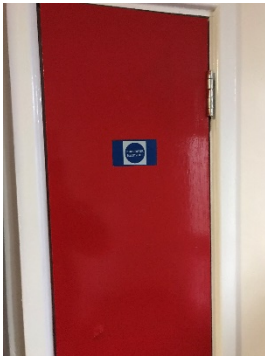
- 14) Dry riser cupboards are notional 44mm, 30-minute fire doors with combined intumescent strips & cold smoke seals through the block.

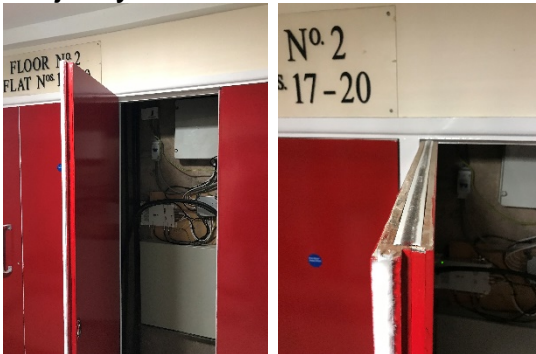
- 15) Service/electrical cupboards with lobby areas are notional 44mm 30-minute fire doors, secured with budget locks through the majority of the block

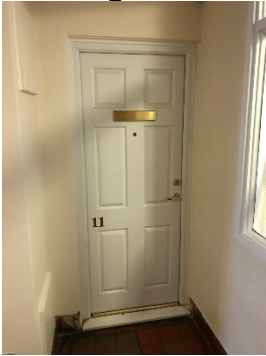
- 20) The building has sufficient passive controls that provide effective compartmentation in order to support a Stay Put-Unless Policy. Therefore, residents are advised to remain in their flat unless the fire directly affects them, or they are asked to leave by the emergency services.
- 21) Individual flat doors are predominantly nominal 44mm composite fire door sets with intumescent strips, cold smoke seals and self-closing devices. Manufactured by Permadoor

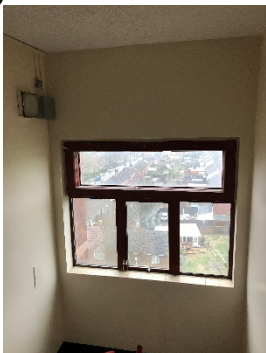
- 22) Access is gained to a sample of properties as part of the fire risk assessment to ensure the doors have not been tampered with by residents etc.
Access was granted to flats 40,38,36 and 23
- 23) Noted fire door keep shut signs had been placed on the final exit doors of the block. These doors are not fire doors and the signage is not needed on final exit doors.
- 24) The refuse chute hoppers are located within the protected stairwell
- 25) Aov located at the top of the front communal staircase only

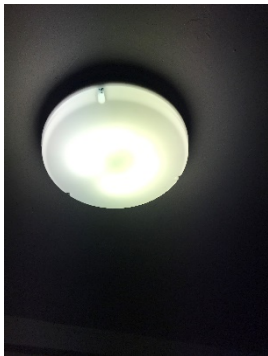
- 1) The premises have a sufficient emergency system in accordance with BS 5266 and has test points strategically located.
- 2) The self-contained units are provided to the communal landings, stairs and lift motor room.

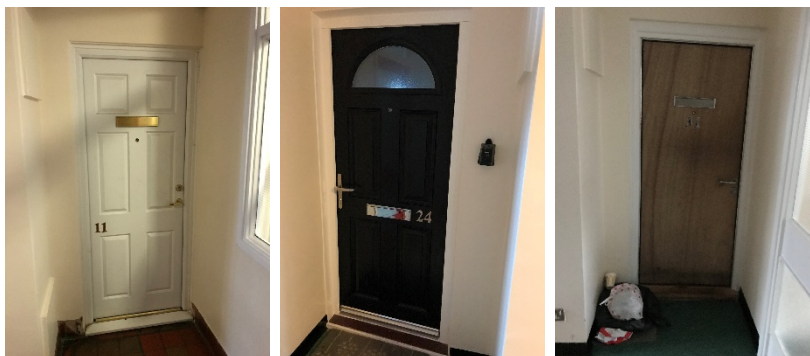
- 7) The fire stopping / compartmentation is subject to a 12-week check by the Fire Safety Rapid Response Team
- 8) Any remedial works arising from the fire stopping / compartmentation check(s) will be actioned immediately by the Fire Safety Rapid Response Team.
- 9) Individual flat doors are predominantly nominal 44mm timber/composite fire door sets with intumescent strips, cold smoke seals and self-closing devices of a Permadoor construction. Noted there is also some timber nominal Blank doors fitted

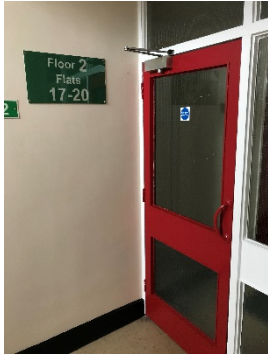
- 10) The communal landing & staircases are protected by use of notional self-closing 44mm 30-minute timber fire doors with vision panels & 25mm stops.

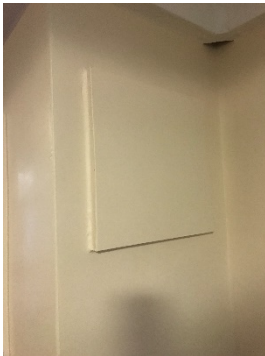
- 11) Access panels to stop taps are fixed to masonry and bedded on Intumescent material. However, in some cases stop taps are housed behind 44mm, 30-minute notional doors.

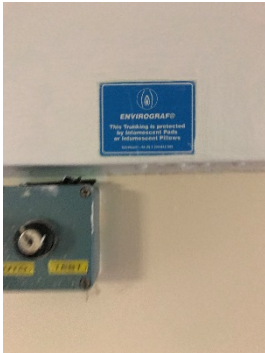
- 12) It was noted that Envirograf trunking had been used within the communal areas to house cabling.

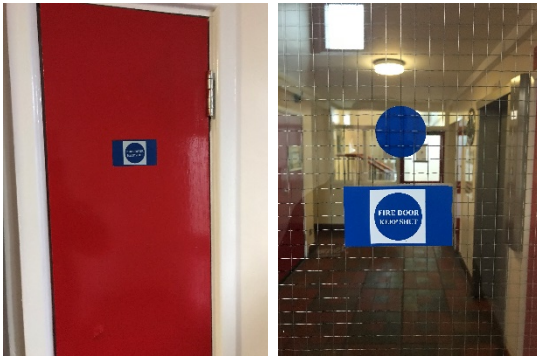
- 1) All fire doors display “Fire Door Keep Shut” where appropriate, communal cupboard doors display fire door keep shut signs rather than fire door keep locked signage however this is considered a trivia risk

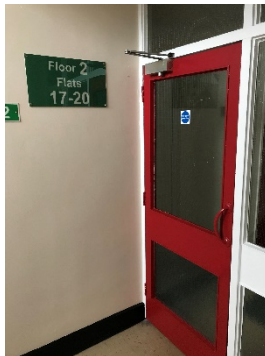
- 5) Wayfinding Signage depicting floor level and flat numbers are fitted to the wall adjacent to lift. They meet the requirements set out in the Fire Safety (England) Regulations 2022 noted that during the risk assessment decorating works was taking place and some signs had been removed in order to paint the walls behind (please see email bellow)

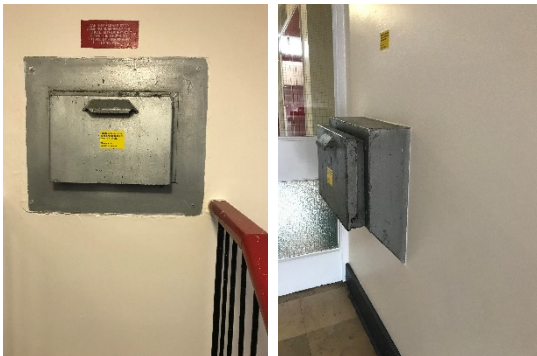
- 1) There is a regular Cleaning Service to the premises.
- 2) Refuse hoppers are accessed on each floor within the front stairwell

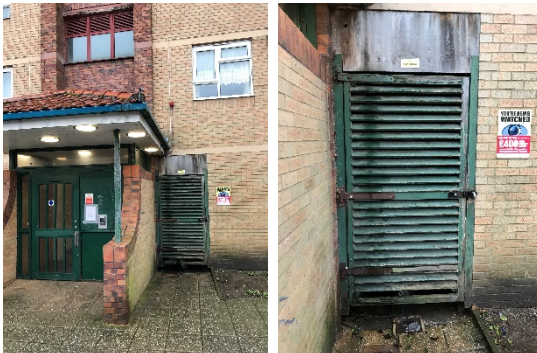
- 3) Refuse containers regularly emptied bin store located at the rear elevation of the block.
