Fire Risk Assessment

Darley House Wallace Close, Oldbury, B69 1HS

Date Completed: 15th July 2021

Current Risk Rating 3 = Medium

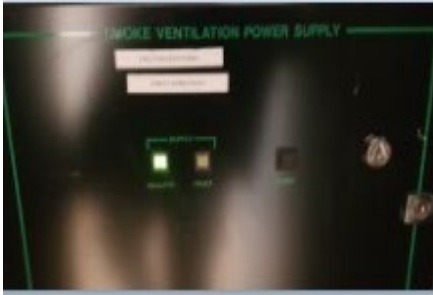
- 8) Automatic smoke ventilation is employed to the flat lift lobby area.

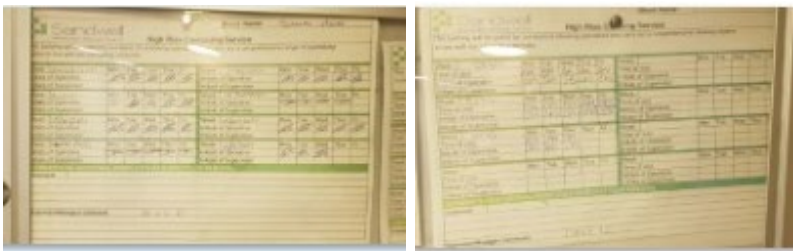
- 10) Communal areas are kept free of flammable items. The communal areas are checked regularly by Caretaking / Cleaning teams 365 days per year and all items of rubbish are immediately removed. There is also an out of hour's service that allows combustible items of furniture / rubbish to be removed.

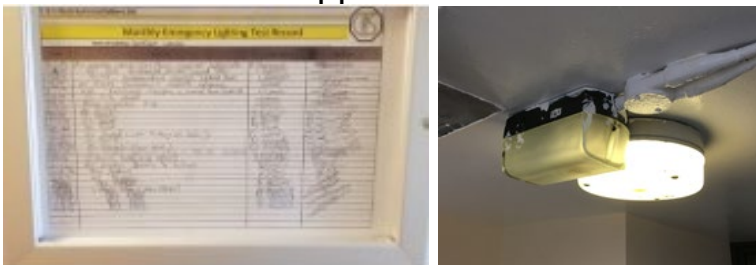
- 11) Emergency lighting is provided to communal landings and stairs. Checks are done on a monthly basis by Sandwell MBC in house electrical team or approved electrical contractor.

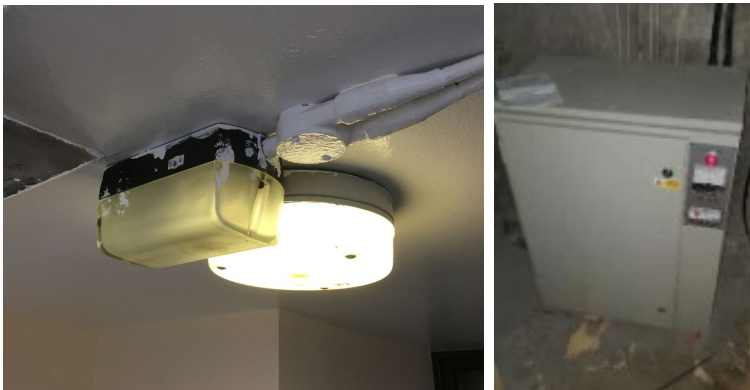
- 1) The premises has a sufficient emergency / escapes lighting system in accordance with BS 5266 and test points strategically located.
- 2) **The units are centrally powered from a unit on the first floor. luminaires are provided to communal landings, stairs and lift motor room. The lighting is dated and currently sufficient but will be upgraded when the block is next refurbished.**

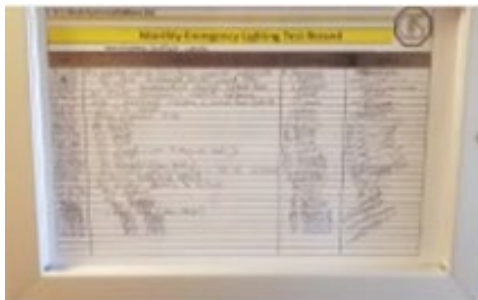
- 3) All installed equipment is checked and tested on a monthly basis by Sandwell MBC in house electrical team or approved contractor, in accordance with current standards.

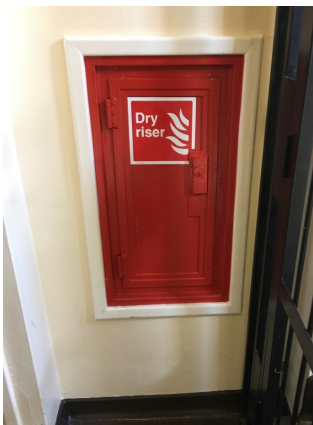
- 1) There is an inlet riser located on the external façade of the front elevation (left hand side of main entrance). The inlet door is of metal construction that has a suited cylinder lock installed to keep it secure.
- 2) There is a dry riser that serves the building. The outlets are located on the stairwell on each floor. The outlet is contained within a purpose-built metal dry riser cabinet that has a suited cylinder lock installed to keep them secure.

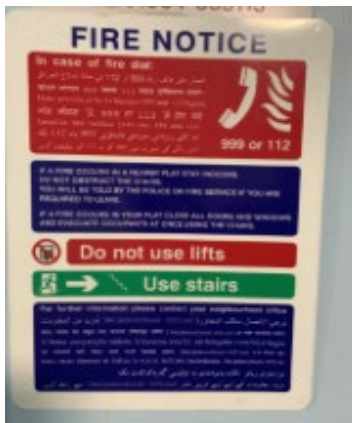
- 1) All fire doors display “Fire Door Keep Shut” where appropriate.
- 2) Direction fire escape signage is not installed. This is not an issue as the building is not of a complex layout thus the means of escape of self-evident.
- 3) It was noted that the ground floor has the fire exits signed.
- 4) Fire Action Notices are displayed throughout the building.

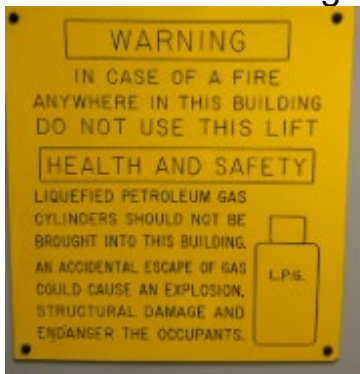
- 5) Yellow LPG warning signs are displayed within the lift cars.

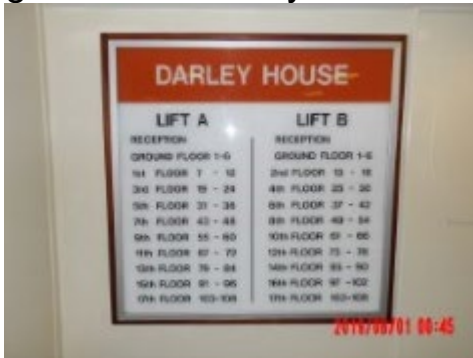
- 6) Signage depicting the floor location of each flat is fitted to the ground floor lobby wall.

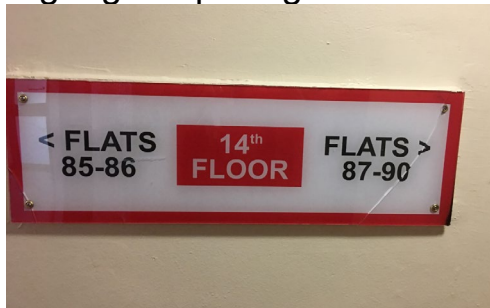
- 7) Signage depicting floor level is fitted to the landings and stairs.

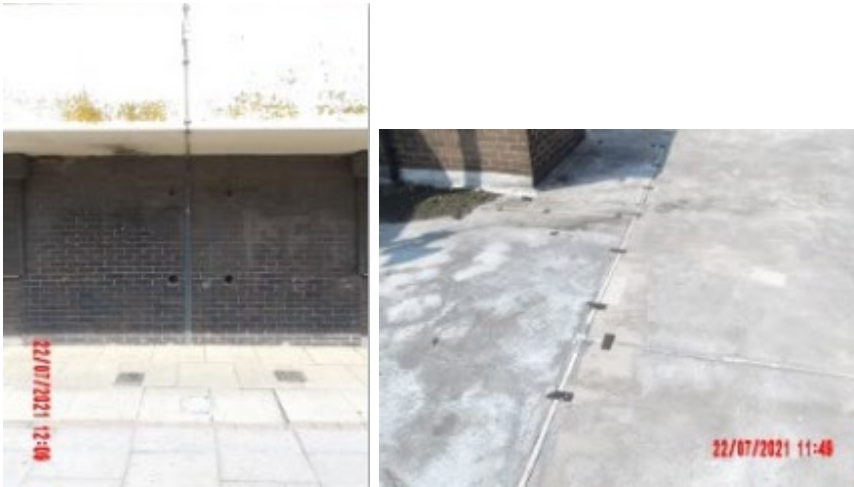
- 6) There is lightning protection installed to the block. Maintenance contracts are in place for lightning conductor testing in accordance with BS 6651.

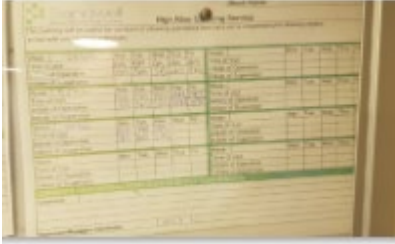
- 1) There is a daily Cleaning Service to the premises.

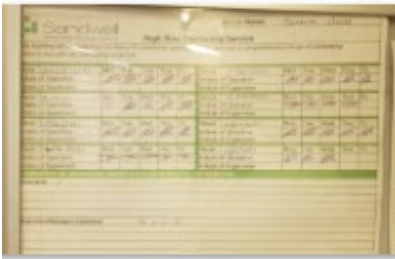
- 3) Regular checks by Caretakers / Cleaners minimises risk of waste accumulation.

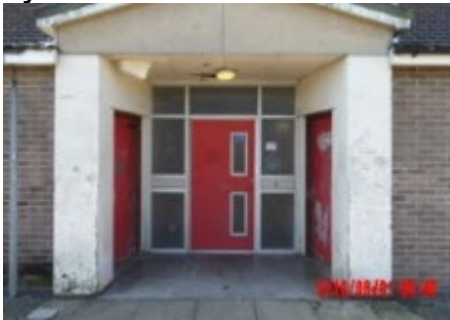
- 1) Regular checks are undertaken by Caretaking / Cleaning Team(s) 365 days per year which helps reduce the risk of arson.
- 2) Restricted access to the premises by means of a door entry system.

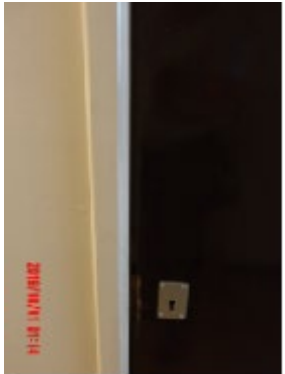
3	Fire Rapid Response August 2021 JM7100330	18/08/2021
07/09	Bin chute hoppers are missing seals on the following floors, G to 3 rd , 5 th , 6 th , 8 th to 11 th , 14 th , 16 th and 17 th . The chute hoppers are in a room protected by a nominal FD30 door and the bin room itself is protected by a water deluge system. It is therefore acceptable that this work can wait for the major refurbishment due shortly.	No picture	2	Future Programme	N/a
07/10	The service cupboard door on 17 th floor opposite flat 103 has an excessive gap on the lock edge. This cupboard is not a shaft and holds minimal wiring. This can therefore wait until the refurbishment.

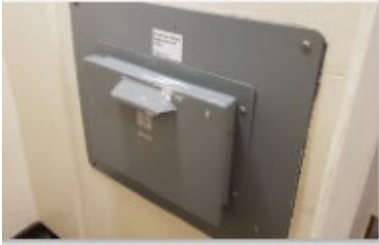
- 21) The stop tap covers are missing between flats 43 & 44 on 7th floor.
- 22) The fire door on 5th floor by flat 33 requires reglazing to provide a seal and secure the glass.
- 23) The bin chute hopper on the 4th floor is misaligned and not closing properly.

07/22	The fire door on 5 th floor by flat 33 requires reglazing to provide a seal and secure the glass.	No picture	3	Repairs (Glazing) August 2021 JM7330223	Completed 23/09/2021
07/23	The bin chute hopper on the 4 th floor is misaligned and not closing properly.

2	Repairs (Metal Fitters) August 2021 JM7201058	07/09/2021
07/24	The bin room fire door on 4 th floor requires adjustment to the door closer as it is too aggressive on closing.	No picture	2	Fire Rapid Response August 2021 JM7105226	19/08/2021
07/25	The fire door on 4 th floor by flat 27 is excessively warped. It may be possible to recut the rebate to accommodate the warped door as a temporary measure as the door will be replaced shortly as part of the planned major refurbishment works.
