Fire Risk Assessment

33-64 Horton St

Tipton, DY4 7JW

Date Completed: 06/10/2023

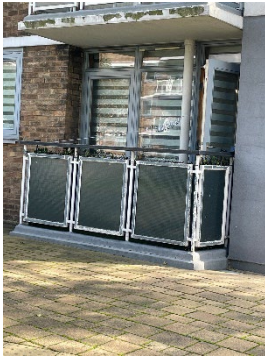
- a) Flat 33 decorative screening installed to balcony.**

The addition of combustible screening / netting to some balconies could potentially support the surface spread of flame in that area which is an unnecessary risk. Once this is removed the level of risk presented by materials present to the external envelope of this building would become acceptable.

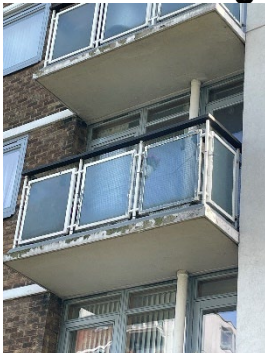
- b) Flat 41 netting / mesh installed to balcony.**

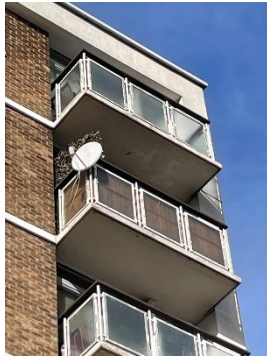
- c) Flat 59 trellis and screening installed to balcony.**
-

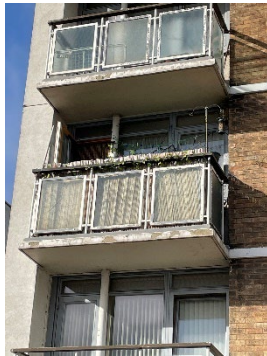
d) Flat 42 bamboo screening installed to balcony.

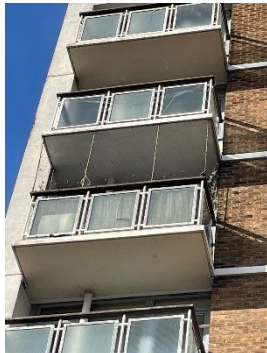
e) Flat 54 screening and netting installed to balcony.

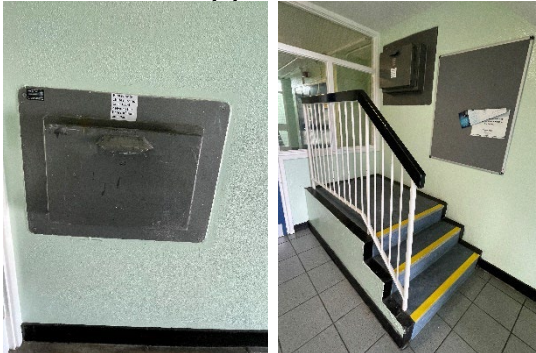
- 11) The waste disposal chutes are located on each landing to the front staircase. Hoppers are 1.5 hour fire rated to BS 476 part 8

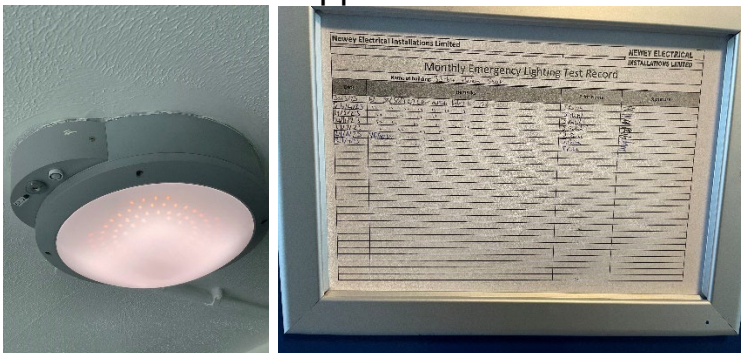
15) Emergency lighting is provided to communal lobbies and stairs. Checks are done on a monthly basis by Sandwell MBC in house electrical team or approved contractor.

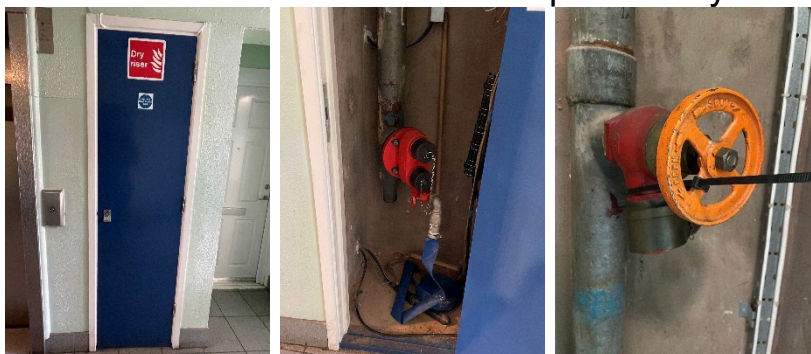
16) Dry riser inlet / outlets on lobbies are housed in cupboards with FD30s doors and secured by suited 54 key mortice locks. All outlet valves are secured in the closed position by cable tie.

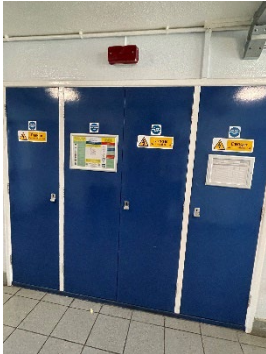
- 17) Service cupboards are 44mm nominal fire doors with intumescent strips and cold smoke seals, secured with type 138 suited mortice locks to allow residents access to their electricity meters.

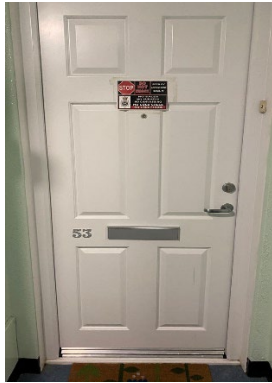
c) Flat 53 - Door is correct.

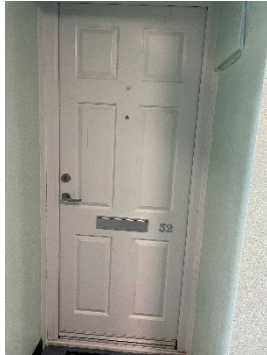
d) Flat 52 – Door is correct.

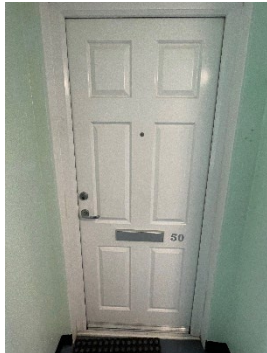
e) Flat 50 – Door is correct.

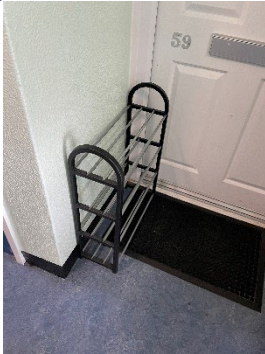
23) Plastic shoe rack outside flat 59.

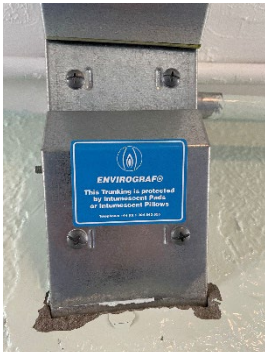
24) All trunking for power cables in communal areas are of metal construction and contain intumescent pads or pillows.

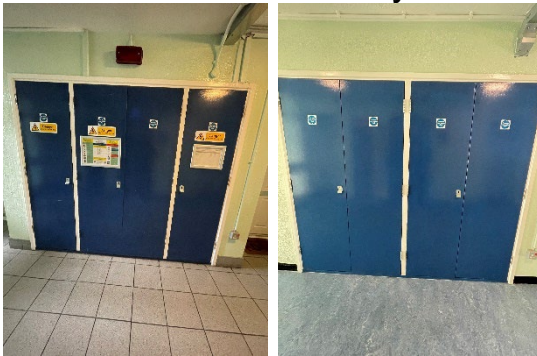
- 4) All communal fire doors are subject to a 12-week check by the Fire Safety Rapid Response Team.
- 5) All service cupboards to communal landings are locked with suited 138 mortice locks. Residents have been provided with a key for access to their electricity metres.

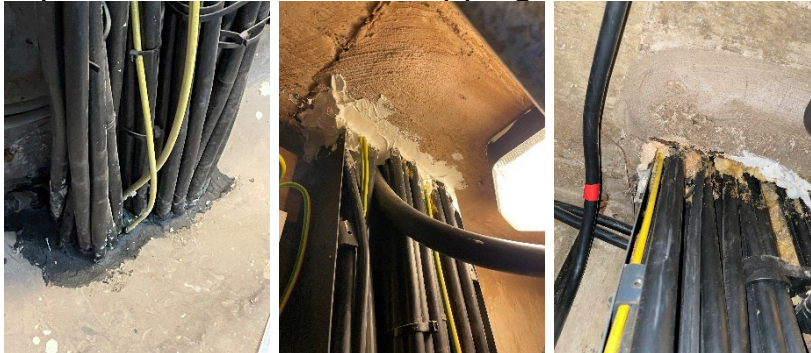
- 6) A variety of methods / materials have been used to achieve fire-stopping including Rockwool, fire rated sponge and intumescent pillows. Minor remnants of expanding foam were noted in service cupboards to 3rd and 6th floor however, enhancement was not required as suitable fire stopping was confirmed from above.

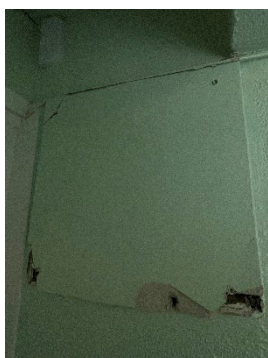
- 7) The fire stopping / compartmentation is subject to a 12-week check by the Fire Safety Rapid Response Team.
 - 8) Any remedial works arising from the fire stopping / compartmentation check(s) will be actioned immediately by the Fire Safety Rapid Response Team.
 - 9) **Stop tap panel to flat 64 / 7th floor is cracked and in a general state of disrepair. Replacement is required to maintain compartmentation.**
-

P2	Within 1-3 months. Electrical Compliance Manager	
10/9	Replace damaged stop tap panel to maintain compartmentation outside flat 64 / 7 th floor

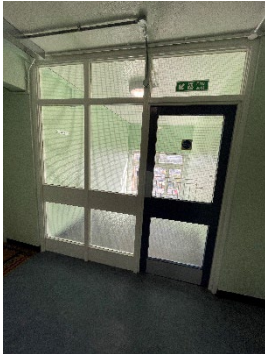
11) The communal landing & staircases are protected by use of notional self-closing 44mm 30-minute timber fire doors with vision panels & 25mm stops. It is recognised that these doors do not meet today's benchmark of a certified FD30s fire door install however, because they were installed at the time of the buildings construction and to the standard of that time they are deemed as acceptable so long as the doors are free of damage and function as they were intended to do so. It has been recognised that all of the landing / staircase notional doors in this block have been upgraded with combined intumescent strips & cold smoke seals to

enhance their original design and minimise departures from today's standards. Where minor shortcomings have been identified actions have been created for corrective works.

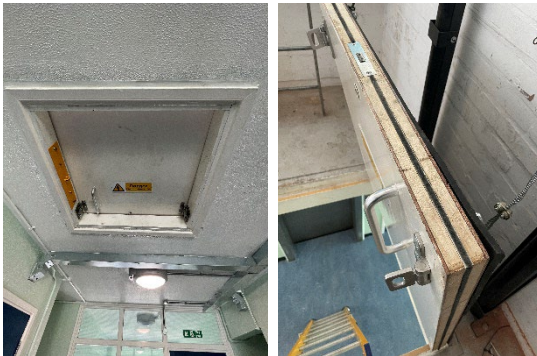
- 12) The hatch to the lift motor room is a 54mm 60 minute nominal fire door with combined intumescent strips & cold smoke seals.

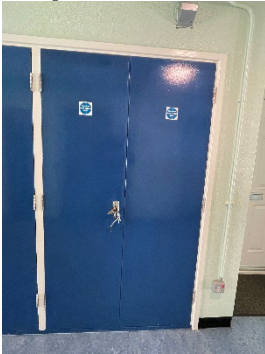
15) 7th floor – righthand service cupboard door not unlocking and requires attention.

<p>P2</p>	<p>Within 1-3 months. Fire Rapid Response JM:12064533</p>	<p>16/10/2023</p>
<p>10/15</p>	<p>7th floor R/H/S service cupboard – repair lock (cannot unlock)</p>

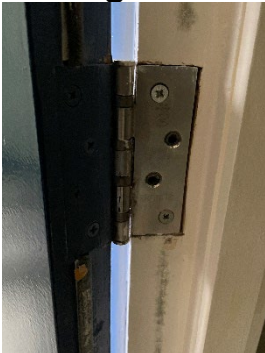
17) Ground floor left service cupboard door requires 2 x screws to hinge.

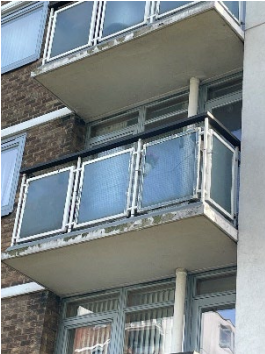
6/3b	Flat 41 remove netting / mesh from balcony.

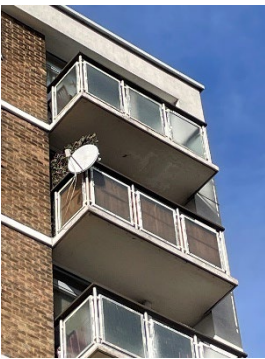
P2	Within 1-3 months. Housing Manager	
6/3c	Flat 59 remove combustible screening and trellis from balcony.

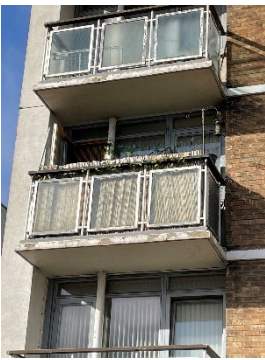
P2	Within 1-3 months. Housing Manager	
6/3d	Flat 42 remove combustible screening from balcony.

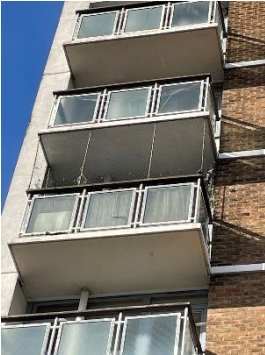
6/3e	Flat 54 remove combustible screening & netting from balcony.

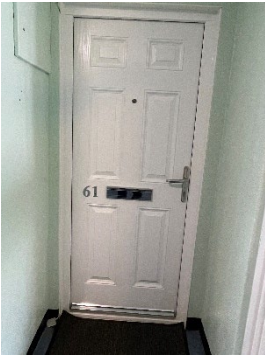
a) Flat 61 – Overhead self-closing device is missing.

P2	Within 1-3 months. Housing Manager	
7/21a	Flat 61 / 7 th floor – install overhead self closer to flat entrance door.

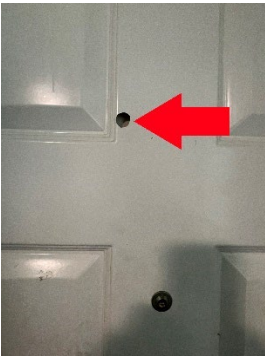
P2	Within 1-3 months. Fire Rapid Response JM:12065035	16/10/2023
7/21b	Flat 55 / 5 th floor adjust self closer to overcome latch & repair small hole in exterior finish to door leaf with suitable fire resistant product.

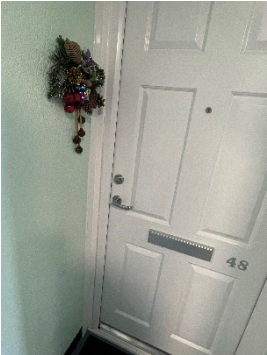
7/22	Flat 48 to remove combustible decoration from wall outside flat door.

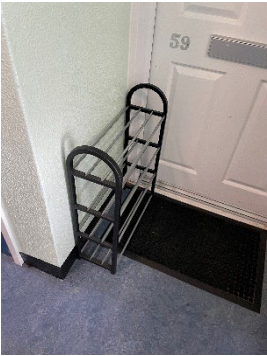
P2	Within 1-3 months. Housing Manager	
7/23	Flat 59 to remove combustible shoe rack from outside flat entrance door

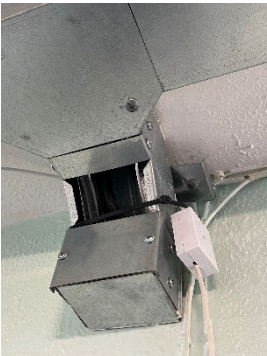
P2	Within 1-3 months. Housing Manager	
7/24a	Reinstate missing section to trunking. Outside flat 44 / 2 nd floor (piece is there behind trunking)

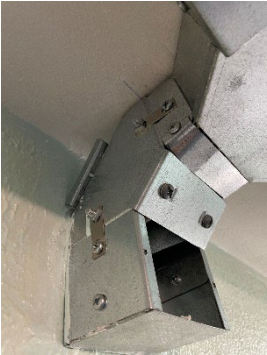
7/24b	Reinstate missing section to trunking. Outside flat 39 / 1 st floor (piece is there behind trunking)

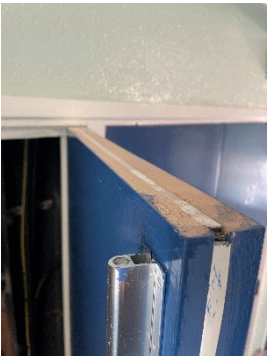
P2	Within 1-3 months. Fire Rapid Response JM:12064435	16/10/2023
10/13	All floors - Install cold smoke seals to heads of all service cupboard slave doors were missing.

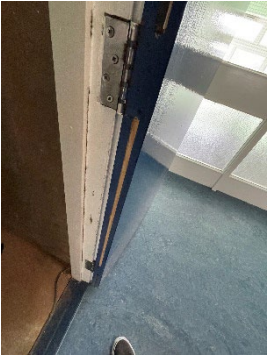
- 14) 7th floor riser cupboard door has sections of combined intumescent strip missing from hinge side.

<p>10/14</p>	<p>7th floor riser cupboard install combined intumescent / cold smoke seals to hinge side</p>

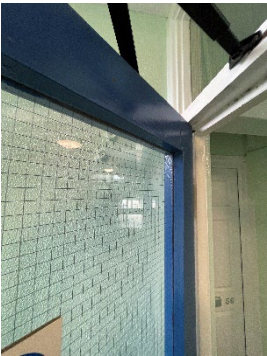
<p>P2</p>	<p>Within 1-3 months. Fire Rapid Response JM:12064574</p>	<p>16/10/2023</p>
<p>10/16</p>	<p>5th floor landing door by flat 56 – secure loose glazing to upper panel.</p>

<p>P2</p>	<p>Within 1-3 months. Glazing Repairs JM12068886</p>	<p>Passed to Glazing 16/10/2023 Planned for 03/11/2023</p>
