Fire Risk Assessment

33-64 Horton St

Tipton, DY4 7JW

Date Completed: 17/09/2024

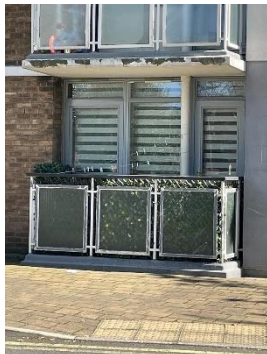
- a) Flat 33 decorative screening / trellis installed to balcony.**

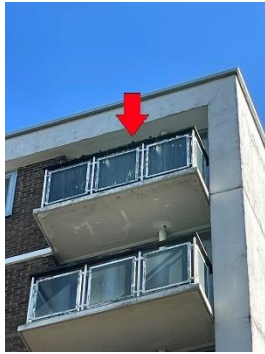
- b) Flat 61 screening installed to balcony.**
-

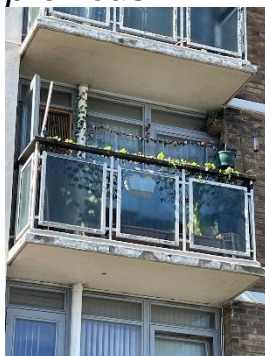
- e) **Flat 42 decorative trellis installed to balcony. *Bamboo screening was removed from this balcony following the previous FRA 2023.***

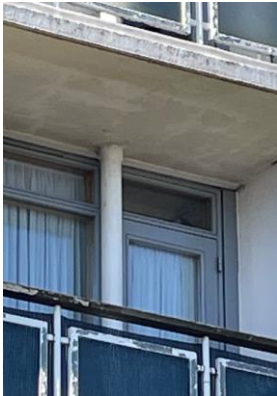
- 6) Rainwater downpipes penetrate each balcony floor slab. The type of downpipe is unknown however taking into account the open balconies, they are maintained free of combustibles, the risk is deemed minimal.

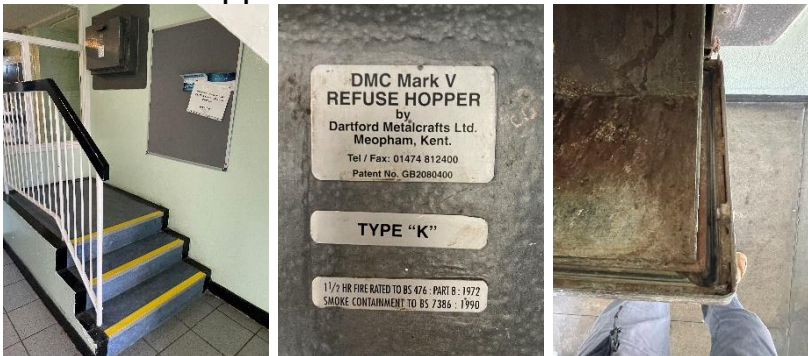
- 11) The waste disposal chutes are located on each landing to the front staircase. Hoppers are 1.½ hour fire rated to BS 476 part 8

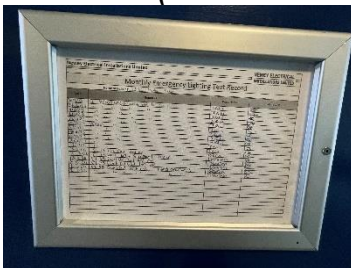
- 3) All installed equipment is checked and tested on a monthly basis by Sandwell MBC in house electrical team or approved contractor, in accordance with current standards. It was noted that the monthly test for August 2024 was outstanding. This is due to there being a change of contractor and therefore will be promptly rectified. *(email sent to electrical manager).*

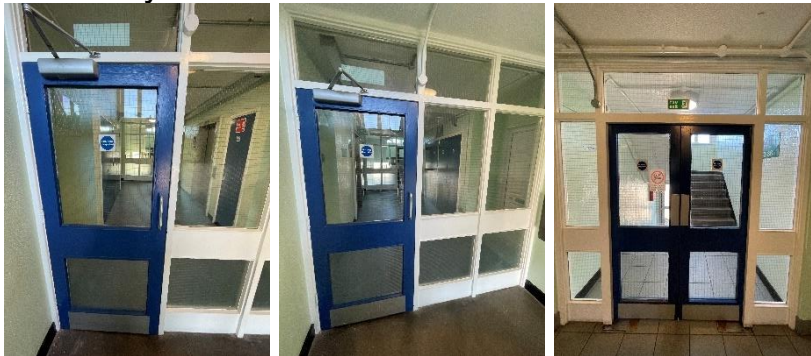
- 10) The communal landing & staircases are protected by use of notional self-closing 44mm 30-minute timber fire doors with vision panels, 25mm stops & screens. It is recognised that these doors do not meet today's benchmark of a certified FD30s fire door install however, because they were installed at the time of the buildings construction and to the standard of that time they are deemed as acceptable so long as the doors are free of damage and function as they were intended to do so. It has been recognised that all of the landing / staircase notional doors in this block have been upgraded with combined intumescent strips & cold smoke seals to enhance their original design and minimise departures from today's standards (upgraded notional fire door). Where minor shortcomings have been identified actions have previously been created for corrective works.

Some notional communal landing doors show signs of wear and tear due to age. Consideration should be given to upgrade with certified FD30s door sets & combination frames as part of a future programme.

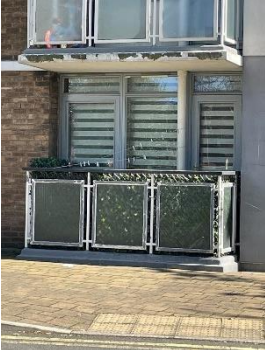
Question/ Ref No	Required Action	Supporting photograph	Priority	Timescale and Person Responsible	Date Completed
6/3a	Flat 33 – remove decorative screening / trellis from balcony. <i>Previously requested to remove in 2023.</i>

P2	Within 1-3 months. Housing Manager

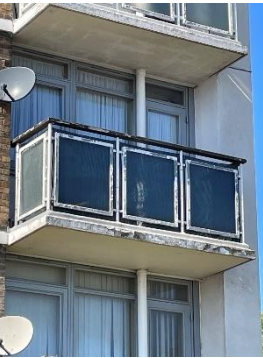
6/3b	Flat 61 – remove screening installed to balcony.	 	P2	Within 1-3 months. Housing Manager	
6/3c	Flat 43 – confirm screening installed to balcony is removed. <i>Tenant confirmed intention to remove to the assessor during the survey.</i>

P2	Within 1-3 months. Housing Manager	
6/3d	Flat 59 – remove trellis installed to balcony. <i>Previously requested to remove 2023</i>

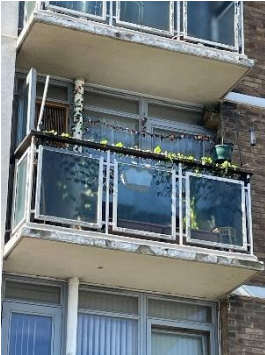
6/3e	Flat 42 – remove decorative trellis from balcony. <i>Bamboo screening was removed following the FRA 2023</i>

P2	Within 1-3 months. Housing Manager	
6/3f	Flat 54 – Remove anti-bird netting from balcony. <i>Previously requested to remove in 2023.</i>

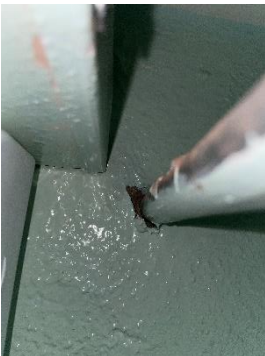
- 12) Fire stop small hole around penetration above flat 51 entrance door (4th floor).

P2	Within 1-3 months. Housing Manager	
10/12	4 th floor - flat 51 – fire stop small hole above entrance door.

P2	Within 1-3 months Rapid Response Fire

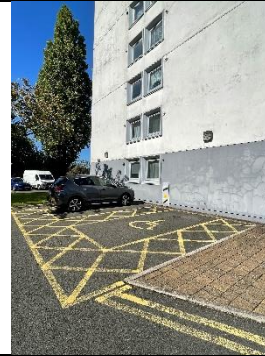
It has also been noted that there are two designated disability car parking spaces to the south facing side elevation. Vehicles are a potential ignition source however, there are no electric vehicle charging points so the risk to the building is currently deemed low. This information has been recorded within section 19 / observations with a recommendation to consider relocating the carparking spaces under future refurbishment projects.

Consider relocating the two disability car parking spaces away from the building and install bollards to prevent vehicles from parking within close proximity.
