Fire Risk Assessment

97-128 Farley Street

Tipton, DY4 7LA

Date Completed: 25/09/2023

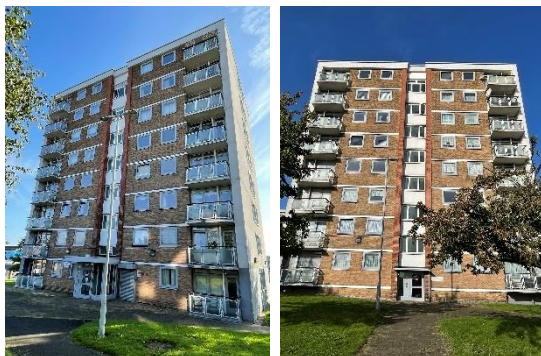
- 1) The front and rear elevations are traditional masonry.

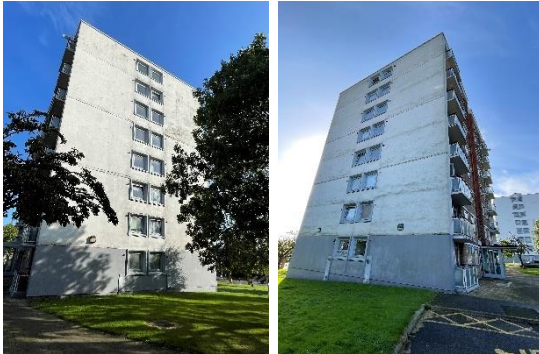
- 2) The side elevations were clad with a Wetherby mineral wool, silicon render system, fire classification A2 during a 2009 refurbishment.

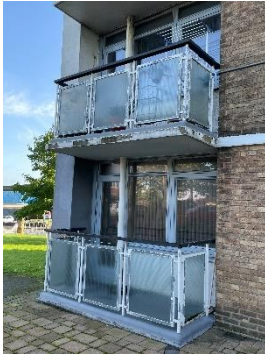
- 3) Each flat within the block has access to an individual balcony. These are cantilevered concrete with a steel and glass balustrade.

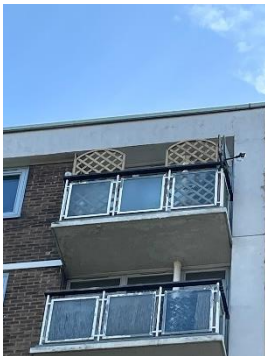
- 4) **Timber trellis** has been installed to the balcony of flat 125

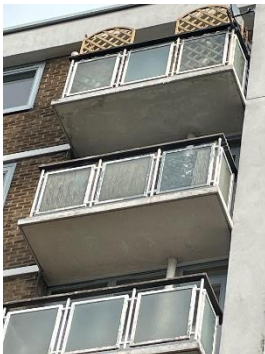
- 5) **Bamboo screening** installed to the balcony of flat 121

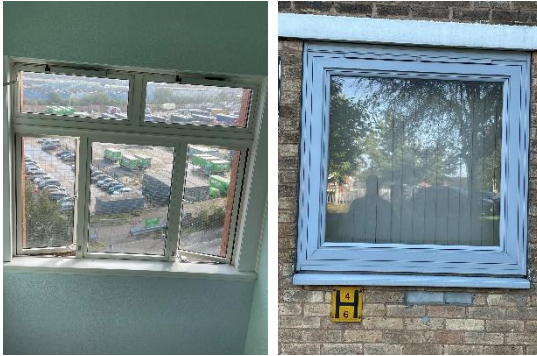
- 6) Communal windows are single glazed units housed in powder coated aluminium frames. Flat windows are double glazed units housed in timber frames with an external powder coated aluminium face.

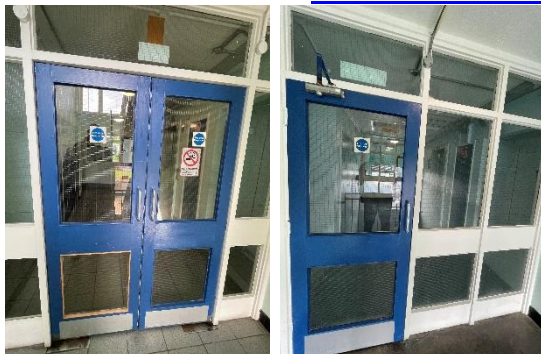
- 5) The communal landing / staircases are protected by use of notional self-closing 44mm 30-minute timber fire doors with vision panels. All doors have been upgraded with intumescent strips / cold smoke seals. [Refer to section 10/10](#)

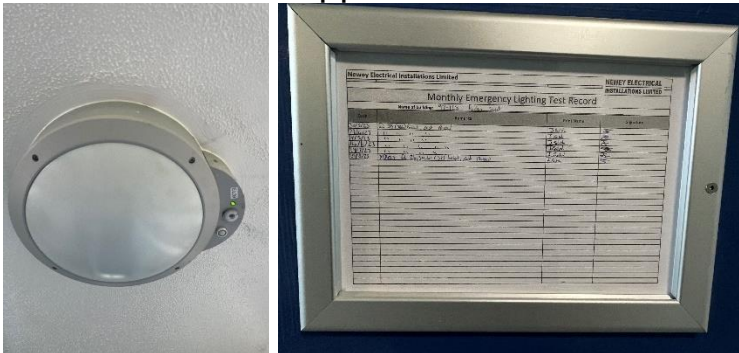
- 15) Emergency lighting is provided to communal lobbies and stairs. Checks are done on a monthly basis by Sandwell MBC in house electrical team or approved contractor.

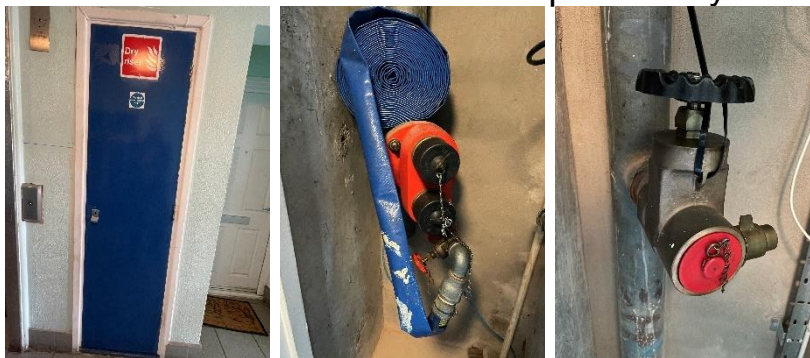
- 16) Dry riser inlet / outlets on lobbies are housed in cupboards with FD30s doors and secured by suited 54 key mortice locks. All outlet valves are secured in the closed position by cable tie.

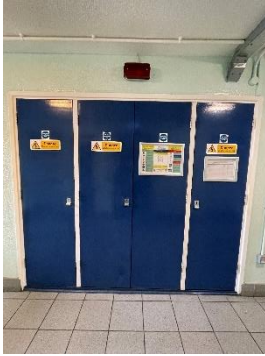
- 17) Service cupboards are 44mm nominal fire doors with intumescent strips and cold smoke seals, secured with type 138 suited mortice locks to allow residents access to their electricity meters.
-

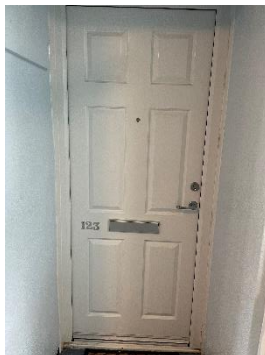
- a) Flat 123 – Door was noted as correct.

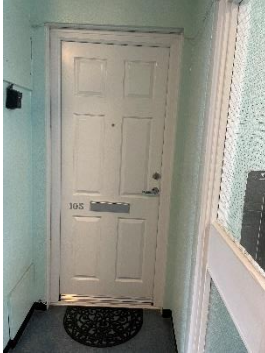
- d) Flat 105 – Door was noted as correct.**

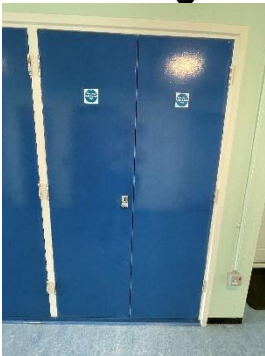
- 16) 4th floor righthand service cupboard unable to unlock.

10/15	5 th floor Install cold smoke seals to riser cupboard.	No image	P2	Within 1-3 months Rapid Fire Team JM:12023577	10/10/2023
10/16	4 th floor right hand service cupboard – unable to open / repair lock

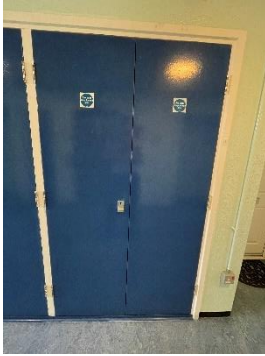
- 17) 2nd floor righthand side service cupboard unable to unlock.

P2	Within 1-3 months Rapid Fire Team JM:12023591	10/10/2023
10/17	2 nd floor right hand service cupboard – unable to open /repair lock

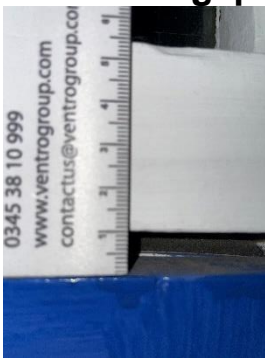
- 18) 1st floor by flat 104 - communal door to stairs has an excessive gap to head of 8mm - 10mm.**

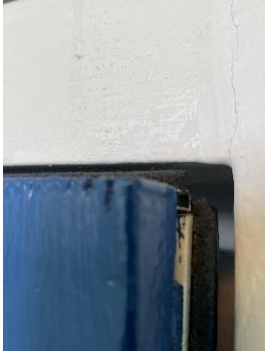
- 19) 1st floor by flat 102 – communal doors to stairs has excessive gap of 8-9mm on handle side. Cold smoke seal not meeting opposite edge.**

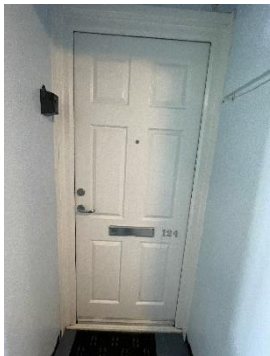
- b) Flat 124 – Overhead self-closing device missing from door.**

<p>P2</p>	<p>Within 1-3 months Housing Manager</p>	
<p>7/21b</p>	<p>Flat 124 – install overhead self-closing device to flat entrance door.</p>

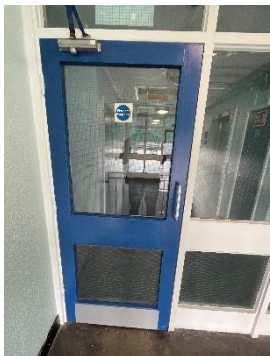
- 11) 7th floor by flat 126 - communal door to stairs excessive gap of approximately 8mm from handle side down. Gap to head is over 4mm and smoke seals not in contact with opposite edge door leaf is warped towards head. Upper glazing slight rattle**

<p>P2</p>	<p>Within 1-3 months Rapid Fire Team JM:12023438 JM:12034613</p>	<p>Carded 10/10/2023 12/10/2023</p>
<p>10/11</p>	<p>7th floor by flat 126 – Landing door warped towards head, requires replacement FD30s.</p>

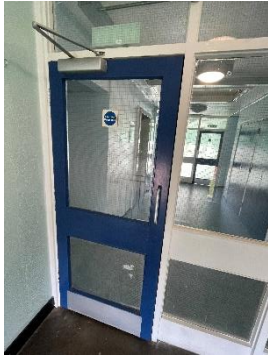
- 12) 7th floor by flat 128 – communal door to stairs excessive gaps and warped towards bottom edge.**

10/12	7 th floor by flat 128 – landing door warped and requires replacement FD30s.

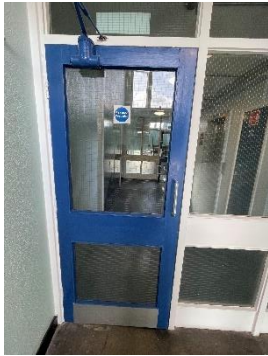
- 13) 6th floor by flat 122 – communal door to stairs gaps of approximately 6mm on handle side / cold smoke seal not in contact with opposite edge.

P4	Exceeding 6 months Repairs Emailed Ian Sorrell	
10/13	6 th floor by flat 122 – landing door - install bigger cold smoke seal to handle side of door leaf.

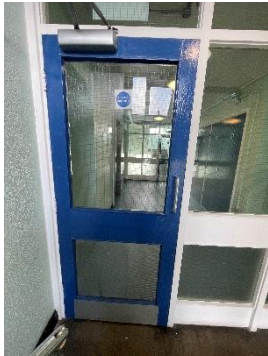
- 14) 5th floor by flat 120 – glazing loose within communal door.

P2	Within 1-3 months Rapid Fire Team JM:12033835	11/10/2023
10/14	5 th floor by flat 120 – secure loose glazing within door communal door.

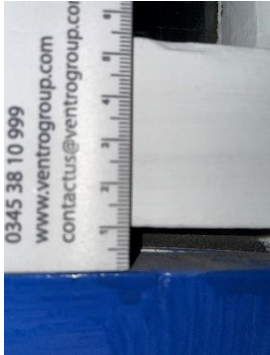
<p>10/18</p>	<p>1st floor by flat 104 - Communal landing door, reduce gap / install 10mm cold smoke seal to head.</p>

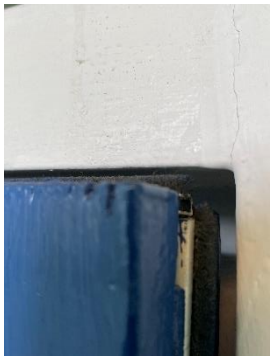
<p>P2</p>	<p>Within 1-3 months Rapid Fire Team JM:12023666</p>	<p>10/10/2023</p>
<p>10/19</p>	<p>1st floor by flat 102 – Communal landing door reduce gap / install 10mm cold smoke seal handle side</p>

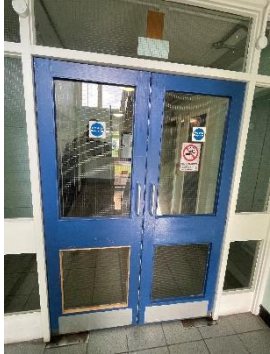
10/21	Ground floor double doors install 10mm cold smoke seal to head of both doors.

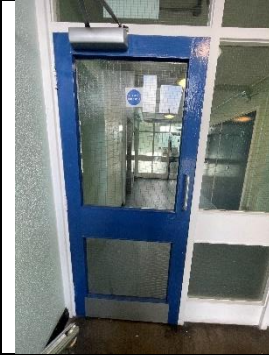
Some notional communal landing doors show signs of wear and tear due to age. Consideration should be given to upgrade with certified FD30s door sets with combination frames.
