Fire Risk Assessment

65-96 Horton St

Tipton, DY4 7JW

Date Completed: 26/09/2023

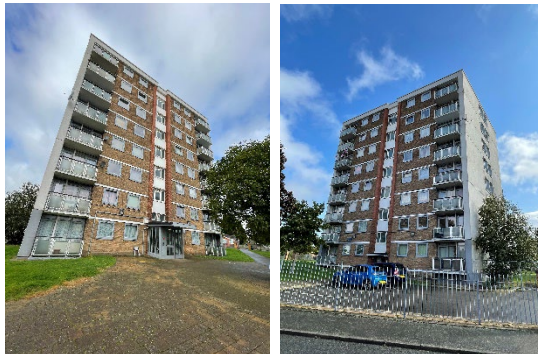
- 1) The front and rear elevations are traditional masonry.

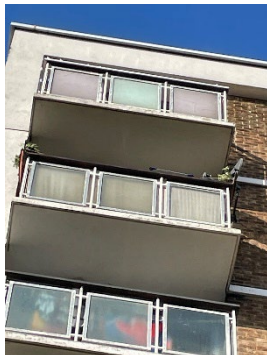
- b) **Flat 92 screening installed to balcony.**

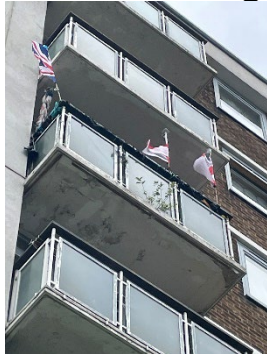
e) Flat 86 3 x flags installed to balcony.

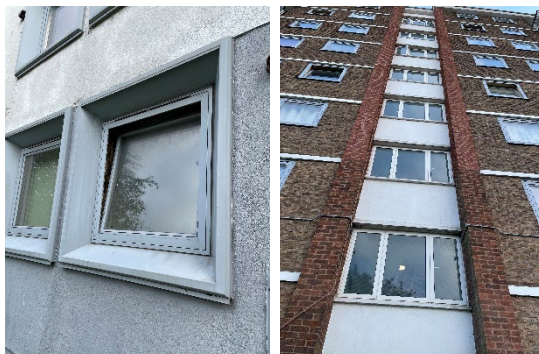
4) Communal windows are single glazed units housed in powder coated aluminium frames. Flat windows are double glazed units housed in timber frames with an external powder coated aluminium face.

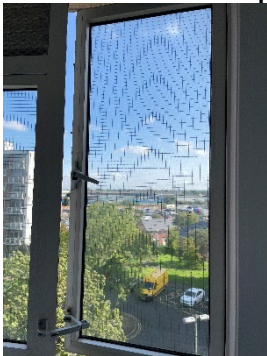
- 12) Communal windows are lockable however, all windows were unlocked and openable.

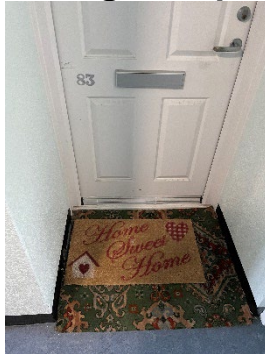
- b) Flat 83 – There is an off cut of carpet beneath the door mat which could potentially lead to slips trips or falls during escape.

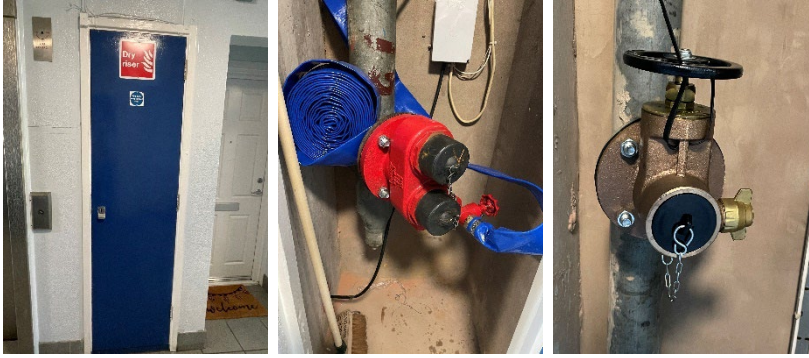
- 16) Dry riser inlet / outlets on lobbies are housed in cupboards with FD30s doors and secured by suited 54 key mortice locks. All outlet valves are secured in the closed position by cable tie.
-

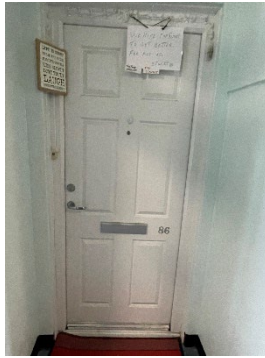
- e) Flat 86 remove signage and battery powered lights from door leaf.
-

P2	Within 1-3 months Rapid Fire Team JM:12022072	11/10/2023
7/21e	Flat 86 – remove all notices and lighting from entrance door.

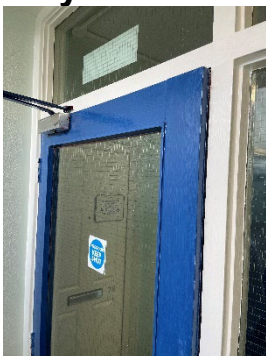
- 17) 3rd floor by flat 78 - communal door to stairs not self-closing fully into frame and requires adjustment.

10/16	4 th floor by flat 82 – secure lower glazing to combination frame / beading damaged & not secure	 	P2	Within 1-3 months Glazing Repairs JM:12035483	30/10/2023
10/17	3 rd floor by 78 - landing door Adjust self-closer.	 	P2	Within 1-3 months Rapid Fire Team JM:12023231	10/10/2023
10/18	2 nd floor by 76 - landing door Adjust self-closer.	 	P2	Within 1-3 months Rapid Fire Team JM:12023255	10/10/2023

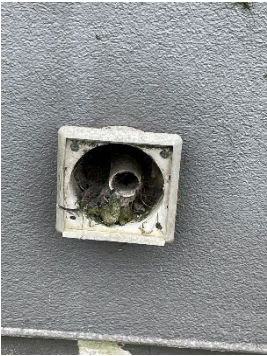
- 2) The side elevations were clad with a Wetherby mineral wool, silicon render system, fire classification A2 during a 2009 refurbishment. It was noted that a section of the render to the south facing side elevation of approximately 4m² has come away exposing the mineral wool insulation. Temporary fencing is in place whilst corrective works are arranged.

P2	Within 1-3 months. Housing Manager	
6/5	Seal penetration to side wall with suitable intumescent grill. (Flat 66 / side elevation)

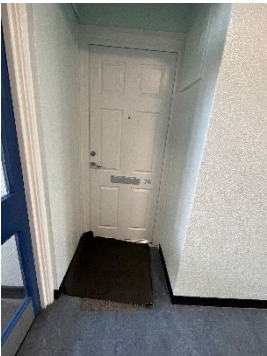
- a) Flat 76 – door mat is too large for the area and therefore folded in half creating a trip hazard.

P2	Within 1-3 months. Repairs	
7/14a	Flat 76 – remove large door matted (folded)

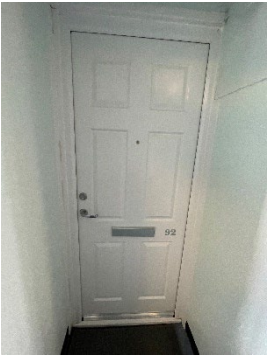
a) Flat 92 – Self closer is missing.

P2	Within 1-3 months Housing Manager	
7/21a	Flat 92 / 6th – install self-closer to entrance door

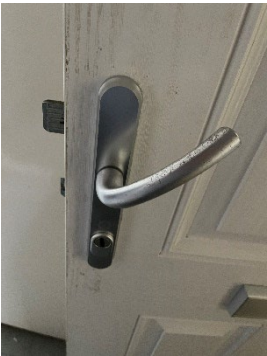
- b) Flat 88 – Handle doesn't reliably return to horizontal from the up position this results in the locking system remaining out which prevents the door from fully self-closing.

P2	Within 1-3 months Rapid Fire Team JM:12021953	10/10/2023
7/21b	Flat 88 / 5th– Service door handle to prevent sticking in the upright position

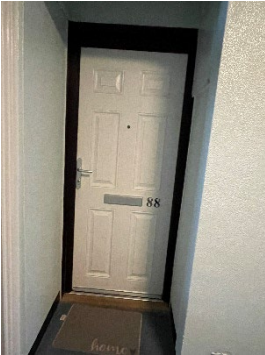
- c) Flat 85 – Door fails to reliably self-close / adjustment required. Seal is also loose and requires re-fixing. photo
- d) Flat 78 – Door is correct.

7/21c	Flat 85 / 5th – entrance door adjust self-closer so door overcomes latch. Re-fix seal.

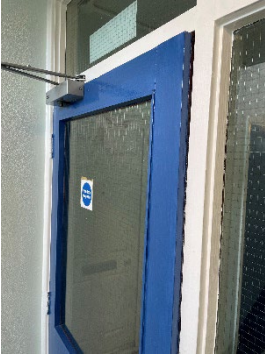
P2	Within 1-3 months Housing Manager	
10/12	5 th floor Communal landing door by 86 – Adjust self-closer.

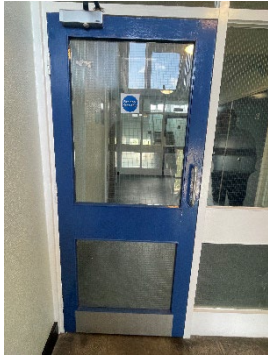
- 13) 5th floor by flat 88 – communal door to stairs glazing loose / rattles because beading is not secure to.

10/13	5 th floor Communal landing door by flat 88 – secure loose glazing to upper panel

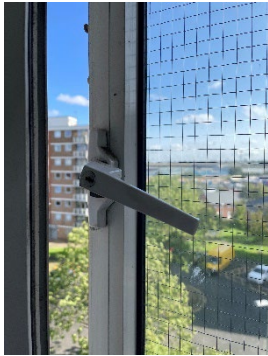
- 14) 5th floor – handle loose to window in front staircase.

P2	Within 1-3 months Glazing Repairs JM12035432	30/10/2023
10/14	5 th floor front staircase – re-secure handle to communal window / RHS

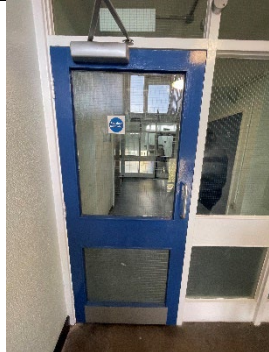
Observations	
Some notional communal landing doors show signs of wear and tear due to age. Consideration should be given to upgrade with certified FD30s door sets & combination frames.
