Fire Risk Assessment

65-96 Horton St

Tipton, DY4 7JW

Date Completed: 19/09/2024

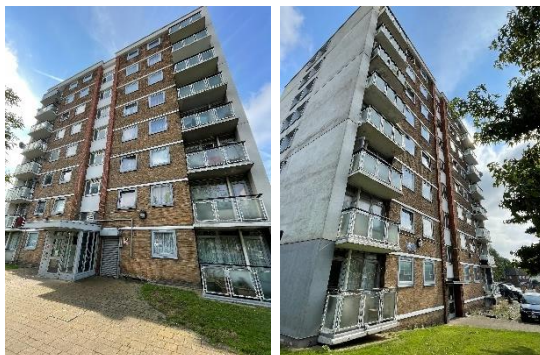
- 1) The front and rear elevations are traditional masonry.

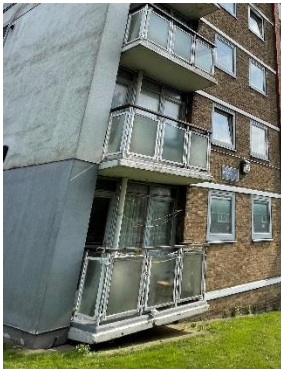
- 3) Each flat within the block has access to an individual balcony. These are cantilevered concrete with a steel and glass balustrade.

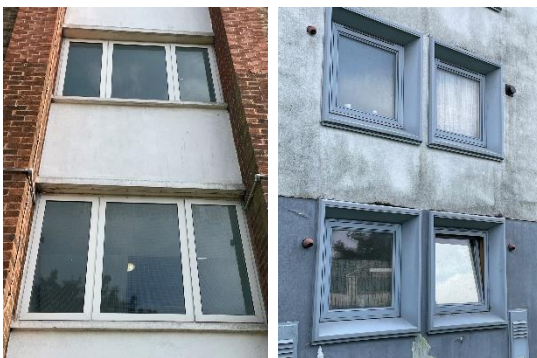
- 4) Communal windows are single glazed units housed in powder coated aluminium frames. Flat windows are double glazed units housed in timber frames with an external powder coated aluminium face.

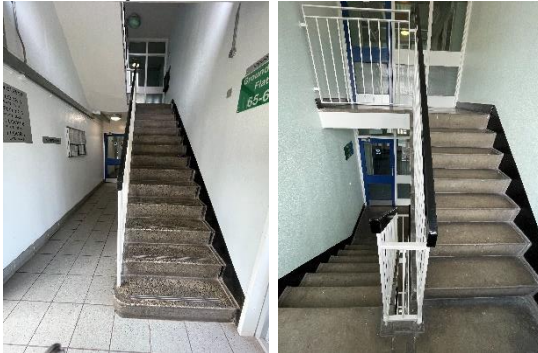
- 1) The site has 2 protected staircases that provide a sufficient means of escape. Each staircase in width is 986mm from hand rail to wall.

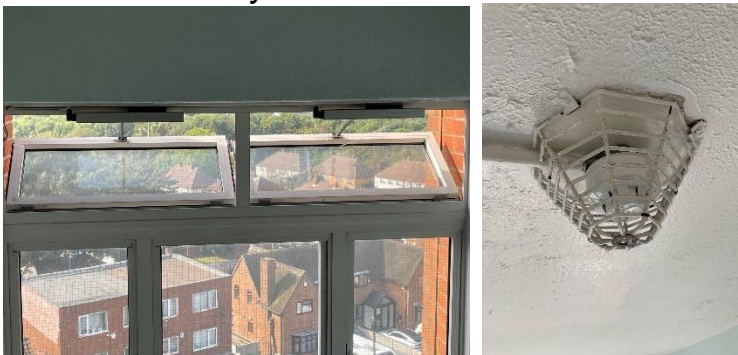
- 9) Automatic smoke ventilation is employed to the head of the rear staircase. This is tested, inspected and maintained by a competent procured contractor in accordance with BS7346. The frequency for the maintenance checks are twice per year (April and October) of each calendar year.

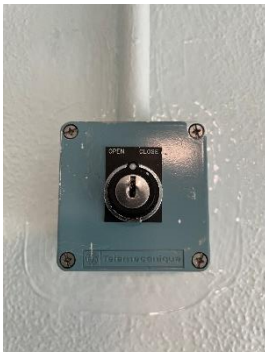
- 10) There is a master reset switch located on the 7th floor rear staircase landing. The switch is operated by a key which can be found in the firefighter's white box.

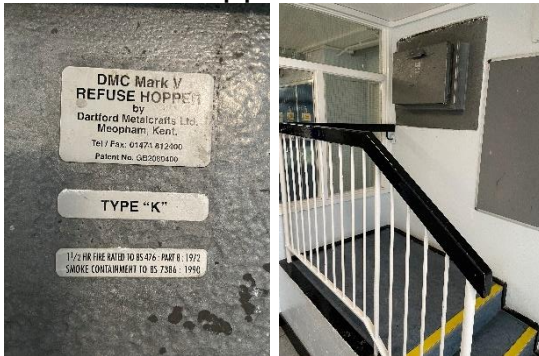
- 11) The waste disposal chutes are located on each landing to the front staircase. Hoppers are 1.5 hour fire rated to BS 476 part 8.

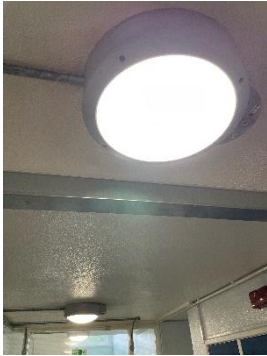
- 16) Emergency lighting is provided to communal lobbies and stairs. Checks are done on a monthly basis by Sandwell MBC in house electrical team or approved contractor.

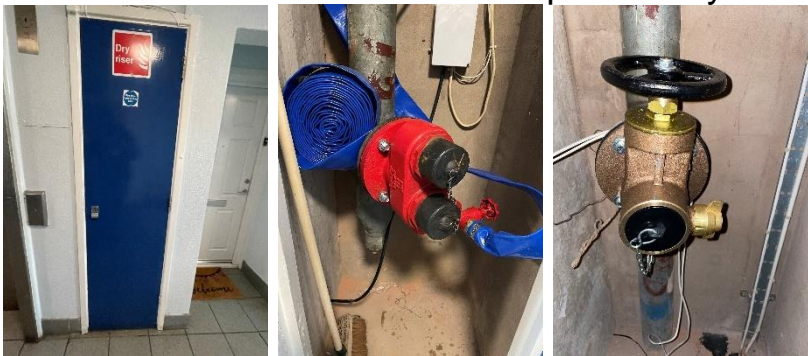
- 17) Dry riser inlet / outlets on lobbies are housed in cupboards with FD30s doors and secured by suited 54 key mortice locks. All outlet valves are secured in the closed position by cable tie.

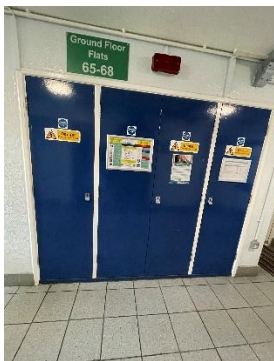
- 18) Service cupboards are 44mm nominal fire doors with intumescent strips and cold smoke seals, secured with type 138 suited mortice locks to allow residents access to their electricity meters.

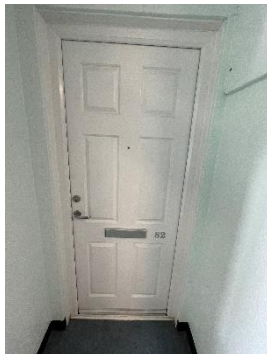
- b) Flat 82 – Door is correct.

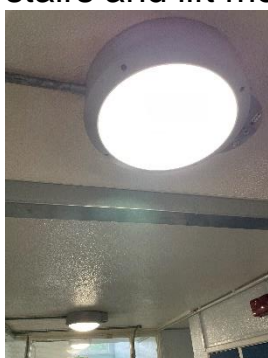
- 1) The premises has a sufficient emergency / escape lighting system in accordance with BS 5266 and has test points strategically located.
- 2) The self-contained units are provided to the communal landings, stairs and lift motor room.

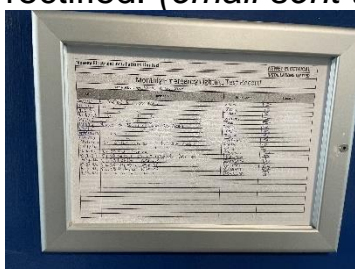
- 3) All installed equipment is checked and tested on a monthly basis by Sandwell MBC in house electrical team or approved contractor, in accordance with current standards. It was noted that the monthly test for August 2024 was outstanding. This is due to there being a change of contractor and therefore will be promptly rectified. *(email sent to electrical manager).*

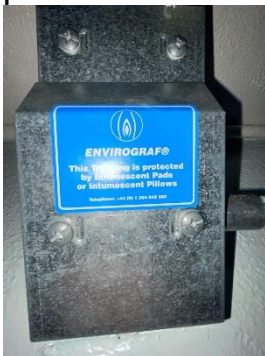
- 10) Access panels to stop taps are fixed to masonry and bedded on Intumescent material. **Stop tap cover adjacent flat 90 is damaged and requires replacement.**

P2	Within 1-3 months. Fire rapid response	
10/10	Replace damaged stop tap cover adjacent flat 90 with suitable 1hr fire resistant product.
