Fire Risk Assessment

**1 – 32, Horton Street
Tipton,
DY4 7JN**

Date Completed: 17/09/2024.

Current Risk Rating = Tolerable

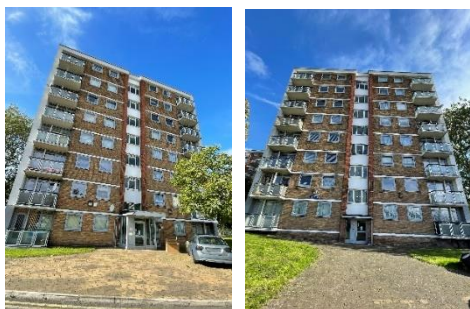
- 1) The front and rear elevations are traditional masonry.

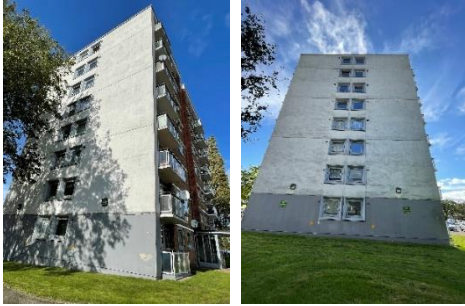
- 2) The side elevations were clad with a Wetherby mineral wool, silicon render system, fire classification A2 during a 2009 refurbishment.

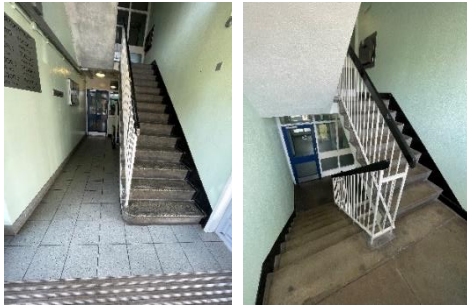
- 1) The site has 2 protected staircases that provide a sufficient means of escape. Each staircase in width is 986mm from handrail to wall.

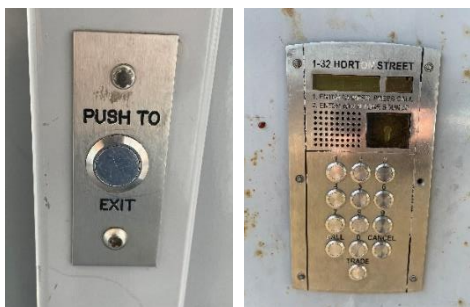
- 7) All communal fire doors are subject to a 12-week check by the Fire Safety Rapid Response Team.
- 8) The final exit doors have door entry systems installed. These systems are designed to fail safe i.e. door unlocked in the event of a power failure. This prevents residents being locked in or out of the building.

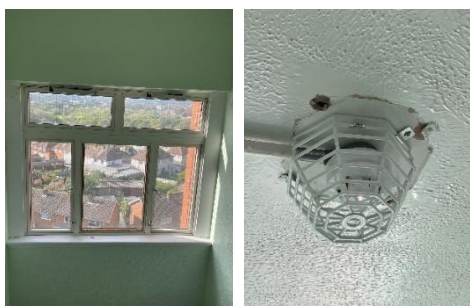
- 9) Automatic smoke ventilation is employed to the head of the rear staircase. This is tested, inspected and maintained by a competent procured contractor in accordance with BS7346. The frequency for the maintenance checks are twice per year (April and October) of each calendar year.

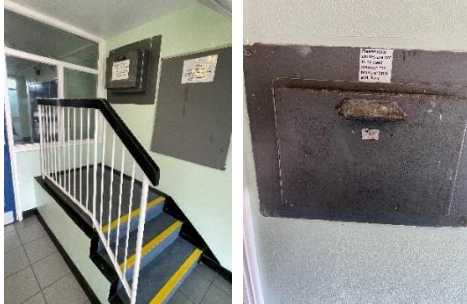
- 11) The waste disposal chutes are located on each landing to the front staircase. Hoppers are 1.5 hour fire rated to BS 476 part 8.

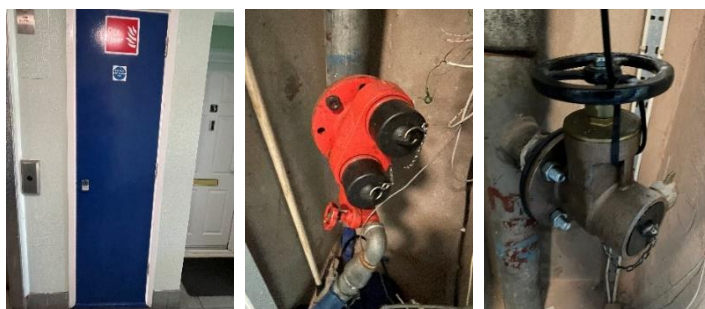
- 16) Dry riser inlet / outlets on lobbies are housed in cupboards with FD30s doors and secured by suited 54 key mortice locks. All outlet valves are secured in the closed position by cable tie.

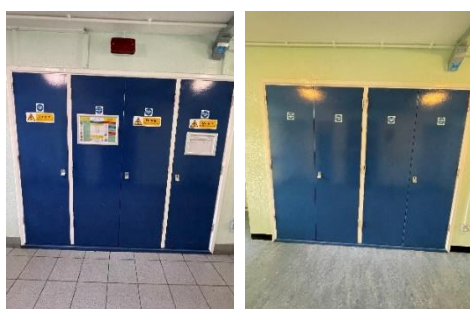
- 17) Service cupboards are 44mm nominal fire doors with intumescent strips and cold smoke seals, secured with type 138 suited mortice locks to allow residents access to their electricity meters.

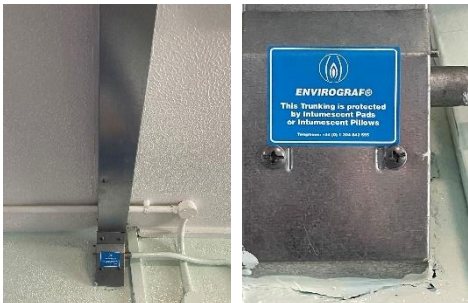
22) Most trunking for power cables in communal areas is of metal construction and contain intumescent pads or pillows.

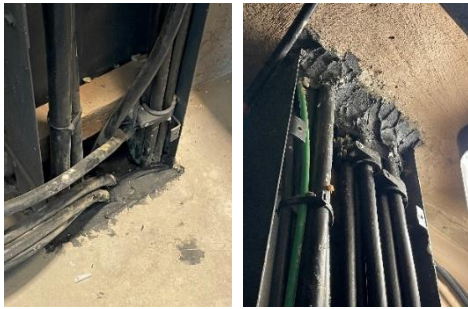
- 6) A variety of methods / materials have been used to achieve fire-stopping including Rockwool, fire rated sponge and intumescent pillows.

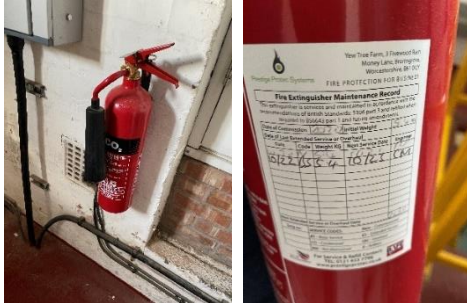
- 6) Portable fire extinguisher (CO2) is provided to the lift motor room. Maintenance contracts in place for maintenance of the extinguisher. The frequency for the maintenance checks are once (October) of each calendar year.

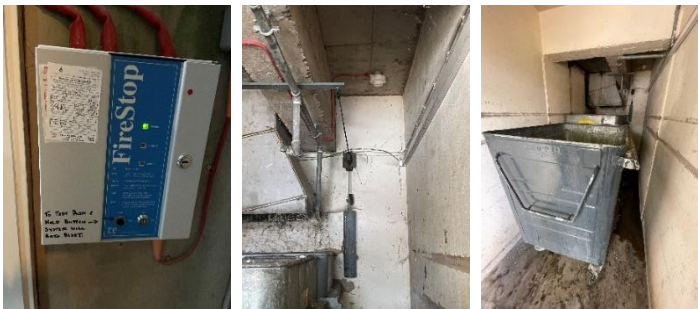
- 7) Bin room is protected by Deluge/sprinkler system and serviced 6-monthly. The control panel is in the ground floor lift lobby service cupboard.

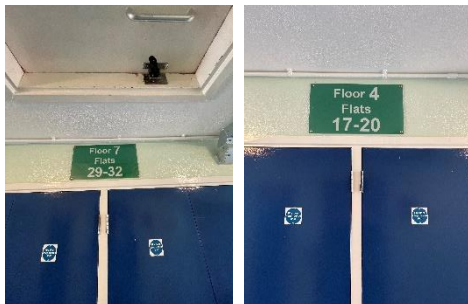
- 7) Generally, directional escape signage has been installed correctly through most parts of the building. However, on the ground floor the exit signage was non-compliant.

| 12/17 | Replace non-compliant exit signage on the ground floor. Replace with | | P3 | Within 3 - 6 months. Fire Rapid Response | |

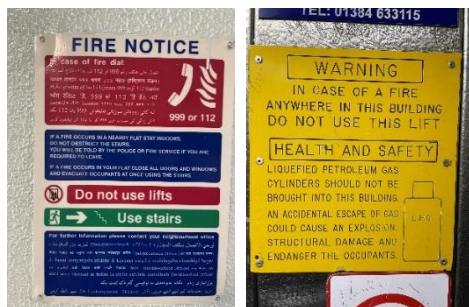
- 7) Fire safety information has been provided as part of tenancy pack. Information regarding the Stay Put Unless fire evacuation strategy is provided to tenants.
