Fire Risk Assessment

1-32 Horton St

Tipton, DY4 7JN

Date Completed: 06/10/2023

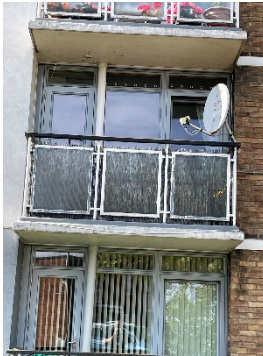
The addition of combustible screening / netting to some balconies could potentially support the surface spread of flame in that area which is an unnecessary risk. Once this is removed the level of risk presented by materials present to the external envelope of this building would become acceptable.

- a) Flat 8 decorative screening installed to balcony.**

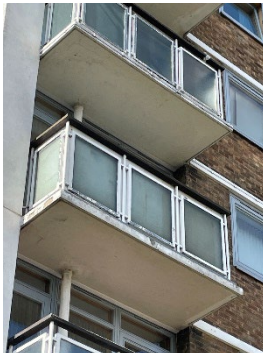
- b) Flat 16 screening installed to balcony.**

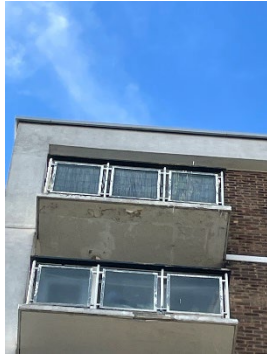
d) Flat 32 screening installed to balcony.

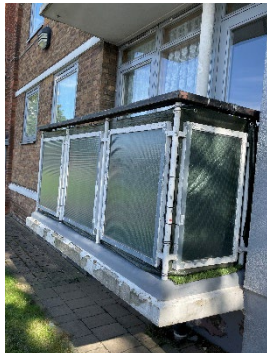
e) Flat 3 screening and netting installed to balcony.

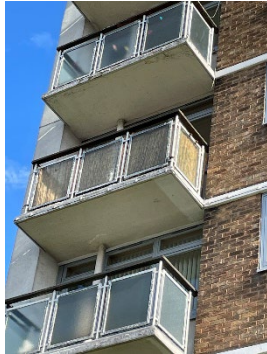
h) Flat 18 screening installed to balcony.

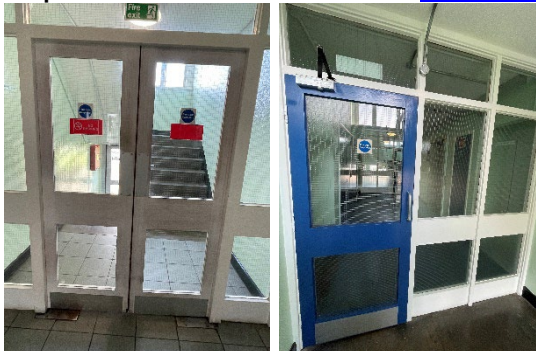
- 2) All corridors are of adequate width (at least 1050mm) and will be maintained clear to that width as a minimum.
- 3) None of the corridors that form part of the means of escape are dead ends
- 4) The means of escape are protected to prevent the spread of fire and smoke.
- 5) The communal landing / staircases are protected by use of notional & nominal self-closing 44mm 30-minute timber fire doors with vision panels. All doors have been upgraded with intumescent strips / cold smoke seals. [Refer to section 10/11](#)

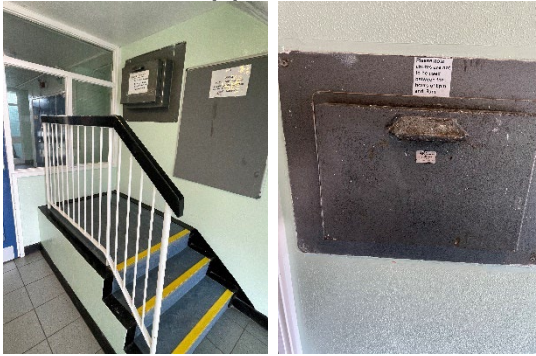
11) The waste disposal chutes are located on each landing to the front staircase. Hoppers are 1.5 hour fire rated to BS 476 part 8

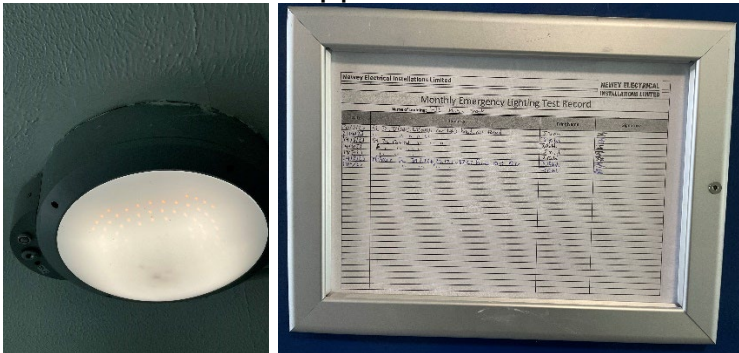
- 15) Emergency lighting is provided to communal lobbies and stairs. Checks are done on a monthly basis by Sandwell MBC in house electrical team or approved contractor.

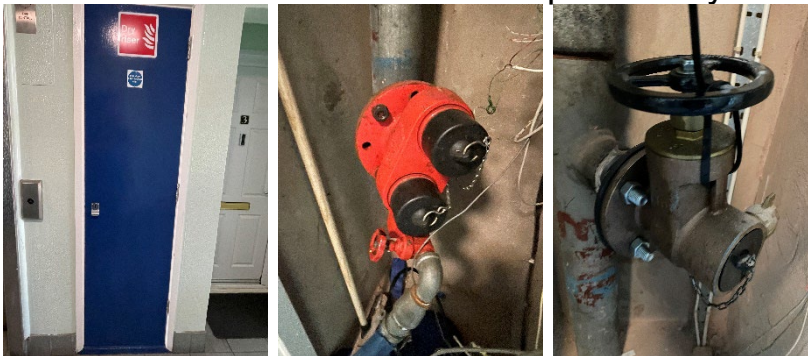
- 16) Dry riser inlet / outlets on lobbies are housed in cupboards with FD30s doors and secured by suited 54 key mortice locks. All outlet valves are secured in the closed position by cable tie.

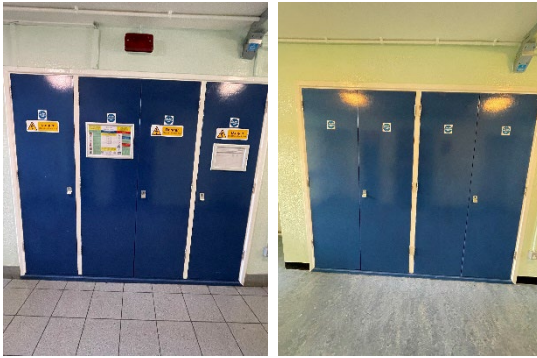
- 17) Service cupboards are 44mm nominal fire doors with intumescent strips and cold smoke seals, secured with type 138 suited mortice locks to allow residents access to their electricity meters.
-

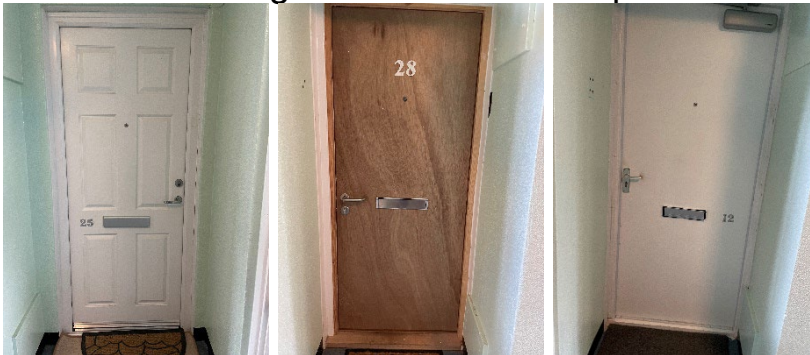
20) Individual flat doors are FD30s composite doors with the majority being manufactured by Permadoor. Flats 12 & 28 have nominal timber flush fire doors with intumescent letterbox liners however, access was not gained for further inspection.

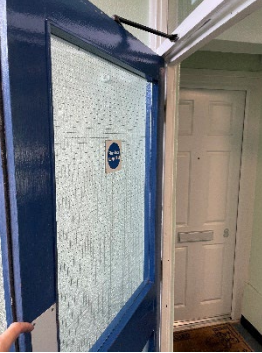
- 22) 1st floor landing door by flat 8 – glazing to upper panel rattles requires re-beading.

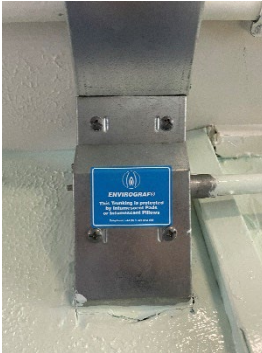
- 23) All trunking for power cables in communal areas are of metal construction and contain intumescent pads or pillows.

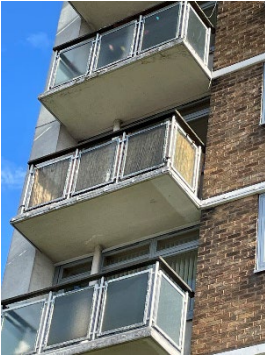
6/3h	Flat 18 remove combustible screening & parasol from balcony.

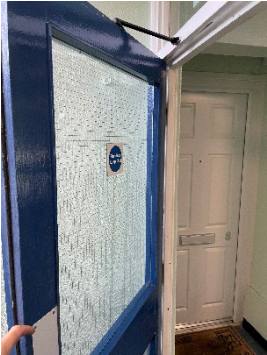
<p>7/22</p>	<p>1st floor landing door by flat 8. Beading requires attention to secure glazing to upper panel, on intumescent glazing tape</p>

<p>P2</p>	<p>Within 1-3 months. Repairs Glazing</p>	
<p>7/24</p>	<p>1st floor by flat 7 door - Refit missing section to trunking. (missing piece is there)</p>

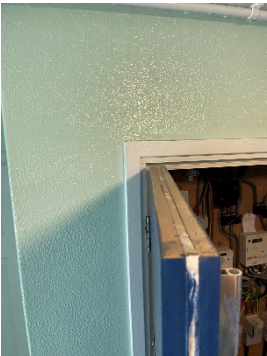
<p>P2</p>	<p>Within 1-3 months. Electrical Compliance Manager</p>	
<p>10/14</p>	<p>All floors – install cold smoke seals to head of service cupboards slave doors.</p>

<p>P2</p>	<p>Within 1-3 months. Fire Rapid Response JM:12143777</p>	<p>02/11/2023</p>

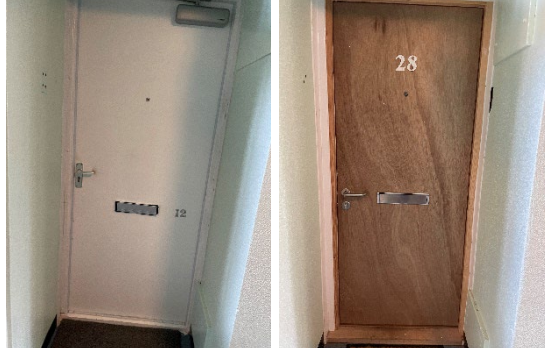
Observations	
Some notional communal landing doors show signs of wear and tear due to age. Consideration should be given to upgrade with certified FD30s door sets & combination frames.

Consideration should be given to install FD30s certified composite door set to flats 12 & 28 as part of a future door programme.
